Failure of a Pipeline in an 800-year Old Debris Fill

FAILURE OF A PIPELINE IN AN 800-YEAR OLD DEBRIS FILL

Paper No. 9.16L

In June of 1994 a 20-m section of 1.4-m diameter, restrained-joint, ductile iron pipe failed during construction of a new section of water pipeline for the city of Cairo in the Arab Republic of Egypt. The failure occurred in an area where the pipe was supported on piles, and compacted silica sand was used as side support for the pipe. Soil above the crown of the failed section of pipe was 6 m or more in thickness. Results of a detailed review of the failure revealed that a number of unique and related factors apparently caused the failure. The most significant of these causes was the native soil surrounding the pipeline, which was formed from an accumulation of 800 years of building and construction debris. At the location of the failure the debris was in excess of 15-m thick. When subjected to water at this location, this debris underwent significant settlement, which eventually led to loss in side support for the pipeline. To repair the pipeline and to avoid future similar failures, a utilidor was used to protect the pipeline in areas where overburden thick

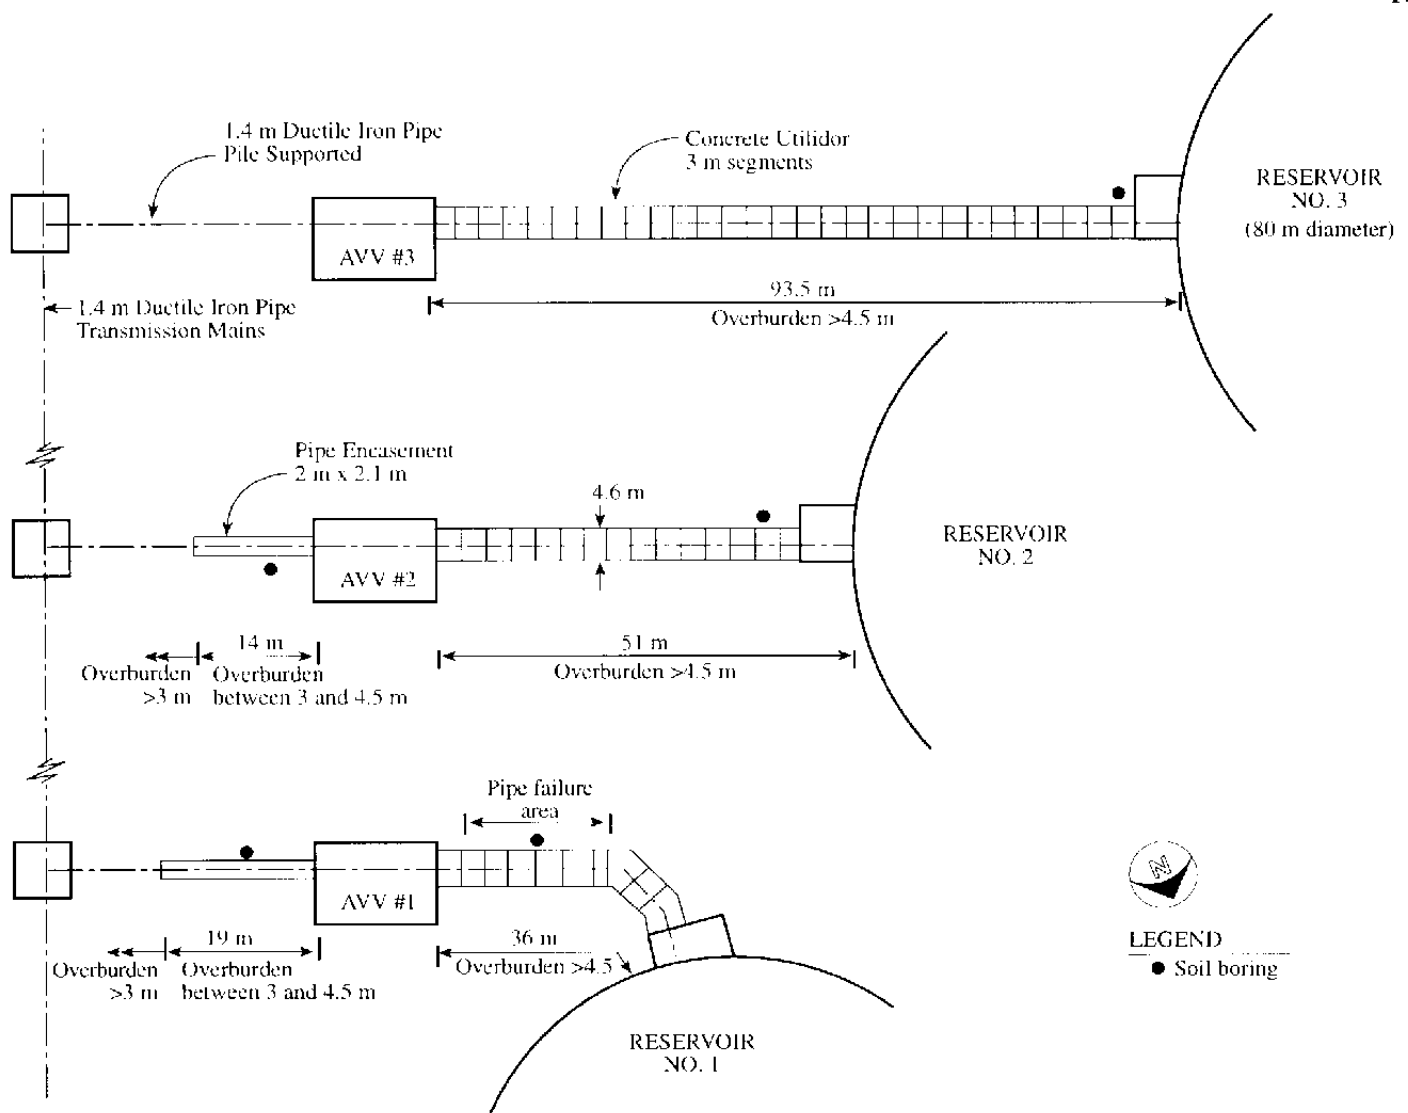
The section of 1.4-m diameter pipe between each of the three reservoirs and the associated AVVs was of primary concern because of the failure near Reservoir 1 and the high overburden loads above the pipe and pile cap. The site and pipeline areas to be modified and/or repaired are shown in Fig. 6. From the post-failure analysis it was concluded that the current pile cap and pipe support design could not handle the combination of large overburden pressures and loss of side support. Alternatives were identified for repairing the pipeline and pile cap conditions from Reservoir 1 and modifying conditions from Reservoirs 2 and 3 to the transmission main.

Fig. 6 Darassa site with three reservoirs, altitude valve vaults, pile-supported pipeline, and transmission mains.

The utilidor consisted of precast concrete "U"-shaped sections each approximately 3-m long and each spanning approximately 4.6 m with a height of 4.1 m. The utilidor sections were designed such that they were not connected to the footings nor to each other, allowing differential movement to accommodate ground settlement.

Each utilidor segment was supported by a relatively flexible, lightly reinforced concrete strip footing 2-m wide and 0.5-m thick. To prevent backfill materials from entering between the segments, a loosely laid nonwoven geotextile covered the exterior face of the utilidor. In addition, the utilidor was developed with a manhole entrance at either end for human access to permit long-term visual inspection and maintenance
