Foundation Problems in a Developing City

SYNOPSIS Foundation problems are normally associated with type of sub strata, soil, rock or any other foreign material met with, and/or if choice of foundation is not compatible with them. In developing cities, the development stress is on highly developed congested areas, limiting the sub soil investigation, and plans to have high rise buildings, requiring deep foundations and some times execution of these posing site problems. The collapse of a multi-storeyed structure caused, according to geotechnical engineers due to overlooking the existance of a drain and a few cases of "composite" foundations are described.

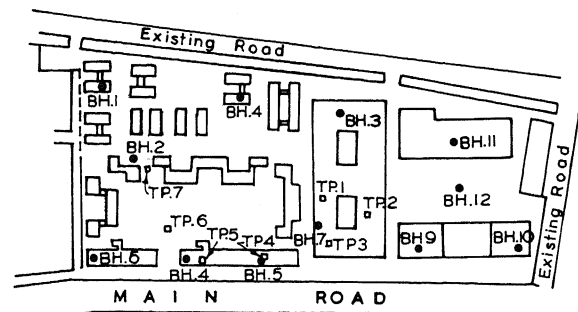
Fig. 2: Layout plan of the housing complex.

Fig.2 is the layout plan of a housing and shopping complex, over a reclaimed area, ruins of old historic structures, residential palace, gardens with deep wells, parks, fountains etc. As shown in the plan a few open trial pits and deep exploratory borings were made and general sub soil profiles are given in Fig.3.
