A Case History of the Collapse Accident of a Temporary Earth Support Structure

SYNOPSIS: This paper presents a case study on the collapse accident of a temporary earth support structure. The examination of the design plans and investigations of the construction site where the accident occurred has been carried out to throw light on the accident situations. Some causes of the accident occurrence which have been derived from these examinations and countermeasures for prevention of these types of accidents are discussed.

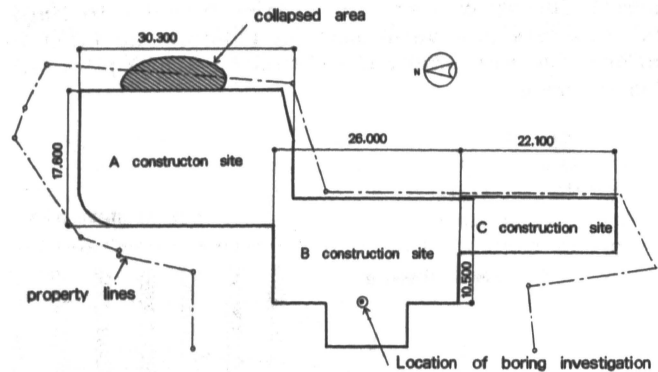
This accident occurred at the building construction site. The ground plan of the construction site is shown in Fig.1. The construction area was divided into three construction sites. The collapse occurred at A construction site which had an excavation area of 17.6 meters wide (north-south direction) and 30.3 meters long (west-east direction).

Fig. 1 The ground plan and the location of boring investigation

Geological survey of A construction site was not performed. However, only one boring investigation had been conducted for the construction of the foundation piles. The location of the boring is shown in Fig. 1. Fig. 2 is the result of the boring investigation. According to this boring log, the ground consisted of cohesive soil (Kanto Loam) from ground level (GL) to -4 meters, sandy silt from -4 to -6.5 meters, fine sand from -6.5 to -9.5 meters and sandy mudstone below -10 meters. The N-value of the sandy mudstone was around 60 and other soil was less than 10. The ground water level was GL-1.5 meters.
