The Santa Helena Dam on Compressible Foundation

The Paper describes the performance of a 28 m high compacted earthfill dam for water supply in Northeast Brazil. For mainly economic reasons, the dam was founded, in part, over soft to very soft silty clays to a depth exceeding 8 metres. Large diameter sand drains were provided to accelerate consolidation in the foundation during construction. Maximum construction settlements of approximately 240 cm were recorded. Results of settlement of spillway structures, pore pressure measurements in the fill and long term settlements, are described in this paper. Transverse cracking of fill occurred as a result of large deformations in the compressible sediments. The cracks were repaired, and the dam is currently operating satisfactorily.

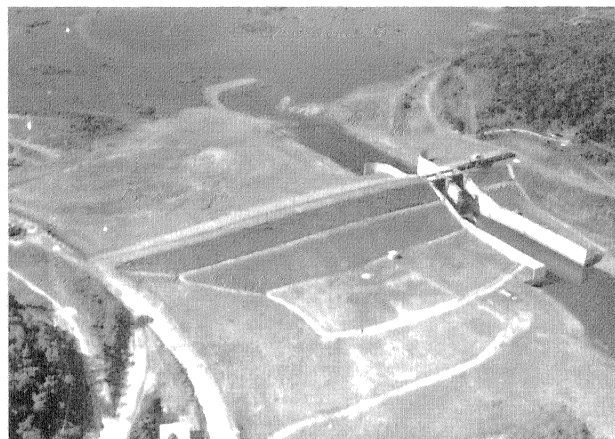
Fig. 1. The Santa Helena Dam

Table 1 lists some principal characteristics of the project. A downstream view of the dam at the end of construction is shown in Fig. 1.

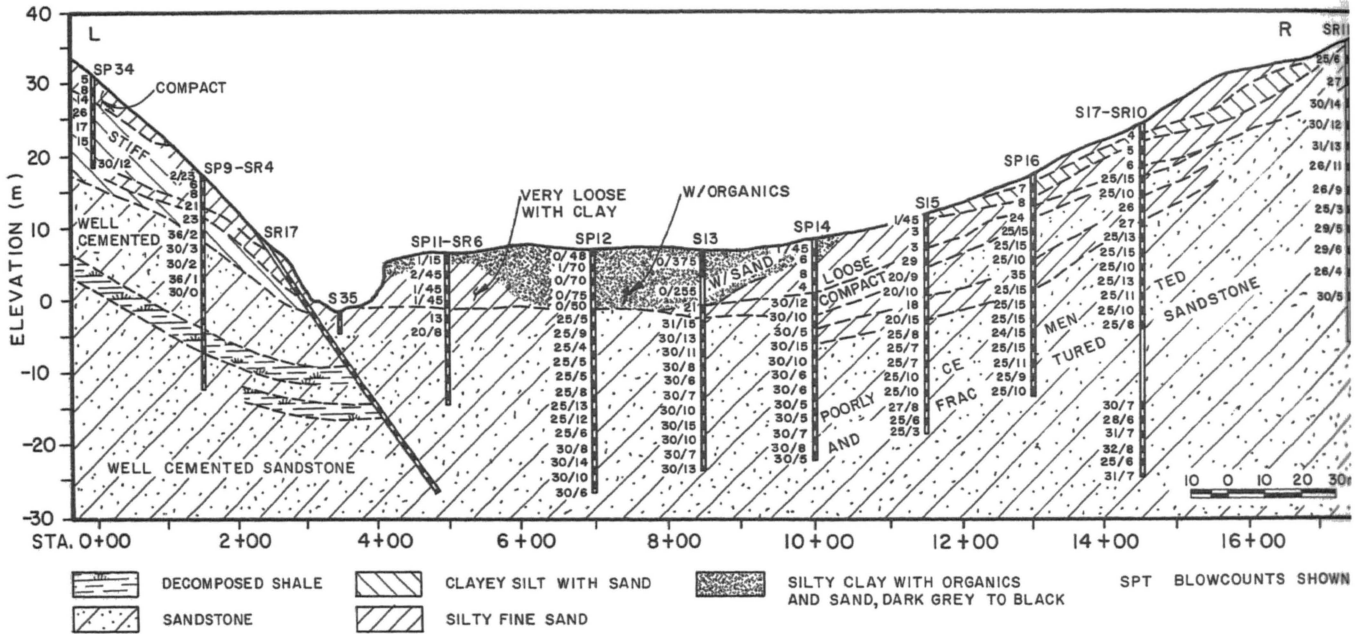
Fig. 2. Subsurface Profile Through Dam Axis

As indicated on Fig. 2, compressible silty clay deposits are encountered in the valley floor, directly underneath the foundation of the dam, to a depth of approximately 8 metres. These silty clays are soft to very soft (often zero SPT blowcount), dark grey to black, and contain some organics. The clay fraction generally varies between 60 and 75%. The soft deposits between Stations 4+50 and 6+00 are significantly more sandy. Fig. 3 shows the typical grain size sand for these clays. The liquid limits range from 33 to 123%; these values are generally above 70 for the very soft deposits. Laboratory edometer tests on 4.7 cm diameter Shelby tube samples indicate the compression index to vary between 0.33 to 2.70. Some samples show an apparent preconsolidation pressure of 0.75- 1.0 kg/cm². The vertical coefficient of consolidation, C_v , ranges from 10^{-3} to 2×10^{-4} cm²/s. Very soft clay samples in the middle of the valley show initial water contents above 200%. These samples are also found to indicate values of compression index in the range of 2.0 to 2.70. The unconsolidated undrained shear

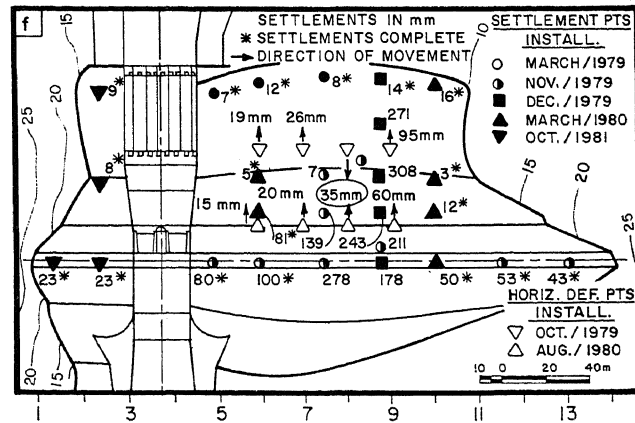
Fig. 5(e) shows post-construction settlement contours of the clay foundation. Settlement

exceeding 420 mm occurred at Stations 8+00-9+00 from August 1979 to October 1983. Fig. 5(f) shows post construction settlements and horizontal movements of both fill and foundation, as observed after installation of the various surface plates. The asterisk denotes measurement points where all settlements have ceased at present.

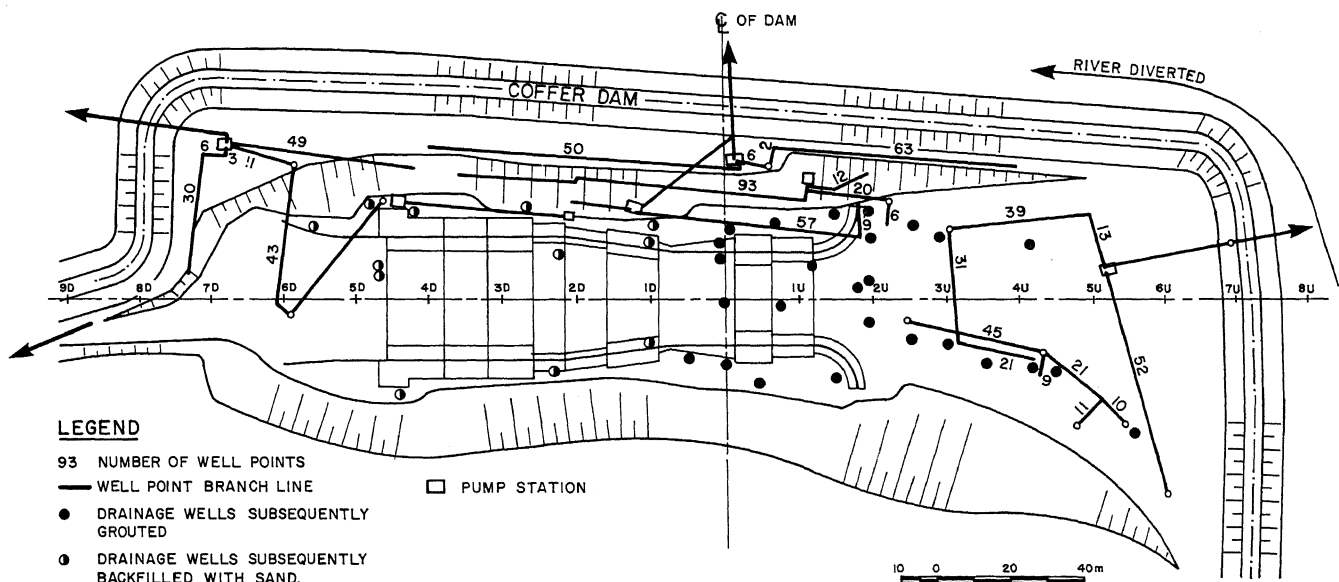
Fig. 7. Dewatering in Spillway Excavation

The excavation for the spillway structure proved to be a difficult task in view of the large inflow of water. Limitation of working area also required some excavation slopes to be steeper than 1:1. Consequently extensive dewatering using well points and deep pumping wells was necessary. Over 700 well points and 38 deep wells, as shown in Fig. 7, were required to enable the foundation preparation to proceed. The water table was lowered by approximately 10.7 metres to El. -3.7. The average flow from the seven pumping stations reached 200 m³/hr. The final excavation depth for the spillway.

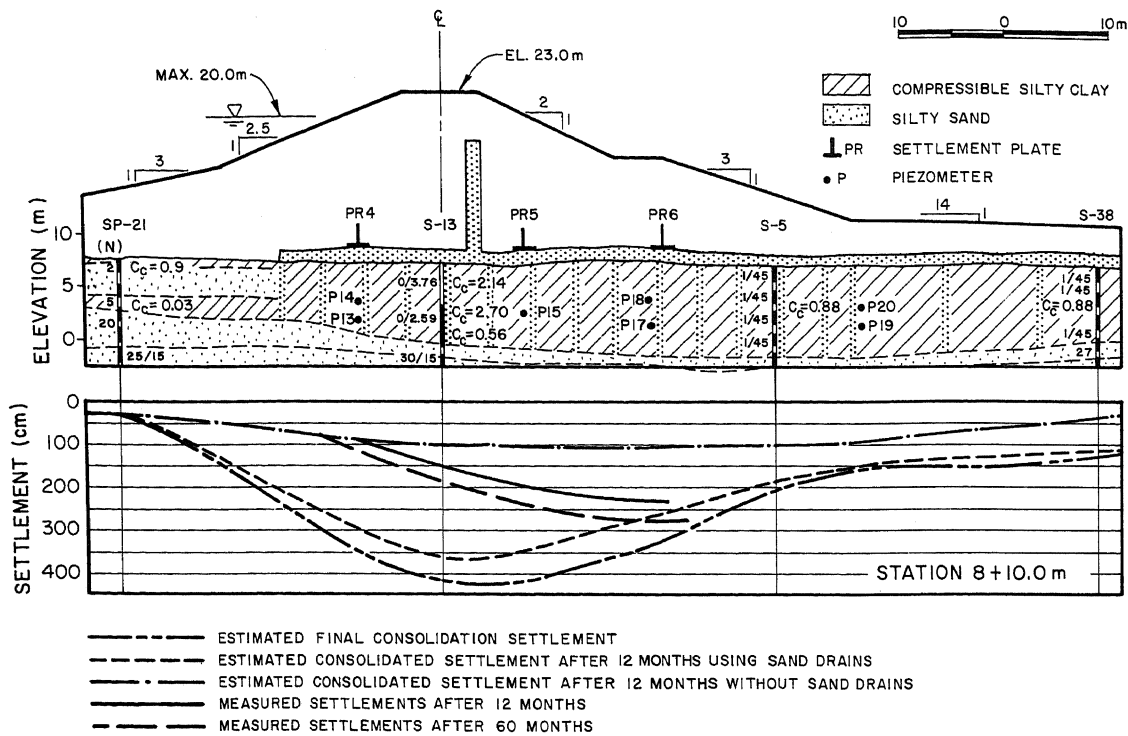
Fig. 3. Estimated and Observed Settlements at Maximum Section

Fig. 8 shows a comparison between the predicted and measured settlements for the maximum section at Station 8+10 m. The measured settlements after twelve months of construction under the centreline of the dam, at drillhole S-13, are almost half of the estimated settlements. After almost five years of settlement data, it can be stated with confidence that the final consolidation settlements under the centreline would be approximately 250 cm in comparison with the estimated consolidation settlement of 420 cm. It would appear that in the case of very soft silty clays, with SPT blowcounts of zero, the value of C_c has been grossly overestimated in laboratory oedometer tests. Some of the difference between observed and measured settlements can also be attributed to the installation of large diameter, compacted, sand drains, which would reduce the mass compressibility of the

soft deposit. Also, in view of the relative stiffness of the sand drains, the load would tend to concentrate on them due to an arching effect, in a manner similar to that for stone columns. The difference in observed and estimated settlements is also a reflection on the variability of fluvial sediments since there is a practical limitation on the quantity of testing that can be undertaken on any project of this nature. Table 2 shows a summary of estimated and measured settlements in the foundation of the dam.

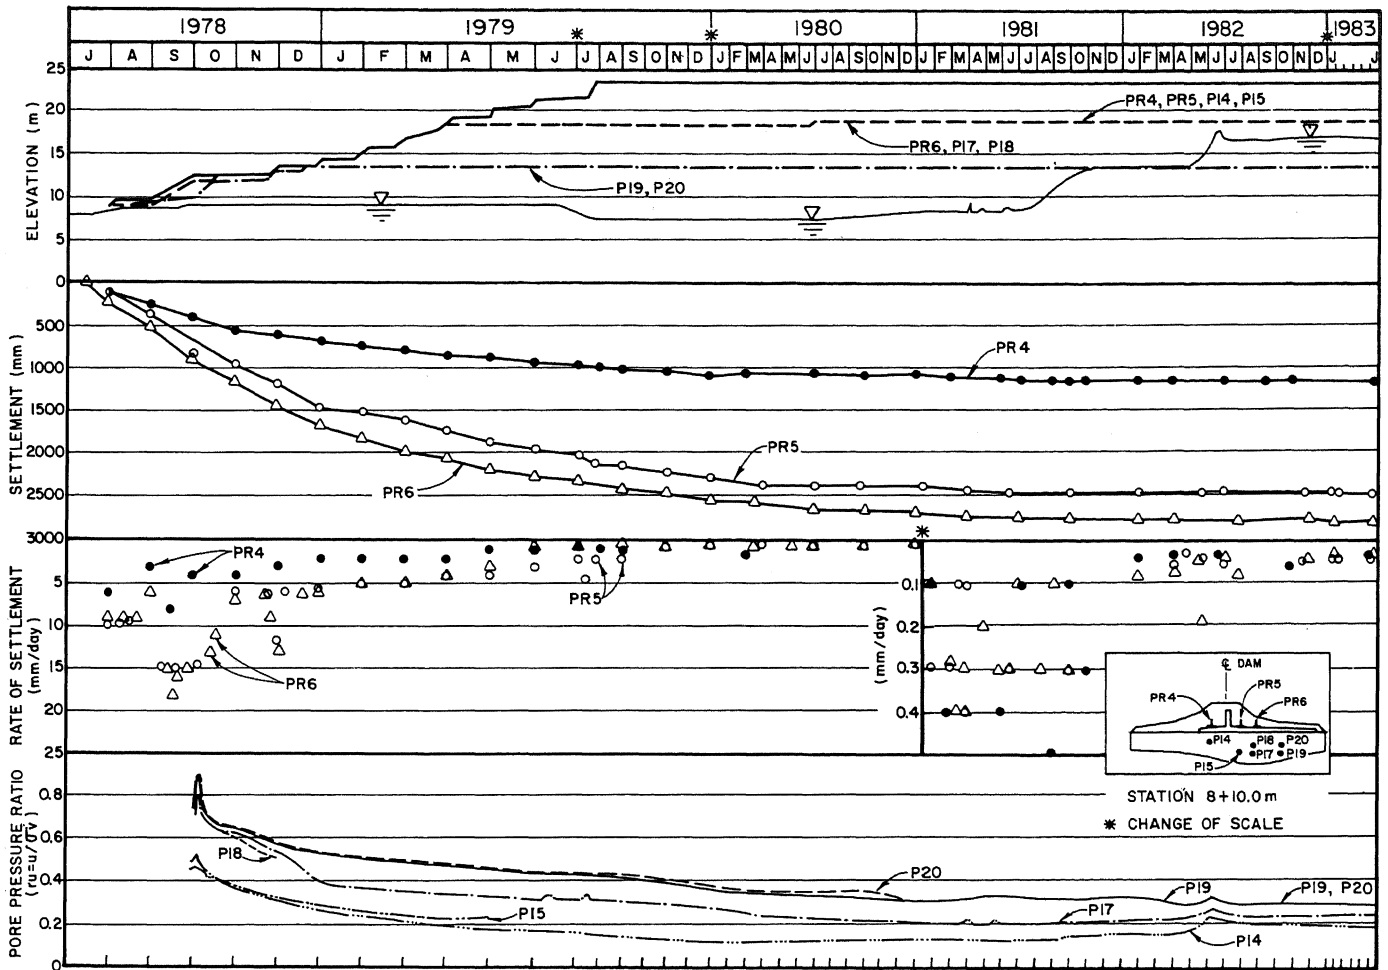
Fig. 9. Variation of Settlement and Pore Pressure with Time

Fig. 9 shows five years of record of settlement and pore pressure measurements at the maximum section with increase in height of fill and reservoir elevation. Over 90% of total settlement occurred during the first 18 months. During early stages of loading, the rate of settlement increased significantly reaching 15 to 1 mm/day in early October. It is interesting to note that this accelerated rate of settlement coincided with alarmingly high pore pressure measurements. Indeed, on the basis of instrumentation readings, the fill placement operation was suspended for 36 days during October and first week of November 1978. The rate of settlements decreased to less than 0.5 mm/day six months after the end of construction. The rate of settlement is currently (Oct. 1983) less than 0.05 mm/day and decreasing.

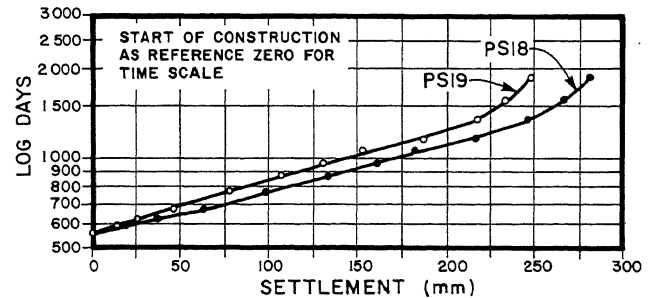
Fig. 10. Long Term Settlements vs Log Time Plot

The diminishing rate of settlements is exemplified in Fig. 10, where settlements of both fill and foundation are plotted on a log time scale. The settlements have been plotted subsequent to January 1980, when over 90% of consolidation settlements had occurred. The thickness of soft clay under settlement points PS18 and 19 was 4.5 metres, respectively. Hence, a strain rate of approximately 0.05% per log cycle is obtained for the 560 to 1500 day interval. The strain rate shows a trend for a significant decrease after 1500 days, possibly as a result of drained creep behaviour. The new strain rate is estimated to be less than 0.02% per log cycle.
