Reconsideration of Failure Initiating Mechanisms for Teton Dam

Reconsideration of Failure Initiating Mechanisms for Teton Dam*

SYNOPSIS A review of failure mechanisms previously suggested for Teton Dam indicated that they were not fully supported by all the available data. The original mechanisms are reviewed and a failure initiation mechanism is then proposed which does satisfy all the available data, and laboratory tests supporting this mechanism are presented. Additional lessons to be learned from the failure are listed.

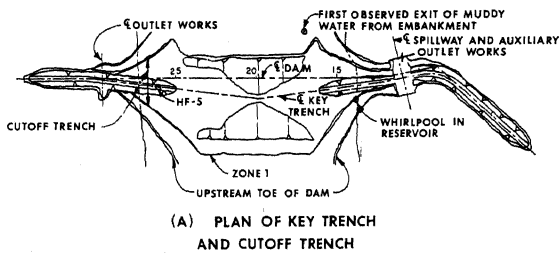
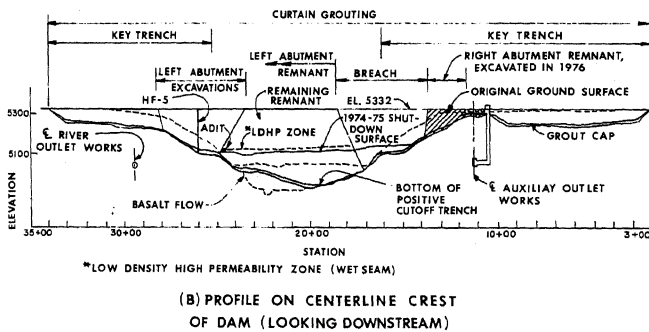
FIG.1 TETON DAM

It is not feasible, nor is it necessary to present herein details of the site conditions, of the design features and the dam configuration adopted, and of the sequence of events preceding failure, as an excellent summary of all these facets is readily available (Seed and Duncan, 1982). However, for general reference, a plan and a profile along the dam axis is shown in Fig. 1. In particular, the geometric similarity of the key trenches in the abutments is noted. From the location where muddy water was first observed to emerge on the downstream face of the dam, from the pattern in which the failure progressed, and from the location of the whirlpool that developed in the reservoir prior to breaching, it can be deduced that failure was initiated in the key trench near Sta. 14+00 and approximately at El. 5200.
