RESTORATION OF EQUALIZATION AND AERATION TANKS OF EFFLUENT TREATMENT PLANT AT THE MYSUGAR FACTORY, MANDYA, KARNATAKA, INDIA

This paper deals with the restoration measures resorted to strengthen the structure and prevent the leakage of the equalization and aeration tanks of effluent treatment plant in a sugar factory. These tanks showed distress at the hydraulic test itself before commissioning due to the failure of the reinforced concrete floor and bund lining on account of loss of support due to excessive deformation of the substratum. Extensive sand piling was resorted to strengthen the substratum before recasting the reinforced concrete floor and bund lining to ensure structural stability and prevent leakage. These tanks are functioning satisfactorily since two years after restoration serving the intended functions of the effluent treatment.

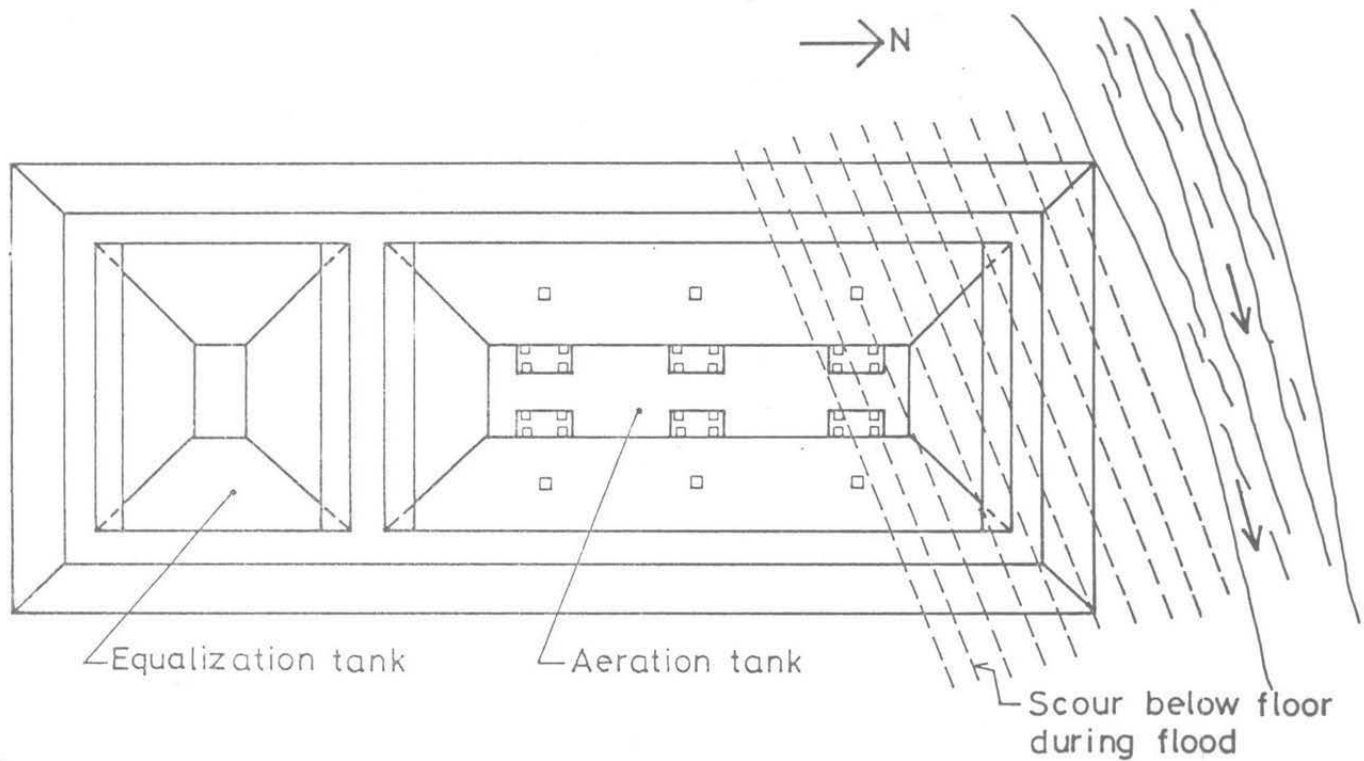
Fig. 1 Layout plan of equalization and aeration tanks.

It can be seen in the plan that a stream runs in the west south direction very close to the bund of the aeration tank. It was imperative that these tanks had to be subjected to hydraulic test before being cleared for their intended purposes. The tanks did not pass through this test. Profuse leaking of water of the order of 2000 liters per hour from the equalization tank and 50000liters per hour from aeration tank were noticed. At this stage detailed investigations were undertaken to find the causes for this leakage and as well as, if possible, to restore these tanks by resorting to suitable measures.
