Post-Earthquake Failure of a Tailings Dam Due to Liquefaction of Pond Deposit

Post-Earthquake Failure of a Tailings Dam Due to Liquefaction of the Pond Deposit

Kenji Ishihara

Department of Civil Engineering, University of Tokyo

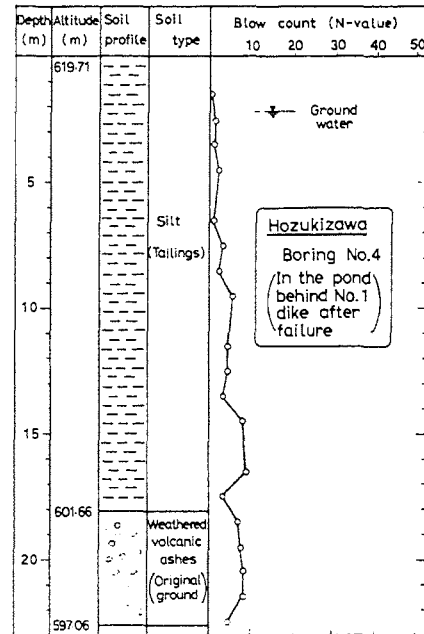
Fig. 9. Soil profile behind No.1 dike (From report of the investigation committee)

main body of the starter dam. It may be seen in Fig. 8 that the fill had a blow count value of 3 to 7 in the standard penetration test. The log of Boring 4 conducted in the interior part of the pond indicates that there exists a thick layer of tailings sludge down to a depth of 18 m underlaid by an original deposit in the mountain. The result of the standard penetration test indicates blow count values on the order of 1 to 2 near the surface but somewhat larger values of 4 to 9 in the lower half portion of the sludge deposit. The progression of consolidation with drainage towards the permeable bed soils may have stiffened the slime deposit near the bottom of the disposal pond. Near the surface which coincides with the failure plane, the penetration rod sank by its self-weight to a depth of 2 m without any hammer blow. The presence of the extremely soft layer must have accrued as a result of liquefaction developed to this elevation during the quake. The log of Boring No. 10 drilled in the center of the pond indicates a

complete soil profile from the pre-earthquake surface level not stripped off by the failure. The blow count value is equal to zero down to a depth of 15 m, whereupon it increases to a value between 3 and 6 near the bottom of the slime deposit. Underneath the slime layer there exists the original deposit of the mountain consisting mainly of weathered volcanic ashes. The fact that there is little resistance to penetration down to the depth of 15 m does not appear to have ever been so, but seems to have been caused by the occurrence of liquefaction due to the earthquake.

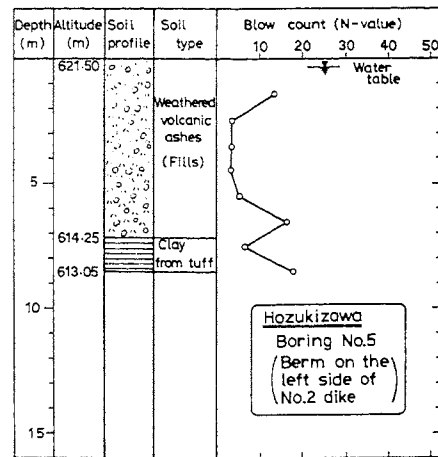
Fig. 12. Soil profile at No. 2 dike (From report of the investigation committee)

during the earthquake. The layers of deposit underlying the tailings slime are those of original mountain deposits at this site, as can be seen from the location of this boring site shown in Fig. 5. The soil profile data at Boring No. 5 shown in Fig. 12 was obtained from the top of the starter dam and accordingly it misses the

portion of the slime deposit. The standard penetration test results show a blow count value of 4 to 5 for the bulldozer-rolled fill of the starter dam. Still another log of Boring 7 obtained from the top of an intact portion of the No.2 dike indicates, as shown in Fig. 13, that the bulldozer-rolled fills constructed by the stepwise top additions had a blow count value of approximately 5.

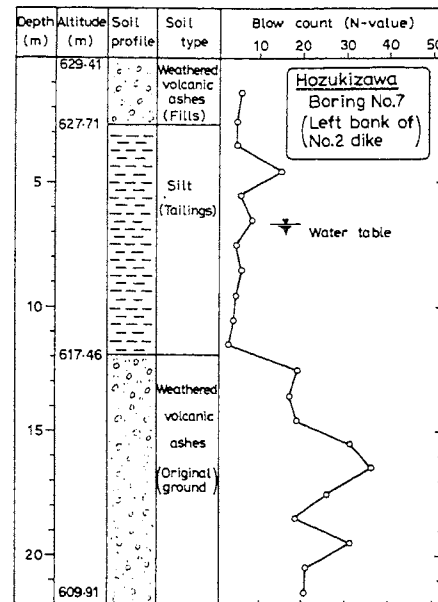
Fig. 13. Soil profile at No.2 dike (From report of the investigation committee)

Reviews of the boring logs as above indicate generally that the slime deposit near the bottom of the pond had been consolidated having a blow count value of 3 to 7, whereas the slime near the failure surface was soft having almost zero

blow count value probably because of the remolding due to liquefaction. The containment dikes constructed by additions of several steps of bulldozer-rolled fills had a blow count value of approximately 5 and a similar degree of penetration resistance was observed for the portion of the starter dam.

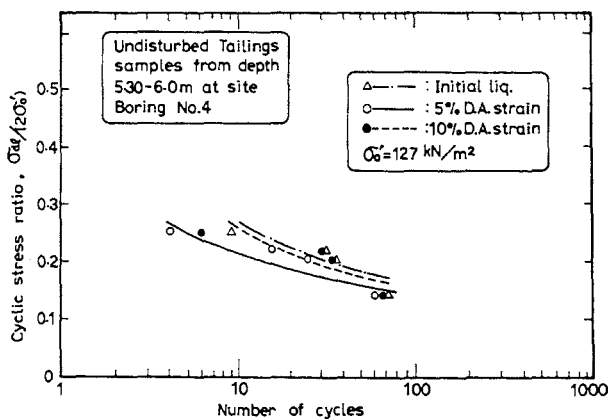
Fig. 16. Cyclic stress ratio versus number of cycles for undisturbed tailings samples from the pond (From report of the investigation committee)

between the cyclic stress ratio, $\sigma_{dl}/2(\sigma'_0)$ versus the number of cycles required to produce 5 % double-amplitude axial strain in the test specimen, where σ_{dl} denotes the amplitude of cyclic axial stress and σ'_0 is the initial confining pressure. Fig. 16 shows that the cyclic stress ratio causing 5 % double-amplitude axial strain in 20 cycles is on the order of 0.2. The results of the tests on other samples from different sampling sites and from different depths showed more or less similar values of cyclic strength to those shown in Fig. 16. Scrutiny of all the test results showed that the cyclic strength of the Mochikoshi tailings may as well be represented by an empirical formula which is promulgated in the Japanese Design Code for tailings dams (Ishihara et al, 1981). According to the code, the cyclic stress ratio causing 5 % double-amplitude strain in 20 cycles of load application, R_L , is expressed as,

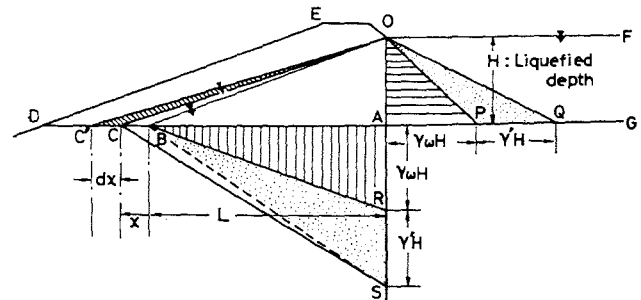
Fig. 21. Setting for analysis of phreatic surface movement

It is highly likely that the build-up of pore water pressure due to liquefaction in the deposit behind the dike created an unbalanced state of seepage conditions within the deposit underlying the dike. A newly created hydraulic gradient appears to have then raised the elevation of the phreatic surface within the dike, leading eventually to a precarious condition of the embankment even in the static state after a series of earthquake shakings. It would, therefore, be necessary first to explore a possibility of analytical treatment in which time-changes of the phreatic surface can be assessed.

developed to a depth of H and any change in seepage conditions in the deposit below this elevation can be disregarded. The dike constructed of cohesive materials is represented by the section OEDB in Fig. 21 and a deposit of tailings below the dike is represented by a triangular section OBA. It will also be assumed that the phreatic surface had been located, prior to the earthquake, along the interface OB between the main body of the dike and the underlying tailings deposit. If the ground water level within the pond is assumed to coincide approximately with the surface of the tailings deposit, and if the tailings below the dike is assumed to have completed consolidation, then water pressure at depth, H, prior to the earthquake is $\gamma_w H$ and its distribution is hydrostatic as indicated by OAP in Fig. 21, where γ_w is unit weight of water. It may as well be assumed that the pre-earthquake water pressure distribution along a horizontal plane AB at depth, H, is represented by a triangle ABR.

the dike might not have undergone liquefaction because of a high confining stress exerted by the overlying dike fills. Therefore, it will be assumed that any pore water pressure change in the deposit below the dike were not brought about by the liquefaction of its own but caused by a propagation of the excess pore water pressures from the liquefied deposit behind the dike. Upon development of liquefaction in the pond, the hydrostatic pressure at depth, H, rose by an amount, $\gamma'H$, as indicated by PQ where γ' is unit submerged weight of the tailings material. Therefore, the pressure distribution along the horizontal plane AB may well be assumed to have increased by an amount represented by a triangle RBS in Fig. 21. It may as well be assumed that such a change in pore water pressure distribution has taken place in a relatively short period of time following the onset of liquefaction. The increase in pressure as above then created a hydraulic gradient which is directed towards the surface of the bank and accordingly migration of water is expected to have been motivated in the direction of ascending the phreatic surface within the dike. The configuration of the phreatic surface will be assumed to be a straight line passing through point O at all instances of time during the ascent of the phreatic surface. To develop an analysis for the phreatic surface movement let it be assumed that within a time interval, t, from the onset of liquefaction the phreatic surface has moved from the location OB up to OC, which is represented by the coordinate, x, taken leftwards from point B in Fig. 21. At this instant of time, the hydraulic gradient of water flow may be taken as

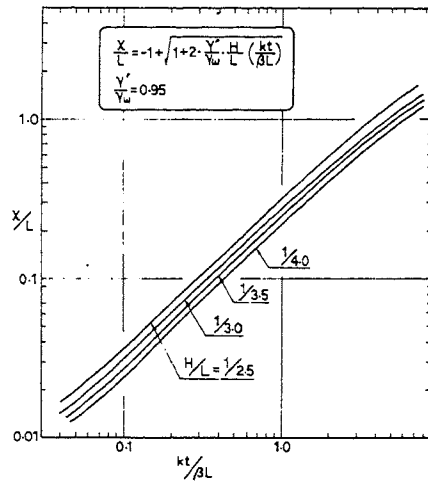
Fig. 22. Travel distance of phreatic surface with time

The relationship of Eq. (5) is numerically presented in Fig. 22, where the ratio, x/L , specifying the front of the moving phreatic surface is plotted versus the time factor, $kt/(\beta L)$, for different values of H/L . Considering a most representative case encountered with tailings deposits, the buoyant unit weight, γ' , is assumed to be 9.5 kN/m^3 .

Read off from Fig. 22 a value of x/L corresponding to the time factor of 0.034, one obtains $x/L = 0.013$ and, therefore, the travel distance of the phreatic surface is estimated to be $x = 0.013 \times 21 = 0.27$ m.

The movement of the phreatic surface as computed above is too short to produce any significant change in a seepage condition influencing the stability of the dike. Therefore, some factors appear to be missing, and some other thoughts may need to be explored.

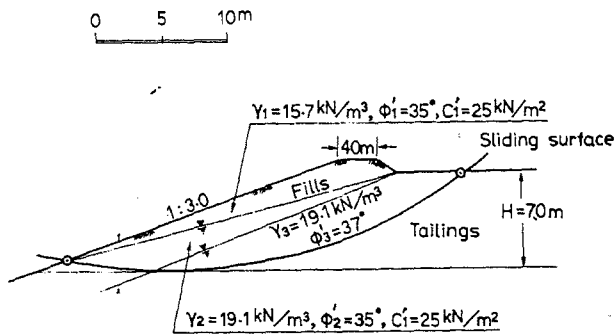
Fig. 23. Sliding surface and soil properties used in the stability analysis

The factor of safety was computed by means of the formula in Eq. (3) whereby disregarding the pseudo-static seismic force terms. Exactly the same soil profile and soil strength parameters as shown in Fig. 23 were employed in the stability analyses. The term allowing for the excess pore water pressure was evaluated graphically as illustrated in Fig. 25. This figure

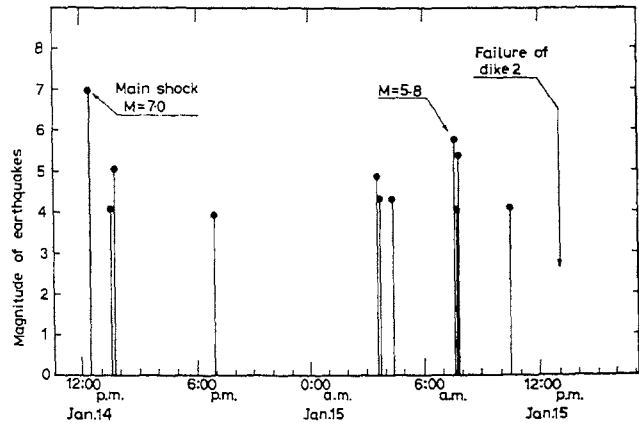
Fig. 24. Occurrence of aftershocks with magnitude greater than 4.0 following the main shock of the Izu-Ohshima-Kinkai earthquake

about 9:00 a.m. on that day. A chain of events that occurred during this period of time is displayed in Fig. 24. It can be seen that a pair of greatest aftershocks with magnitude, 5.8 and 5.4 successively occurred at 7:31 a.m. and 7:36 a.m., respectively, on January 15th, (Tsumura et al, 1978). On the other hand, as mentioned in the foregoing section, a surveillant discovered several strips of fissures running in parallel to the axis of the dike after this series of aftershocks. This fact would appear to indicate that a larger number of invisible

cracks were created within the fills as a result of the shakings due to the pair of the greatest aftershocks. Therefore, there are reasons to believe that the permeability of the dike had been significantly enhanced. Although there is no way for knowing a correct permeability characteristics, it may well be assumed with a judgement that the gross permeability coefficient had increased to a value on the order of magnitude of $k = 2 \times 10^{-2} \text{ cm/sec}$ as a result of crack development over the slope of the No.2 dike. It may as well be assumed that the period of elapsed time between when the permeability was significantly increased and when the failure took place in No.2 dike is approximately 5.5 hours

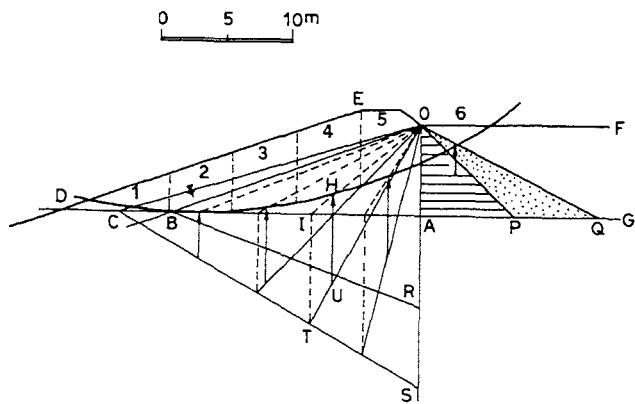
Fig. 25. Layout for the stability analysis

plane ABC may well be represented by a rectangle RSCB. In the computational scheme of stability, a sliding circle was determined from the observed surface of failure in No.2 dike, and the soil mass above this sliding plane was divided into 6 slices as shown in Fig. 25. To illustrate the graphical procedure for estimating the pore water pressure, consider a sliced soil element labelled "4" in Fig. 25. Since the pore water pressure at point I is represented by the length IT and that at the surface point O is zero, the distribution of pore water pressure along the line OI may be approximated by a straight line OT. Therefore, at point H at the bottom center of the slice 4 in question, the total pore water pressure can be determined by drawing a vertical line through point H and locating the point U at its intersection with the line OT representing the distribution of pore water pressure along the line OI. The total pore water pressure at point H is therefore represented by the length HU. The pore water pressures thus determined for all other sliced soil elements, being indicated by upward arrows in Fig. 25, were employed in the computational scheme of stability analysis using the formula in Eq. (3). Factors of safety were computed in this manner for several stages of movement of the phreatic surface. The result of these analyses is presented in Fig. 26. by

shows a state of the dike profile where the front of phreatic surface has advanced to point C halfway between the initial location, B, and the point D at the toe of the slope surface. It is assumed, as mentioned in the foregoing section, that the pore water pressure at point A had increased by an amount, $\gamma'H$, as a result of liquefaction that developed in the pond behind the dike. Therefore, the excess pore water pressure at point A is laid off as the length RS on the diagram by an appropriate scale. Since there exists a sufficient amount of liquefied material behind the dike, and hence a continuous supply of water from behind, the magnitude of excess pore water pressure at point A may be assumed to have remained unchanged for a reasonably long period of time. On the basis of this assumption, the distribution of excess pore water pressure on the horizontal

of the tailings deposit underlying the dike but not yet pushed up the initial level of the phreatic surface prior to the earthquake. In the computational scheme shown in Fig. 25, the distribution of pore water pressure along the horizontal plane GD was taken to be a triangle of ASB for the stability analysis of this stage. Since no significantly strong aftershock had taken place until 7:30 a.m. in the morning of the next day, the front of the phreatic surface had not presumably advanced to an extent producing any significant change in the computed factor of safety. However, when a couple of large aftershocks occurred around 7:30 a.m., several strips of visible fissures developed over the surface of the dike, leading to a sharp increase in the permeability of the dike fills. From then on, the front of the phreatic surface had presumably moved at a faster rate whereby reducing gradually the factor of safety. The decreasing feature of the computed factor of safety during this stage is also shown in Fig. 26. At about 1:00 p.m., 5.5 hours after the occurrence of the large aftershocks, the phreatic surface had probably moved through a distance of about 8.6 m approaching the toe of the dike surface bringing the embankment to a very precarious state. The computed factor of safety at this stage was 0.98 as accordingly indicated in Fig. 26, and, therefore, the safety of the dike is considered to have been seriously endangered. It is indeed at this stage that the failure actually took place in the fills of the No.2 dike.
