(1984) - First International Conference on Case
Histories in Geotechnical Engineering

Quest and Probe Related to Erosion in the Wrap-Around of an Embankment

R.J.R. Cardia

Civil Engineer, Civil Engineering Central Laboratory, CESP, Ilha Solteira, SP, Brazil

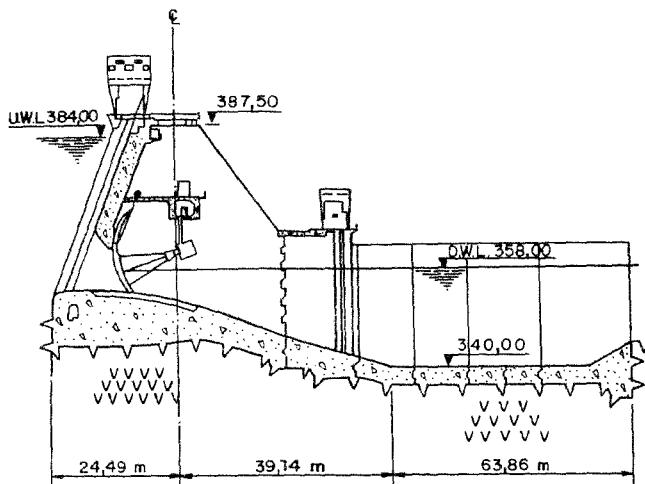
Fig. 2 - Section through bottom outlet and stilling basin.

During one of the aforementioned routine underwater inspections (1977), large amount of salt blocks, iron rebars and scaffolding pipes and bracing components were found, scattered over the stilling basin, near the end sill. Initially, those materials were suspected to have been detached and drawn backward from the protected rock-bottom downstream, by recirculating water.
