Structural Damage of a 5-Storey Building: Differential Settlement Due to Construction of an Adjacent Building or Because of Construction Defects?

STRUCTURAL DAMAGE OF A 5-STOUREY BUILDING: DIFFERENTIAL SETTLEMENT DUE TO CONSTRUCTION OF AN ADJACENT BUILDING OR BECAUSE OF CONSTRUCTION DEFECTS ?

ABSTRACT

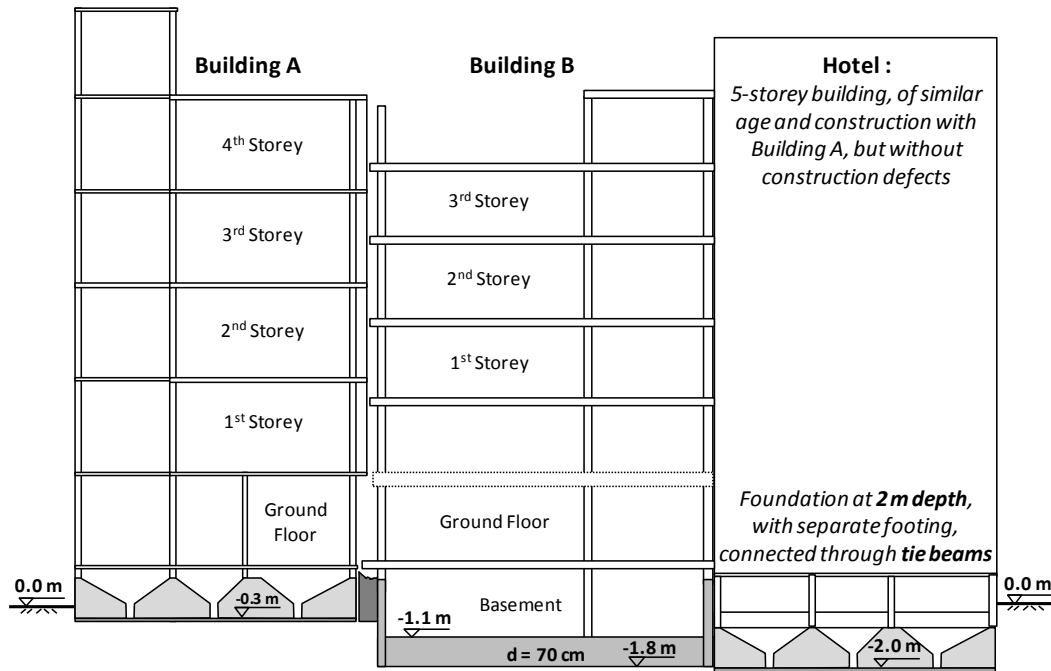
Fig. 1. Sketch showing the damaged Building A, the under-construction Building B, and the neighboring Hotel Building.

The damage to Building A first appeared in July 1999, just before completion of the erection of the RC frame of Building B, and consequently about 3 months after completion of the basement excavation. Therefore, it would not be reasonable to associate the damage with inadequate retaining during excavation, since in such a case the damage should have appeared much earlier. The damage is mainly in the form of shear cracks on infill walls in the transverse direction and distortions of internal door frames. An example of the observed cracks is shown in **Fig. 4a** (see **Fig. 2** for the exact location). Inclined at approximately 45° , the observed shear cracks are indicative of differential settlement of the first column row (closest to Building B) with respect to the second one (see also **Figs. 1** and **2**).
