Geotechnical Forensic Investigation of Observed Cracks on a Building in Tallahassee, Florida

GEOTECHNICAL FORENSIC INVESTIGATION OF OBSERVED CRACKS ON A BUILDING IN TALLAHASSEE, FLORIDA

In July 2010, two vapor extraction wells were installed about 15 feet from a building at an angle of 50 degrees to the horizontal using rotosonic drilling technique (RDT). In June 2011, a crack approximately 0.5 inch wide on the wall of the building was reported. Several other small cracks were observed on the building following inspection by the authors. The owner of the building expressed concerns that the rotosonic drilling was the cause of the cracks and wanted assurance that subsequent drillings would not exacerbate the problem.

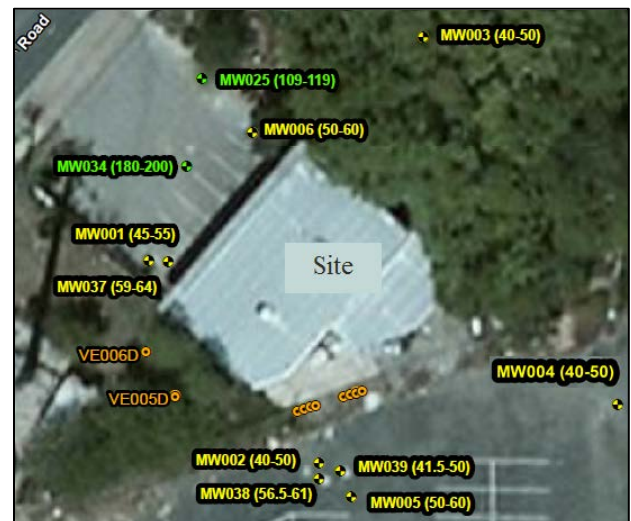
The site consists of a single-story concrete block masonry building on an approximate 0.5-acre parcel of land and is located in Tallahassee, Leon County, Florida. Dry cleaning operations at the site reportedly started in 1958 and continue to the present day. Over time, soil and groundwater at the site have been impacted with dry cleaning solvents, primarily tetrachloroethylene (PCE). As a result, the site is currently undergoing remediation under the Florida Department of Environmental Protection (FDEP) Dry Cleaning Solvent Cleanup Program. As part of the site assessment and remedial activities, soil borings and groundwater monitoring wells have been completed near and in the vicinity of the building since early 2006 by Ecology and Environmental Inc. (E&E, 2007a,b) and Geosyntec Consultants (2008, 2010). The locations of soil borings and groundwater monitoring wells completed as part of these investigations are shown on Fig. 1.

Fig.1. Site layout and location of monitoring wells.

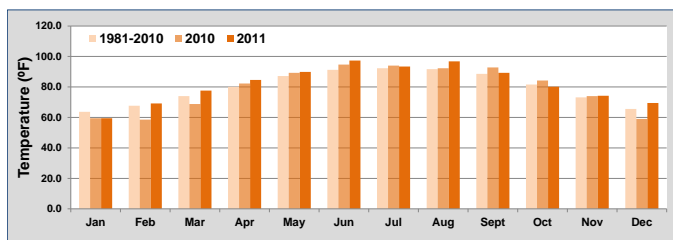
Historic temperature and precipitation data were obtained from NWS’s Tallahassee weather station. Figure 5 presents the monthly average maximum temperatures for 2010, 2011, and average values from 1981 to 2010. The monthly average maximum temperature for the past 30 years ranged from 63.7 to 92.3 degrees Fahrenheit (°F). However, in 2010 they ranged from 58.6 in February to 94.7 °F in June.

Fig. 5. Monthly average maximum temperatures (°F) in Tallahassee, Florida.

Further, according to NOAA, June of 2011 recorded the all-time high temperature of 105 °F in Tallahassee with a monthly average maximum temperature of 97.3 °F. It should be noted from Fig. 5 that the 2010 and 2011 summer (June through

September) temperatures were all higher (0.6 to 6.1 °F) than the monthly average maximum temperatures for the past 30 years. Further, it was observed that the monthly average temperature for 2010 and 2011 summer were all higher (1.4 to 4.2 °F) than the average temperatures for the past 30 years.

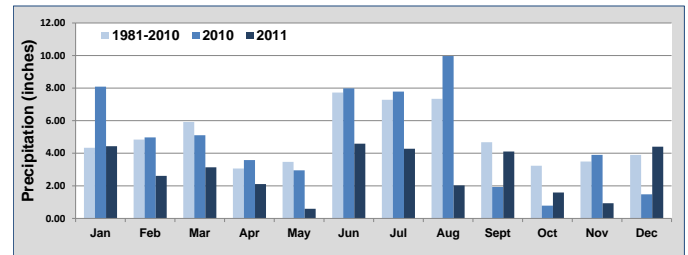
Fig. 6. Monthly average precipitation (inches) in Tallahassee, Florida.

It was observed that August 2010 experienced very high precipitation, immediately followed by two months of very low precipitation as compared to the average precipitation. On September 1, 2010 the NWS of Tallahassee reported “...rainfall at the Tallahassee Regional Airport for August measured 9.97 inches, 2.94 inches above normal. There were 20 days with measurable rainfall which was 5 above normal. The greatest amount in a 24-hour period was 2.31 inches on August 4th...” [<http://www.srh.noaa.gov/tae/?n=summer2010>] Further, it was observed that the precipitation from January to August 2011 was significantly low relative to the average precipitation.

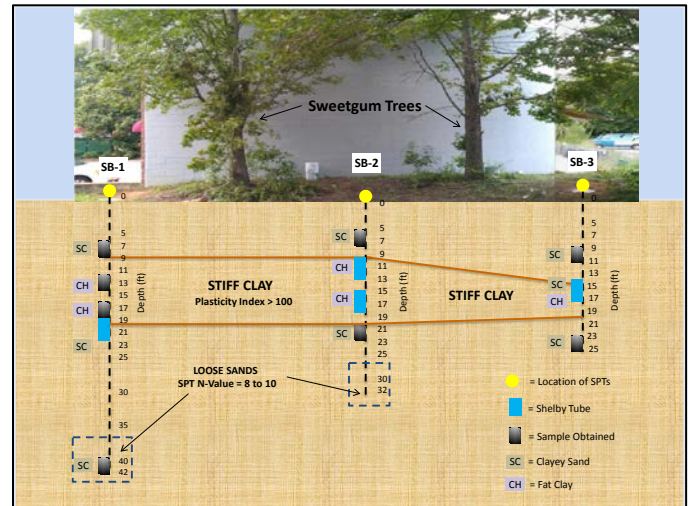
Three SPT soil borings, designated as SB-1 through SB-3, were advanced at the locations shown in Fig. 9 using hollow-stem auger (HSA) drilling techniques. As shown in Fig. 9, all three soil borings were advanced near the southwest wall of the structure which had evidence of cracking. Soil boring SB-1 was advanced to a total depth of 42 ft. whereas SB-2 and SB-3 were drilled to the depths of 32 and 25 ft., respectively. Soil sampling and SPT blow counts were performed using split-spoon sampling procedures (ASTM D 1586) during soil boring advancement. Continuous soil sampling was performed for all the borings up to 25 ft. BLS and then at 5-ft. intervals.

Fig. 9. SPT soil boring and sampling.

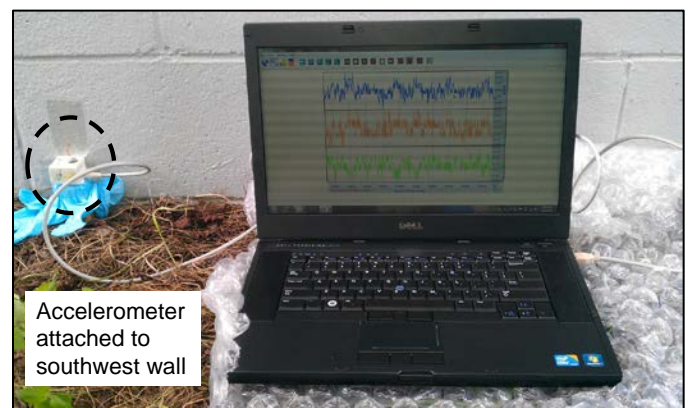
Fig. 10. Real-time vibration monitoring using an accelerometer connected to a personal computer.

The recording location is shown in Fig. 10 relative to drilling location SB-2. The recording was performed during the HSA drilling and the SPTs at boring SB-1 and SB-2. During boring
