Rapid Recovery of Demolished Young-Dong Highway 205.4km Due to Heavy Rain

RAPID RECOVERY OF DEMOLISHED YOUNG-DONG HIGHWAY 205.4KM DUE TO HEAVY RAIN

ABSTRACT

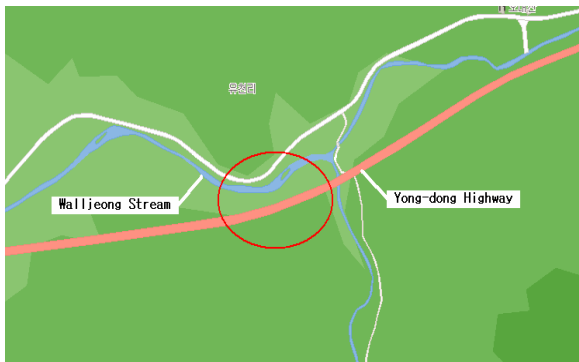
Fig.2 Geometry at 205.4k of Yong-dong highway

The destroyed location of Yong-dong highway that goes through many mountains is the westbound two lanes near 205.4km from the west end. Fig. 2 shows the westbound lane is contact on Walljeong stream, whose bed slope is 4.26% and drainage area is 130.75km². The steep bed slope of the stream makes a rapid flow in a heavy rainfall in spite of S-shape stream channel, and it makes S-shape's head sharpened. Fig. 3 shows a horizontal and vertical geometry. If the highway moved toward the mountain to escape a contact of the stream, excavation of the mountain would be higher and it would have more possibilities for rocks to fall. High mountains and deep valleys gave us a difficulty to choose highway geometry. Fig. 4 shows cross section drawings at 205.4k before the accident. The westbound lane

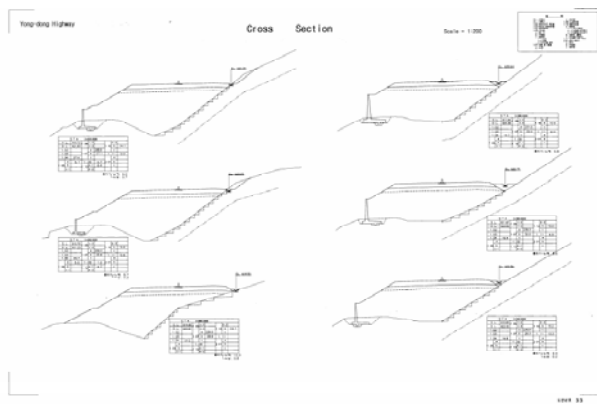
Fig.4 Cross section at 205.4km of Yong-dong highway

of the highway has concrete retaining walls and the eastbound lane is contact on mountains without excavating mountains, which have a steep slope and are very high. Most of this area is consist of granite, and lots of small rocks that are made from small wedge and toppling failure fall frequently.
