International Conference on Case Histories in Geotechnical Engineering

Technical Analyses and Lessons of The Embankment Failure at the Ajka Red Mud Reservoir

TECHNICAL ANALYSES AND LESSONS OF THE EMBANKMENT FAILURE AT THE AJKA RED MUD RESERVOIR

József Mecsi

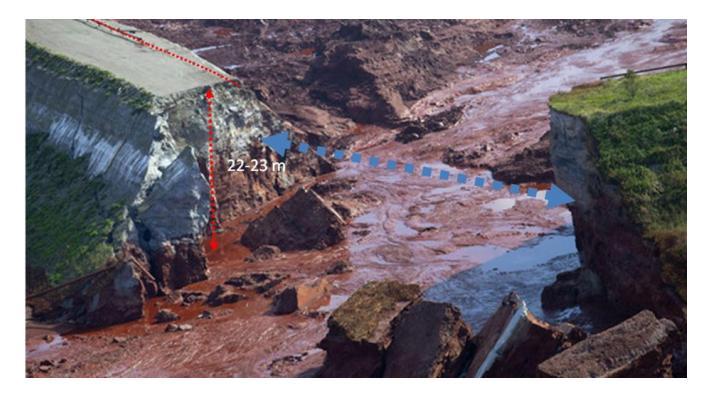
On October 4, 2010 at 12:25 the northwestern part of the dam of red mud reservoir No. 10 has collapsed, and near one million m³ alkaline red mud mixed with water has plunged in the valley of the Torna stream. Fig. 1.-Fig5. The red mud flooded the valley-side parts of the village Kolontár and the town Devecser, then trough the Marcal river it has reached the river Danube in very short time. 10 people died, 123 injured, 260 houses became uninhabitable, and significant ecological damage occurred.

Fig. 4. Aerial photo with the alkaline red mud mixed with water extension

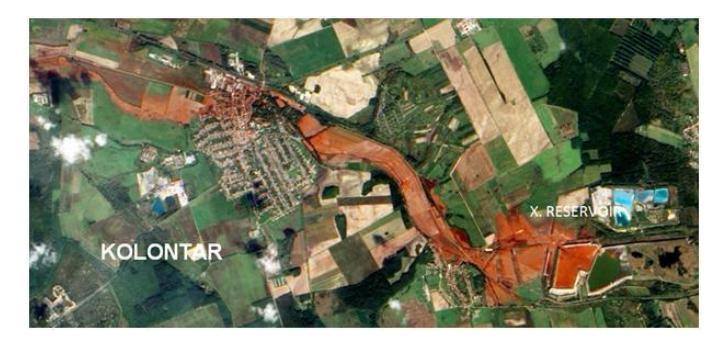
Fig. 5. Natural-color satellite image of the area surrounding the spill(http://redsludge.bm.hu/wpcontent/uploads/2010/10/image002.jpg)

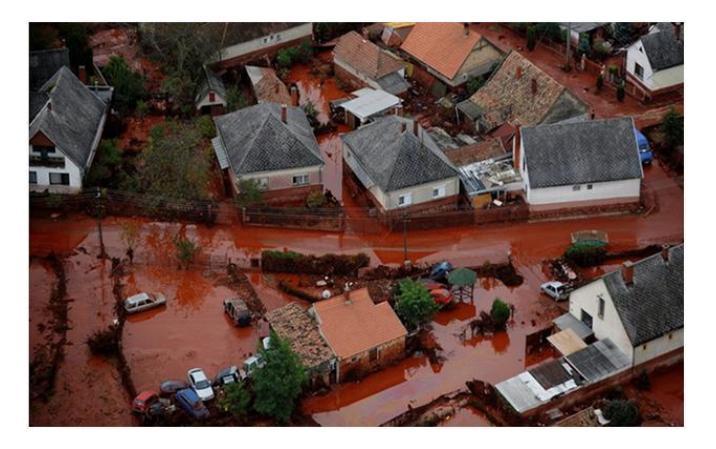
Fig. 5. Aerial photo with the flooded territory of Kolontár (photo: MTI)

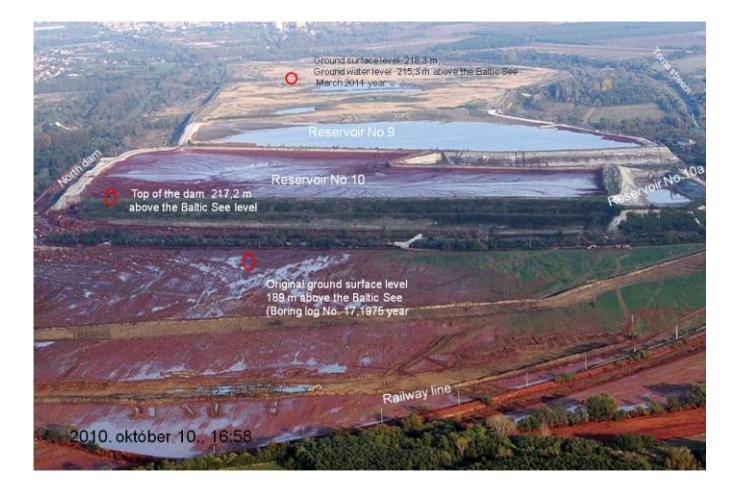
Figure 8 shows the reservoir system after the failure by the aerial photo. From the picture you can see visually the reservoir system and the relationship with surrounding terrain. (Schweitzer F. et al)

Fig. 9. Picture and altitude figures of the reservoir system after the embankment failure in October 2010 (http://redsludge.bm.hu)

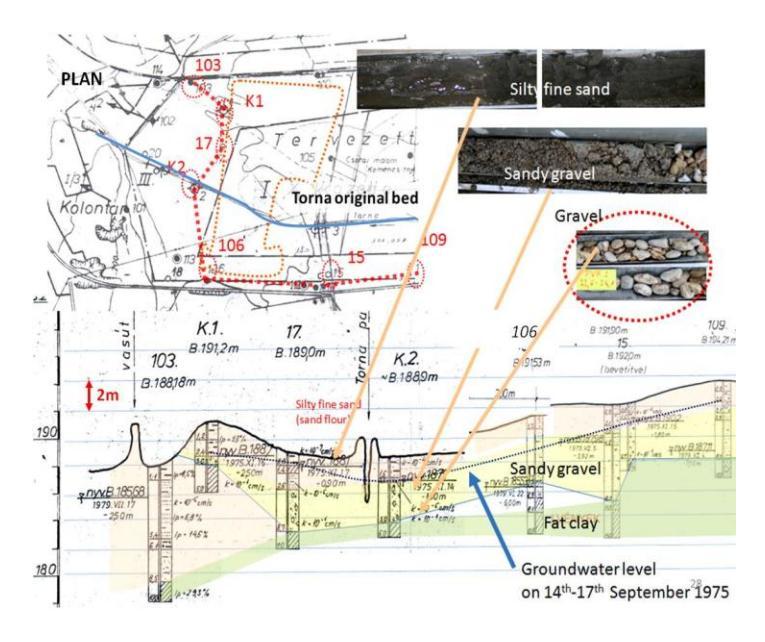
Figure 11 shows the subsoil conditions of the area based on detailed soil tests performed between 1975 and 1980. The reservoir system was built on the gravel terrace ("gravel basin"), in the 1-3 km wide eroded valley of the Torna stream. The gravel terrace 5-6 m deep sedimentary deposit.

The deeper part of the "gravel basin" consist of the very permeable gravel with water permeability of $k=10^{-1}$ cm/sec.

Fig. 11. Illustration of the subsoil conditions of the reservoir system based on the original plans (1975 year). (nygroundwater level at rest ;k- coefficient of permeability; Ip-Index of plasticity)

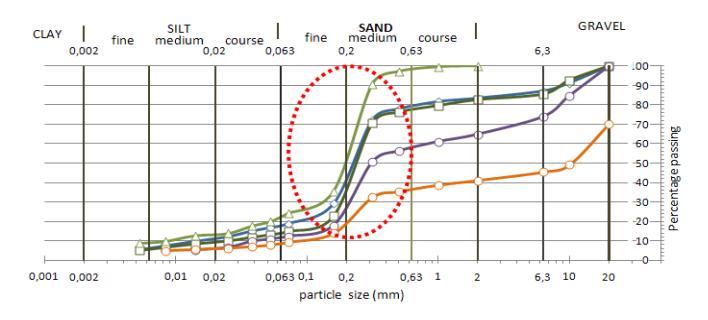
The gravel terraces are not homogeneous. This is illustrated by an exploratory borehole in different soil depths in soil samples analyzed in terms of particle size distribution curves. (Fig. 12) The geological origin, the gravel content increases with depth, diameter of the particles is not evenly spread, dominant in the fine sand of the same particle size range, which shows the tendency of soil potential liquefaction.

Fig. 12. Typical particle size distribution diagrams of the soil

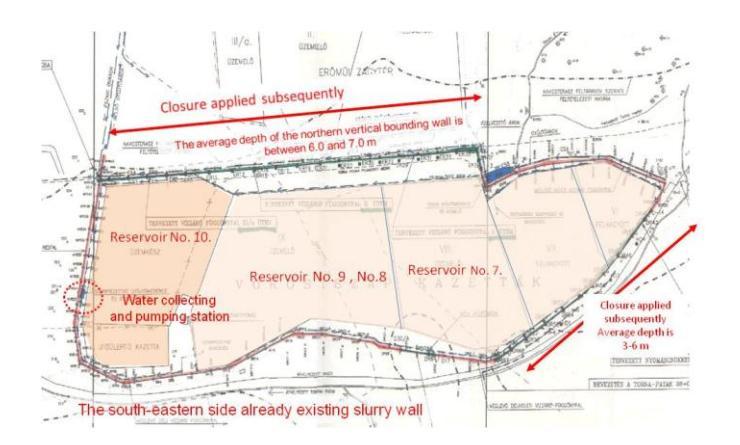
Water pollution was detected in the groundwater monitoring wells near the reservoir system in the 1970s–1980s. In compliance with the regulatory requirements, a watertight slurry wall was constructed to close down the southern and the western sides of the reservoir. Later, as the pollution spread over towards the north, the construction of a new type of grout curtain was started around the reservoir system in 1999. The length of the grout curtain was 1045 m on the northern side, 200 m on south side, and there were connected to the already existing slurry wall. Figure 18 shows the boundary structure around the reservoir system. The depth of the vertical closure was determined in relation to the depth of the watertight clay substratum, by minimum 1.0 m bellow it. The depth of the southern wall varies between 3.0 and 8.0 m, while 6.0-9.0-12.0 m appear on the south-eastern side.

Fig. 18. Site plan of the slurry wall and grout observed in the 1998 year (curtain boundary constructed at several stages)

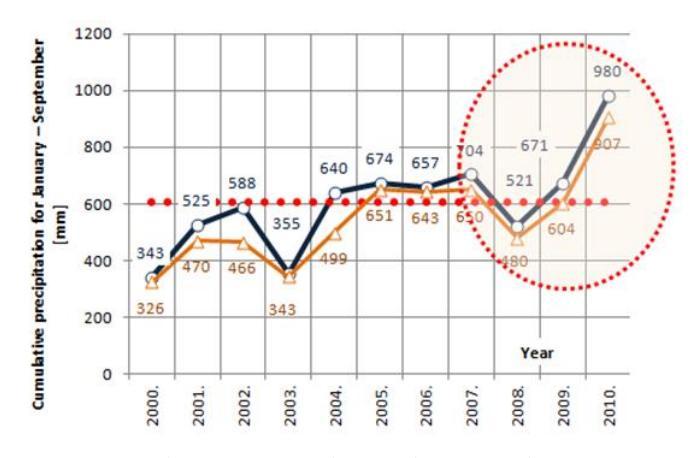
Fig. 21. Total precipitation data in the 1st– 3rd quarter year between 2000 and 2010. The figure shows data from two observation places near the investigated territory

Comparing the total precipitation of the period between January and the end of September 2010 with that of 2009, a 44% increase can be observed, while comparing the same with 2008 data, the increase in precipitation is 74%. This volume of water is rather significant considering the character of the drainage basin. The volume of total precipitation in the period between January and the end of September 2010 is more than one and a half times higher than the 10-year average (154%).

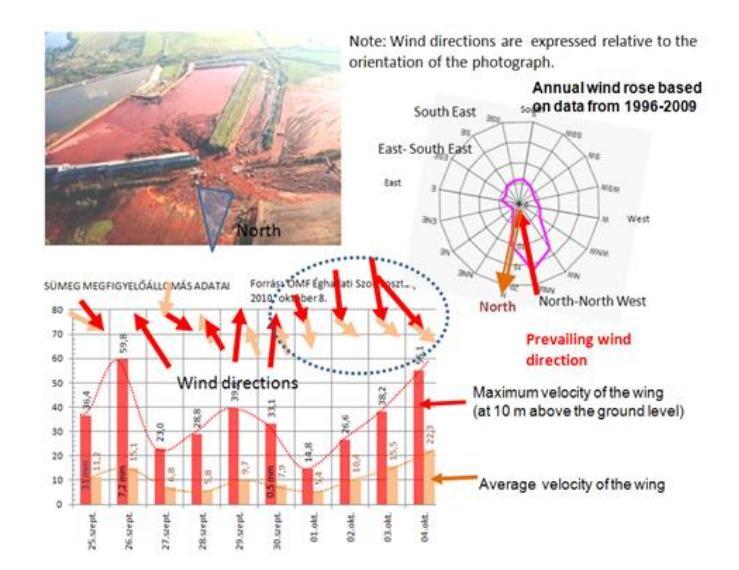
The prevailing wind direction in the vicinity of Reservoir No. 10 is northern–north-western as shown in the wind direction frequency chart. Wind parallel with the direction of the embankment failure is very rare (Figure 22).

Peculiar wind conditions were observed in the area between September 25 and October 4. Between October 1 and 4, a gradually strengthening, unfavorable wind speed toward the direction of the embankment failure was accompanied by casual wind gusts (Weather data services, National weather Services, October 8, 2010).

Fig. 22. Vectors of prevailing wind directions and wind speeds between September 25, 2010 and October 4, 2010 (Weather Data Services Department of the NWS)

There is reason to assume that these unusual wind direction and wind speed conditions contributed to the development of the embankment failure. In addition, the possible sucking effect of the wind on the northern side of the embankment must also be taken into consideration. Fig. 23.

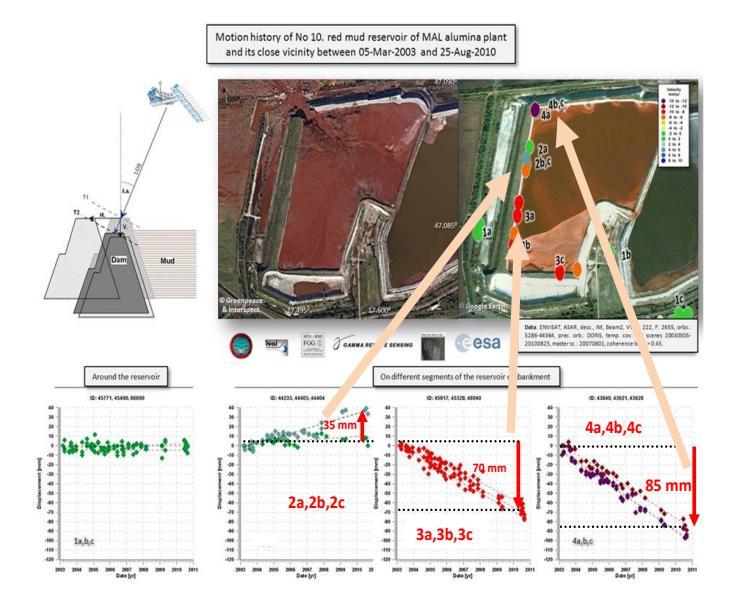
Following the embankment failure, the Satellite Geodetic Observatory (KGO) of the Institute of Geodesy, Cartography and Remote Sensing (FÖMI) published its monitoring data in respect of Reservoir No. 10 on the internet. "InSAR study of the failed red mud reservoir near Kolontár, Figure 24.

It can be concluded from the monitoring data that the maximum range of the values measured was 1-1.3 cm/year and it showed a steady, gradually increasing tendency. At a few locations however a lower increase of a total value of 1.0-2 cm was measured within a period of 7 years.

The range of subsidence and movements is not significant but is indicative and can primarily originate from the "unsettled" behavior of the soil underlying the dam. Even considering measurement inaccuracy, the values measured cannot be regarded significant.

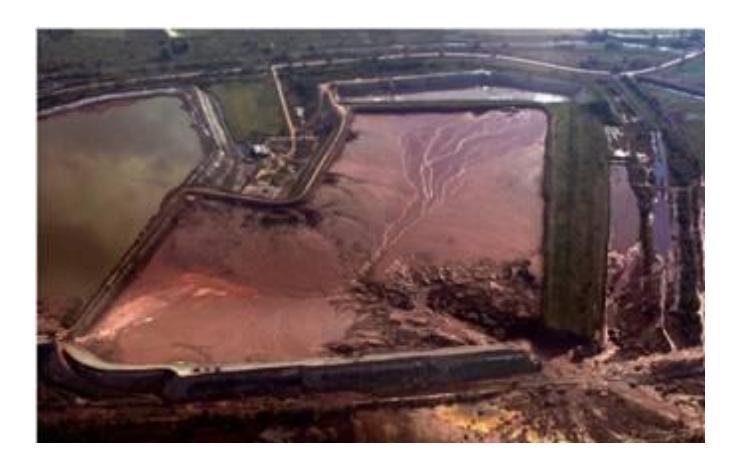
Fig. 28. The damaged reservoir of an alumina plant is seen from the air near the village of Kolontar, Hungary, Monday, Oct. 11, 2010. AP / Abel Szalontai
