## Identification of Potential Seepage Locations Along the Herbert Hoover Dike, Lake Okeechobee FL., by Electromagnetic Geophysical Method. Prediction and Confirmation.

*U.S. Army Corps of Engineers, Jacksonville, Florida*

## Identification of Potential Seepage Locations along the Herbert Hoover Dike, Lake Okeechobee FL, by Electromagnetic Geophysical Methods. Prediction and Confirmation.

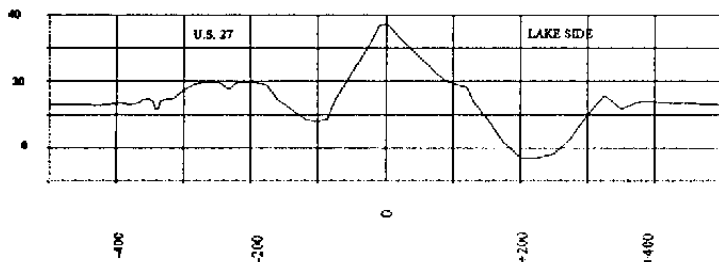
Fig. 3. Cross section MRR2-E. Distances and elevations in feet.

**Section from S-77 to S-4.** This represents the western eight miles of the area of consideration. A typical cross section of the embankment, MRR2-E, is shown in Fig. 3. The geologic conditions in this area are generally sand overlying layers of shell and limestone. The sand also contains varying percentages of shell. The shell and limestone layers are very pervious relative to the sand. Meyer (1971) also found this area had the highest transmissivity of five sites studied along the south shore of the lake from Moorehaven east to Canal Point. (See Fig. 1.). The deep excavation on the lake side of the embankment is the borrow canal. The ditch between the embankment and U.S. 27 serves as both a seepage control ditch and surface runoff interceptor. These excavations intersect some of the shell and rock layers in the foundation.

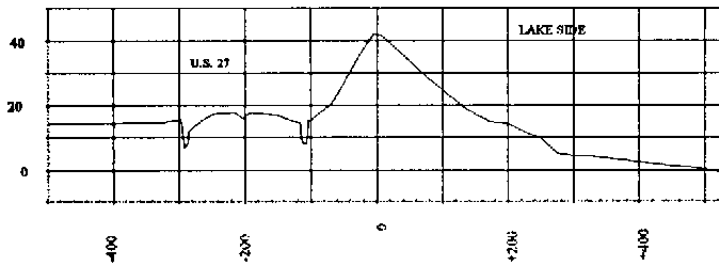
Fig. 6. Cross section MRR3-A. Distances and elevations in feet.

Section from S-236 to S-2. This represents the easternmost ten miles of data collected. A typical cross section, MRR3-A, is shown in Fig. 6. The foundation conditions in this section are markedly different from that in the western two sections. A thick surficial layer of peat overlays a layer of silt. Below the silt are interbedded layers of sand and limestone. As in other areas, the percentage of shell in the sand layers can be significant. Also, note the depth of the drainage ditches between U.S. 27 and the embankment.
