Mississippi River Road Gabion Wall/Slope Stabilization

MISSISSIPPI RIVER ROAD GABION WALL/SLOPE STABILIZATION

Lee County widened Mississippi River Road north of the Keokuk, Iowa in the early 1990s, removing material from the toe of slopes along the alignment. Gabion walls were constructed to provide grade separation. Significant precipitation occurred in the spring of 2010, and two (2) wall sections (about 100 feet each in length) failed. Based on our site exploration and instrumentation monitoring data, the gabion wall sections appeared to fail due to additional lateral load from a soil mass sliding on top of the shale bedrock and a buildup of high ground water levels. To support the additional load of the soil mass, reestablish the gabion wall/slope, and to keep the road open to traffic, a tied back, closely-spaced drilled shaft wall was designed to remediate the slide and augment the original gabion wall. This paper describes the investigation, analyses and the design and construction of the remedial measures adopted.

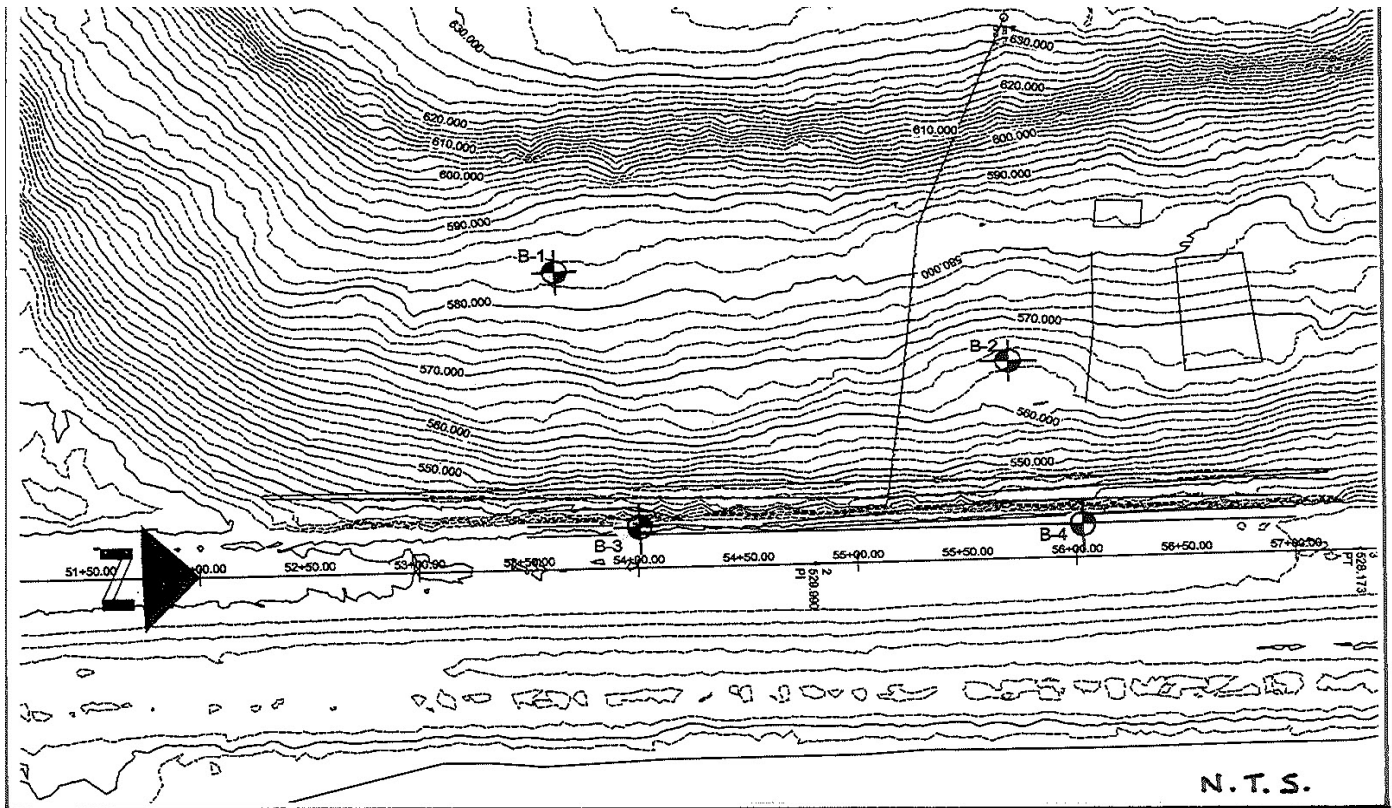
Fig. 4 – Boring Location Plan

Four (4) borings extending into the shale bedrock were performed in October 2010 at the approximate locations shown on the Boring Location Plan (Fig. 4). Slope inclinometer guide casing was installed in Boring 1; PVC well casing was placed in Borings 2 through 4. Subsurface conditions at the boring locations generally consisted of fill overlying native soils, underlain by residual soil above shale bedrock. The thickness of the fill and residual soils overlying the shale bedrock beneath the slope surface varied from about 11 to 11½ feet. Figure 5 indicates the stratigraphy of the slope.
