Observations of Site Amplification and Liquefaction in the Jun 23, 2001, Southern Peru Earthquake

OBSERVATIONS OF SITE AMPLIFICATION AND LIQUEFACTION IN THE JUNE 23, 2001, SOUTHERN PERU EARTHQUAKE

ABSTRACT

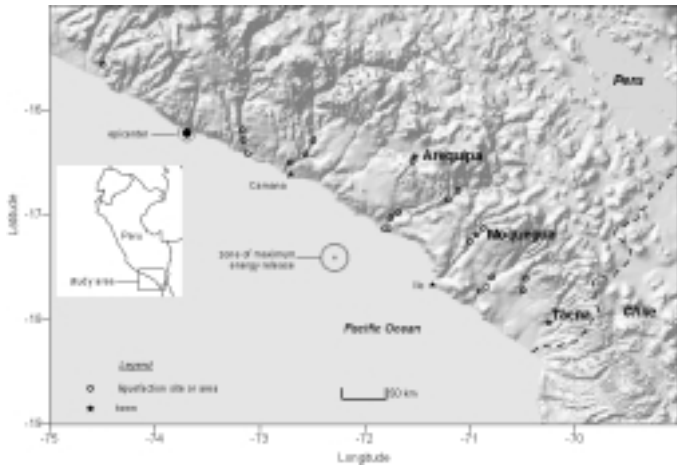
Despite the large magnitude of the earthquake ($M_w = 8.4$), relatively few instances of soil liquefaction were observed or reported in the region. This is principally due to the significant depth to groundwater in most parts of the region. Groundwater depth varies throughout the affected area, but in many locations, it is in excess of 150 m. Exceptions are many river valleys that cross the affected region. Fig. 4 maps the sites or areas where liquefaction was observed by the geotechnical reconnaissance team or was reported by others (Audemard et al. 2002, Gomez et al. 2002, Koseki et al. 2002). In each case liquefaction was confirmed by the presence of sand boils at the ground surface. It is possible that liquefaction may have occurred at depths great enough to preclude surface expression at other sites that were visited, but where liquefaction was not confirmed. The majority of the mapped liquefaction sites were located near road and highway crossings of rivers. It is reasonable to assume that liquefaction also occurred at other undeveloped river sites not visited by reconnaissance or research teams. A research team from the Geophysical Institute of Peru (IGP) reported occurrences of liquefaction along all of the major river valleys located between the Yauca River in the north to the Sama River near the Peru-Chile border (Audemard et al. 2002, Gomez et al. 2002).

Liquefaction primarily affected bridges, although other types of structures were also damaged. A unique liquefaction failure of a heap leach pad, discussed below, occurred at a local mine. Liquefaction was not observed in the town of Ilo, home to the only major port in the region. Subsurface conditions at the Port of Ilo consist of shallow bedrock.

The local geology at each of the liquefaction sites consisted of Holocene-aged alluvial sediments with shallow groundwater. The alluvial sediments typically consisted of gravelly, coarse to fine sands, often with trace amounts of non-plastic silt. Ejecta found at the liquefaction sites typically consisted of poorly graded medium to fine sands with varying fractions of non-plastic or low plasticity silt.

Fig. 4 Distribution of liquefaction in the affected region (compiled from information provided by the NSF reconnaissance team and from, Gomez et al. 2002, Audemard et al. 2002, Koseki et al. 2002).
