Interaction with Nearly Environment and Old Structure for a Deep Excavation. Case History in Bucharest

INTERACTION WITH NEARLY ENVIRONMENT AND OLD STRUCTURE FOR A DEEP EXCAVATION. CASE HISTORY IN BUCHAREST

The paper presents the influence of a deep excavation performed in Bucharest on the adjacent ground and on some old buildings around it; the damages and effects appeared during the excavation and the remedial measures are presented in detail, too. The excavation was designed to be 16.15 meters deep, sustained by a slurry wall enclosure of 60 cm thickness and pre-stressed anchors, and steel struts. Due to an accident that occurred to the trench walls, a thorough monitoring by instrumentation started. The results of this monitoring are shown.

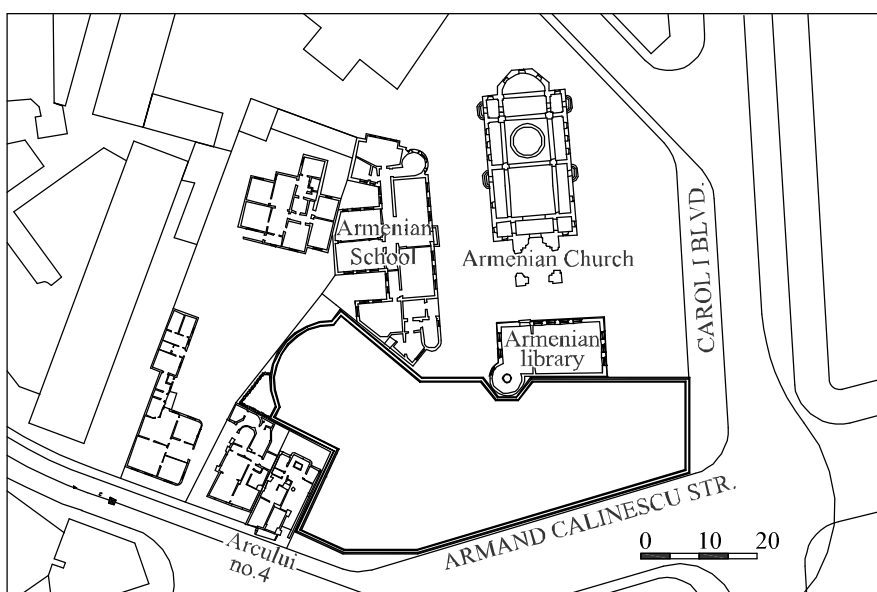
Fig. 2. Deep excavation contour and neighbourhood

The site location (Fig. 1) were will be the Millenium Bussiness Center (MBC) is situated in the proximity of old buildings (Armenian Church, Armenian School, Armenian Library, Arcului 4 block of flats) and heavy traffic streets (Carol I Blvd, Armand Calinescu Street.) as is shown in the Fig. 2.

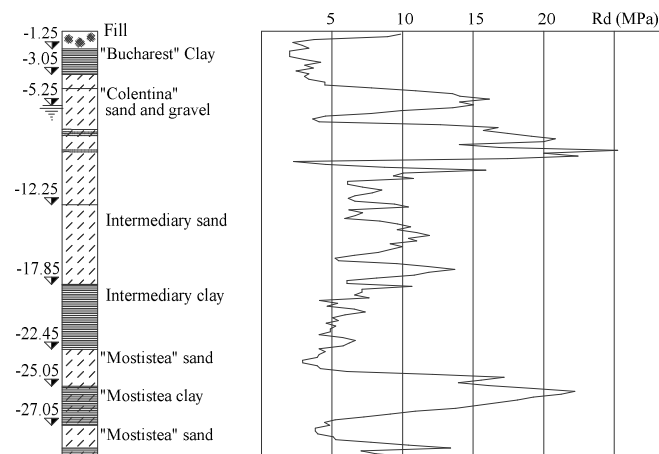
Fig. 4. Lithological column and SPT results

The site location, in Bucharest, is characterized by the following geological formations (according to Fig. 4)
