## Damage of Governmental Building Due to Geotechnical Properties (Case History)

## **DAMAGE OF GOVERNMENTAL BUILDING DUE TO GEOTECHNICAL PROPERTIES (CASE HISTORY)**

This paper is a case study for a governmental building in a site located at Katamia zone (an extension of Great Cairo, Egypt). The site is belonging the Great Cairo Bus Station under the authority of Ministry of Transportation. It consists of two buildings and a shed for buses cleaning and lubrication. The buildings had been constructed since 15 years. However after two years of construction many cracks were noticed in the main building. Furthermore, after another few years, sever cracks had appeared in different parts of the building and the concrete water tank on the roof of same building had suffered from failure. The aim of this study is to know and examine the reasons of these cracks and damages which happened to the building, particularly the other building suffered no cracks or damages although it was built on the same soil and under the same conditions. Observation of the building movements were recorded over several years as well as soil investigation around and under the building. A structural analysis and

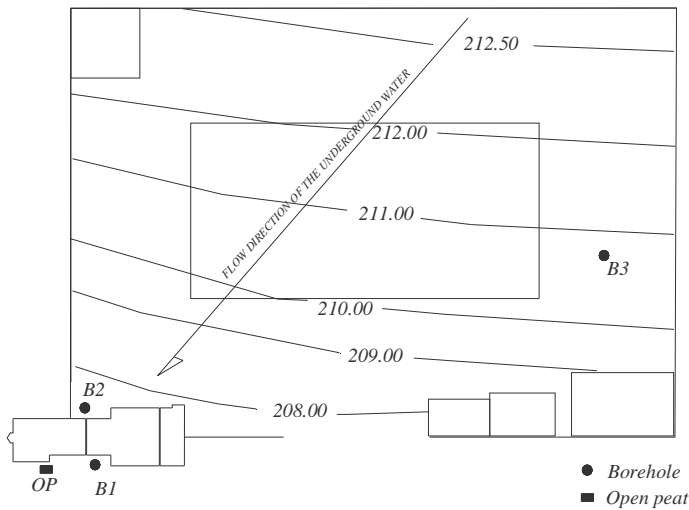
FIG. 1 The General Layout and Borehole Locations and Levels

In order to determine the causes of cracks and the movement of the building, two types of investigation were made, firstly two boreholes and one open pit were done. Figure (1) shows the location and level of them. Secondly, excavation around representative numbers of footing was made Fig. (2).

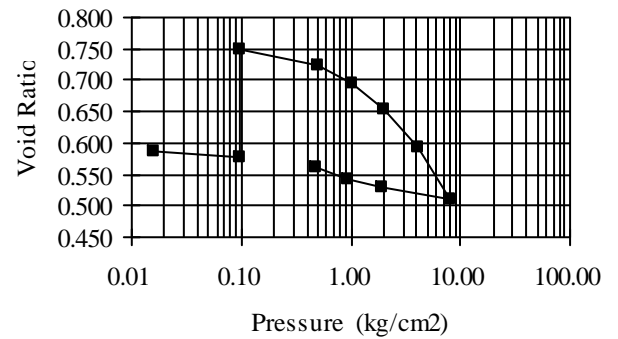
Fig. 3. Consolidation test for a clay sample

To investigate soil properties under the foundation undisturbed samples were obtained for routine laboratory tests. Consolidation tests were carried out on specimens at different depths to obtain soil swelling pressure.

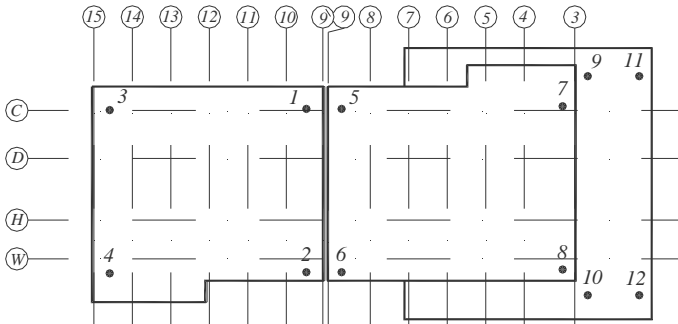
Fig.( 6 ) Plan of The Locations of The monitoring Points and the Axis

Observation of the building movements were recorded over 5 years from 1996 through 2001. The horizontal and vertical movements were observed at 12 points as shown in Figs. (4 & 5). They were recorded by an optical teodolite, and the increase in the width of the construction joint was also measured.

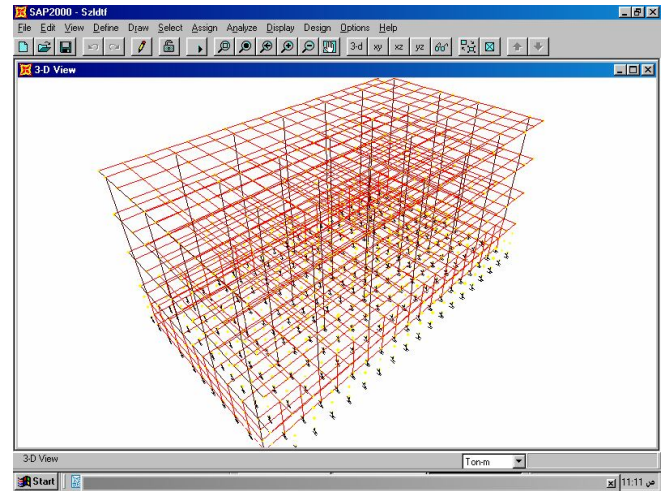
Fig. 6. Idealization of the Structure ( F.E. Program )

After the deformation of the building and making up the monitoring of the vertical movement, a structural analysis for the building as well as estimation of stresses under foundation have been calculated using a three dimensional modeling (SAP 90program) for the finite element whereas the soil was modeling using springs and as shown in Fig. (6).

As it was noticed the biggest settlement occurred at points 3 and 4 on axis number 15, where there was a big change in stresses. An increment nearly about 50% and sometimes is more than that. For the column at point (1) beside the expansion joint at axis number 9', it was broken near the beam as shown in Pho. ( 2).
