A Detailed Study on the Liquefaction-Induced Settlement of Timber Houses During the 2000 Tottoriken-Seibu Earthquake

A DETAILED STUDY ON THE LIQUEFACTION-INDUCED SETTLEMENT OF TIMBER HOUSES DURING THE 2000 TOTTORIKEN-SEIBU EARTHQUAKE

More than 100 timber houses settled and tilted due to liquefaction at a housing development during the 2000 Tottoriken-seibu earthquake in Japan. Among the damaged houses, 47 houses tilted more than 15/1000. Heavily tilted houses were necessary to restore to become horizontal after the earthquake, though several houses, that tilted slightly, were not necessary to restore. The authors studied the boundary of the angle of the restored and non-restored houses. According to the study by the authors, the critical angle of tilting to restore houses was about 10/1000. The authors studied soil conditions also, and found that groundwater level was shallower than about 1.7 m in the damaged zone. This implies that small structures such as timber houses have no damage due to liquefaction if the groundwater level or the bottom of surface non-liquefiable layer is deeper than about 1.7 m.

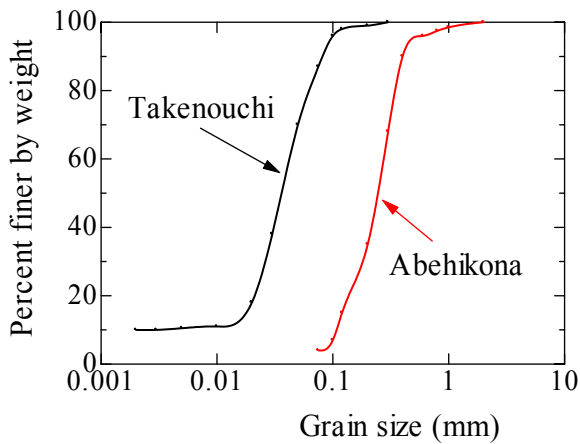
Fig. 2. Grain size distribution curves of boiled sands in Abehikona housing development and Takenouchi industrial park

towards the small river due to liquefaction-induced flow as shown in Photo 5. Boiled soil was very fine silt as shown in Fig.2. Sand boiling continued for about 8 hours after the earthquake because of low permeability of the liquefied silt. This area was constructed by the soil excavated from a channel near Takenouchi Industrial Park. According a boring data, very loose silt layer with SPT *N*-values of 0 to 3, is deposited from the ground surface to the depth of 11.75 m.

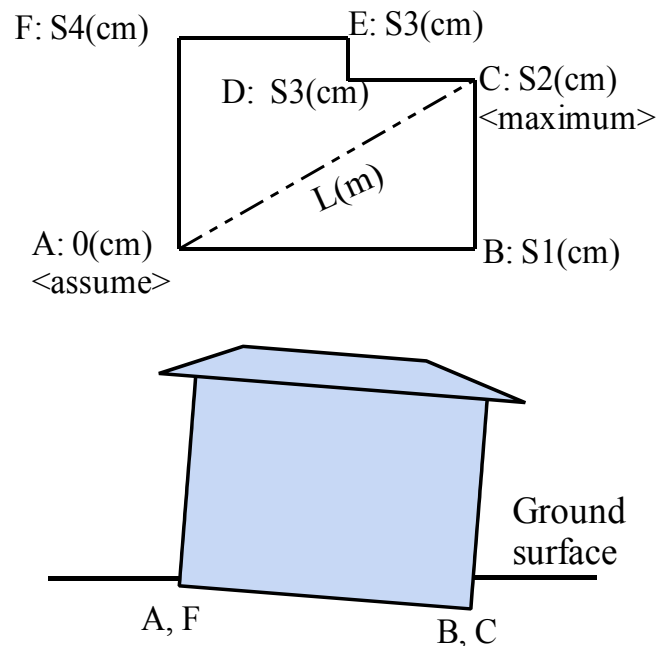
Angle of inclination was classified into four ranks, (a) more than 15/1000, (b) 10/1000 to 15/1000, (c) 5/1000 to 10/1000 and (d) less than 5/1000. Numbers of houses belong to the four ranks were 47, 30, 39 and 53. Figure 4 shows distribution of the rank of angle of inclination in Abehikona housing development. Heavily tilted houses distributed mainly in northeast zone. Observed sites

of sand boils are also shown in Fig.4. By comparing the angle of inclination and sand boils, it can be seen that sand boils were induced at severely tilted houses. This means that main cause of settlement and tilting of houses was liquefaction.

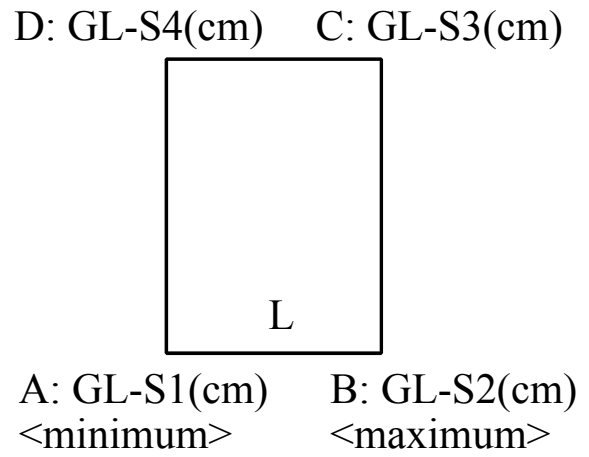
Average settlement $S_{av} = (S1+S2)/2$
 Angle of inclinatinon = $(S2-S1)/L$

Fig.7. Definition of average settlement and angle of inclination of RC buildings

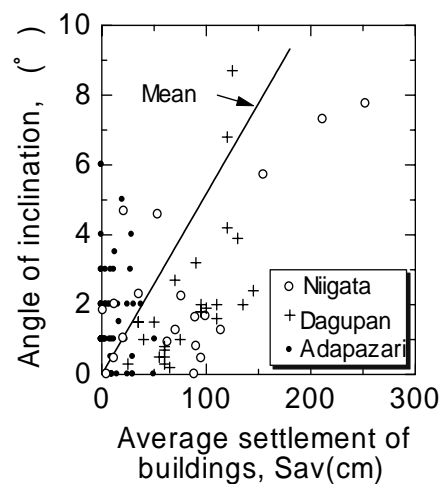
Fig.8. Relationship between average settlement and angle of inclination of RC buildings

the building from the ground surface. Figure 8 shows relationships of the average settlement, S_{av} (cm) and the angle of inclination, Θ (degree). Though the data are scattered, the following formula was derived:

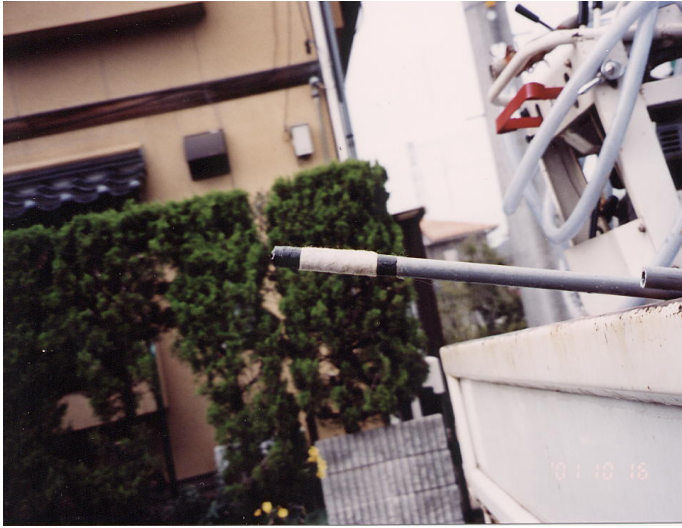
Photo 6. Vinyl tube with strainer to measure depth of groundwater level

As shown in Fig. 4 severely damaged and sand boiled zone was districted at mainly northeast in Abehikona housing development, though the housing area is almost flat. Then detailed survey of the depth of groundwater level was conducted by the authors to demonstrate the reason why the damage was concentrated at this zone. Photo 6 shows a vinyl tube with strainer to measure the groundwater level. Outer diameter of the tube is 13 mm. Four small holes of 3 mm in diameter were drilled and covered by a
