## The Importance of Field Tests and Monitoring Activity for the Remedial Measurements Corresponding to Some Old Buildings in Bucharest

Anton Chirica  
*Technical University of Civil University, Bucharest, Romania*

## THE IMPORTANCE OF FIELD TESTS AND MONITORING ACTIVITY FOR THE REMEDIAL MEASUREMENTS CORRESPONDING TO SOME OLD BUILDINGS IN BUCHAREST

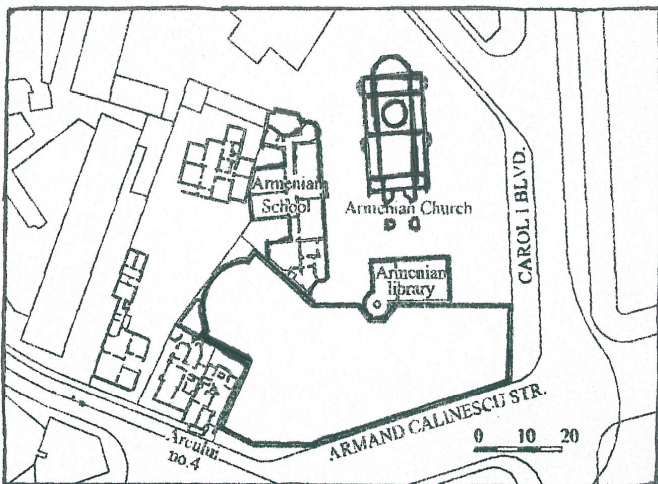
Fig.1. "Armenian complex" and the deep excavation contour

The paper presents the history of a deep excavation supported by slurry walls in the historical centre of Bucharest. As shown in figures nr 1 and 2, the emplacement chosen for the construction of an 18 level building already finished, is found in the very proximity of some old constructions (the Armenian complex and a block of flats). The building is also placed at the crossing of two high traffic boulevards. According to the project on this difficult emplacement was built a complex structure consisting in 4 level basement a ground floor and 18 office levels. The design excavation was realized 16,15 m deep and sustained by walls cast in situ 60 cm thick and 21 m deep, which means 5 m under the excavation base.

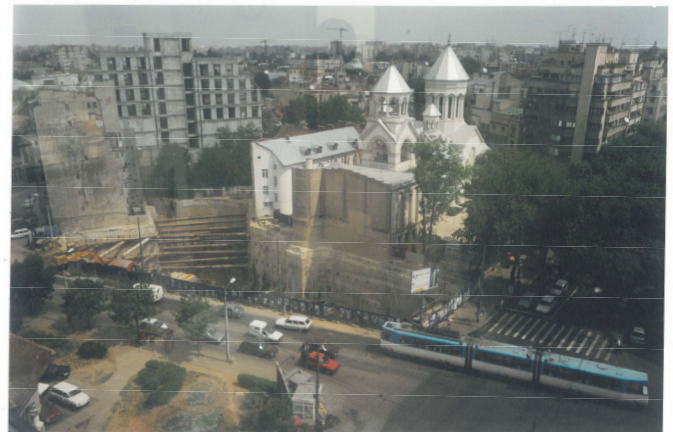
Photo 1. General view of the "Armenian complex" and of the deep excavation area

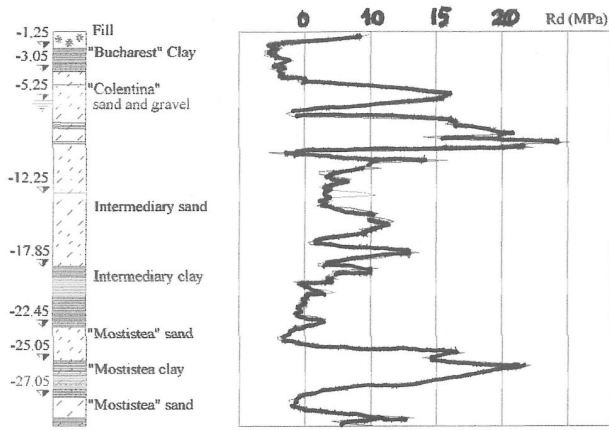
From a geotechnical point of view, the emplacement is characterized by the presented formation in fig.2 that is:

Fig.2 Litological colum and SPT results

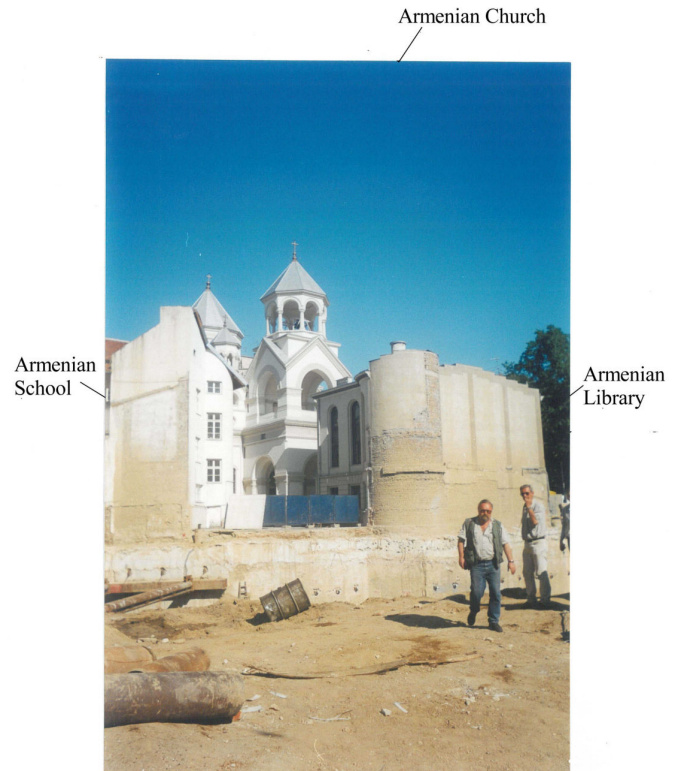
On photos 2 and 3 one can see the buildings situated in the vicinity of the excavation under slurry walls protection. It is about the “Armenian complex” with 3 main buildings (church, library and school) and an old multi-storey structure situated in Arcului 4 Street.

Photo 2. Armenian complex and the executed slurry wall

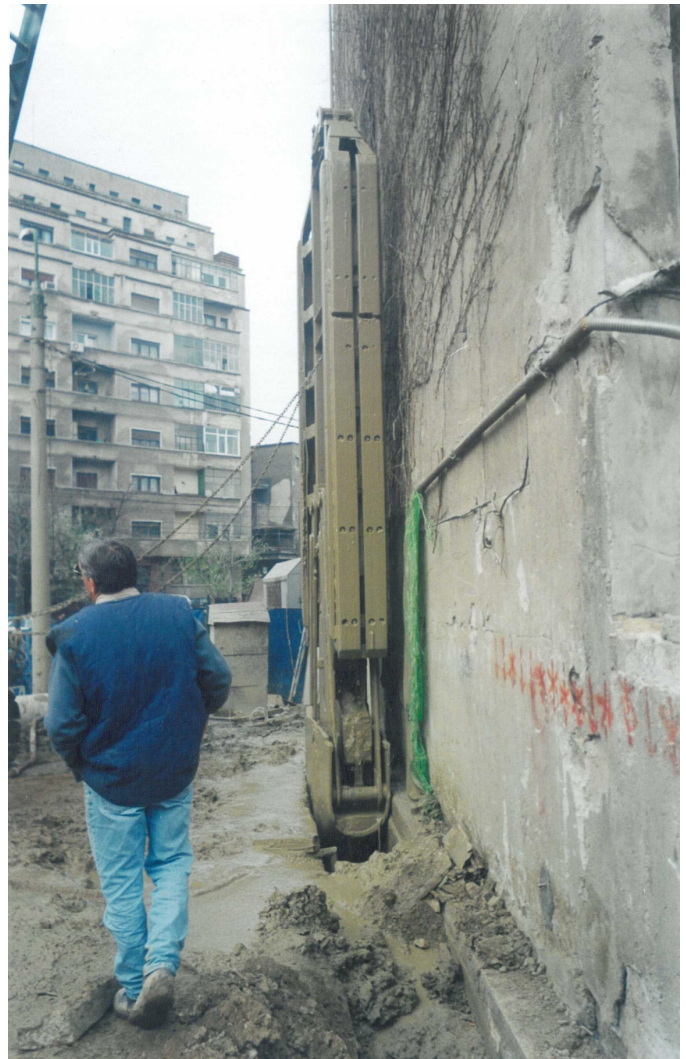
The screen was made before the excavation for the slurry walls in that area, in order to protect the basement of the building. On photos 4,5 and 6 one can see the beginning of slurry wall execution adjacent with the old building and the micropiles screen position. On photo 7 a general view of the slurry walls and sustaining structure near the “Armanian Complex” is presented

Photo 5. The slurry wall execution - lateral image

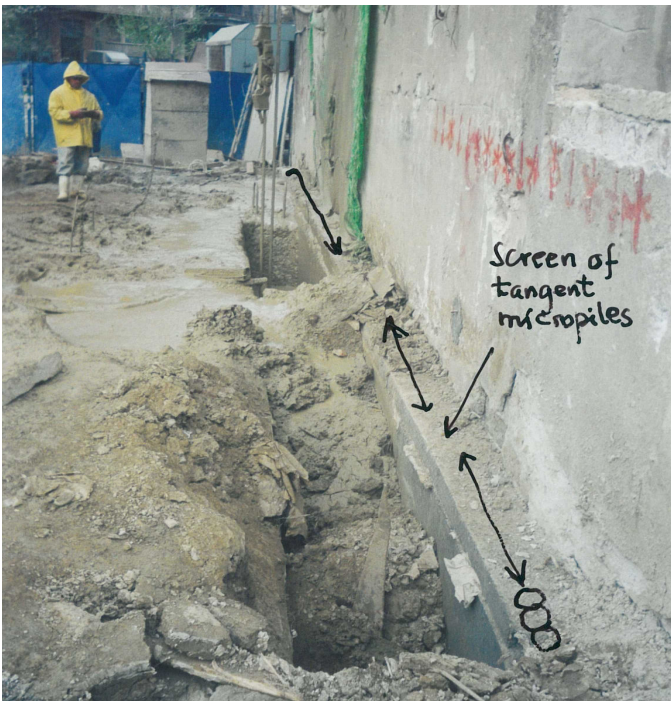
Analyzing the existing structure of the buildings in the close proximity of the site, it was decided to increase the safety of the old multi-storey building in Arcului 4 Street, by a screen of tangent micropiles of 180mm diameter drilled 8.00m deep (See photo 3).

Photo 4. The screen of tangent micropiles position and the beginning of slurry wall execution near the old building

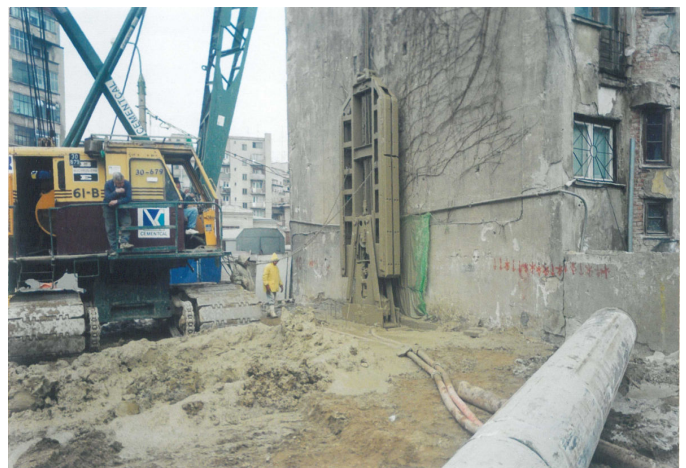
Photo 6. The slurry wall execution - front image

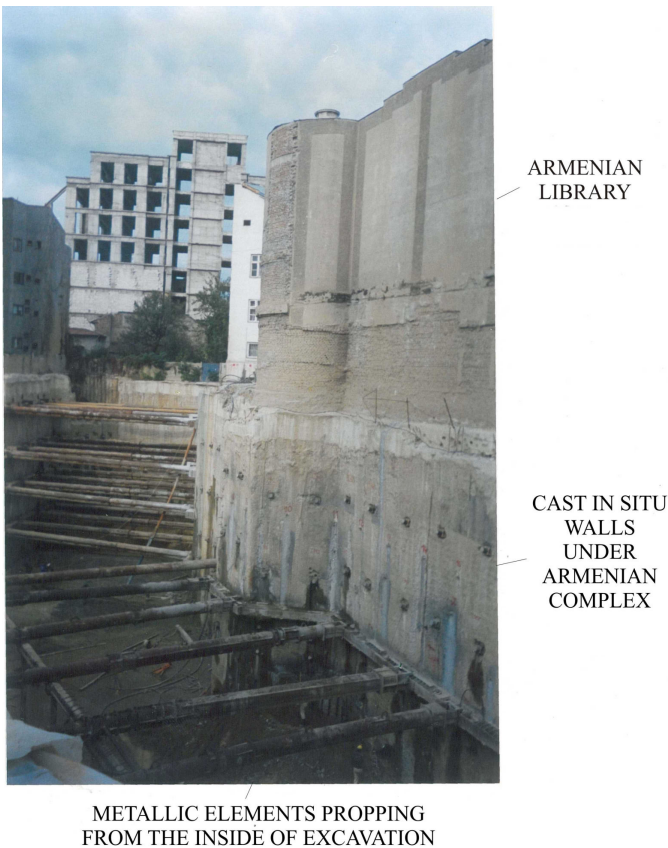
*Photo 7. General view of the deep excavation near the "Armenian complex" location*

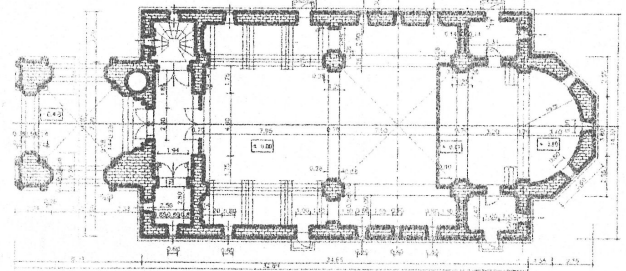
Fig.9 Ground level plan

The bell tower (fig.9) has a ground floor and two square levels with 8 m side, the third level is octagonal and has a metal structure to sustain the bell.

The tower is symmetrical on both directions with a 2.5 : 2.9 ratio between height and base.
