International Conference on Case Histories in Geotechnical Engineering (1984) - First International Conference on Case Histories in Geotechnical Engineering

# The Pathology of Metal Culverts

**SYNOPSIS** Metal culverts are robust structures, but the very large number built every year entails, statistically, a rather high level of pathology. The various aspects of this pathology are analyzed below, first from a general point of view and then through an examination of three particularly instructive cases.

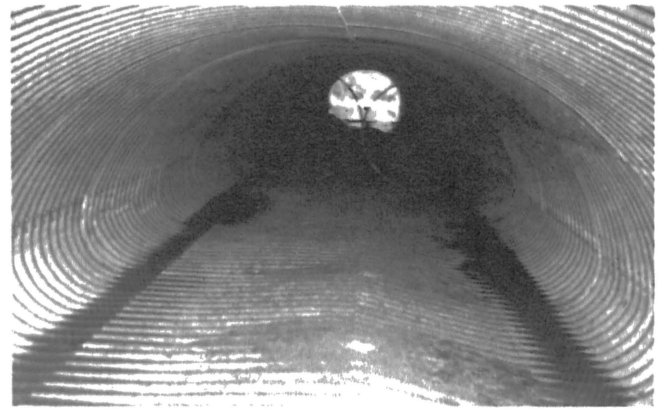
FIGURE 6

These are generally local problems that may occur

either during the building of the structure, in which case repairs are in general easy, or after commissioning, which makes repairs much more delicate.

In the first category, we rather often find deformations caused by :

- dumping of earth too close to the wall;
- impacts by levelling machines;
- contacts between compactor rolls and the walls of the culvert, which may also result in the shearing of some of the bolts;
- travel on the structure by various machines when it is still inadequately covered, or not at all.
