Stability of Slopes - A Case History

SYNOPSIS A Lecture cum-cinema hall was constructed on a terrace developed at the top of a hill-ock at a site located in the north-eastern part of India. At the time of development of the site, excavated soil was dumped on the slopes and retaining walls were constructed to retain the earth. After the first monsoon, the retaining walls gave way. Further distress in the vicinity of the building was noticed in the subsequent three years. The paper describes the details of the above failure, the investigations carried out and the remedial measures suggested.

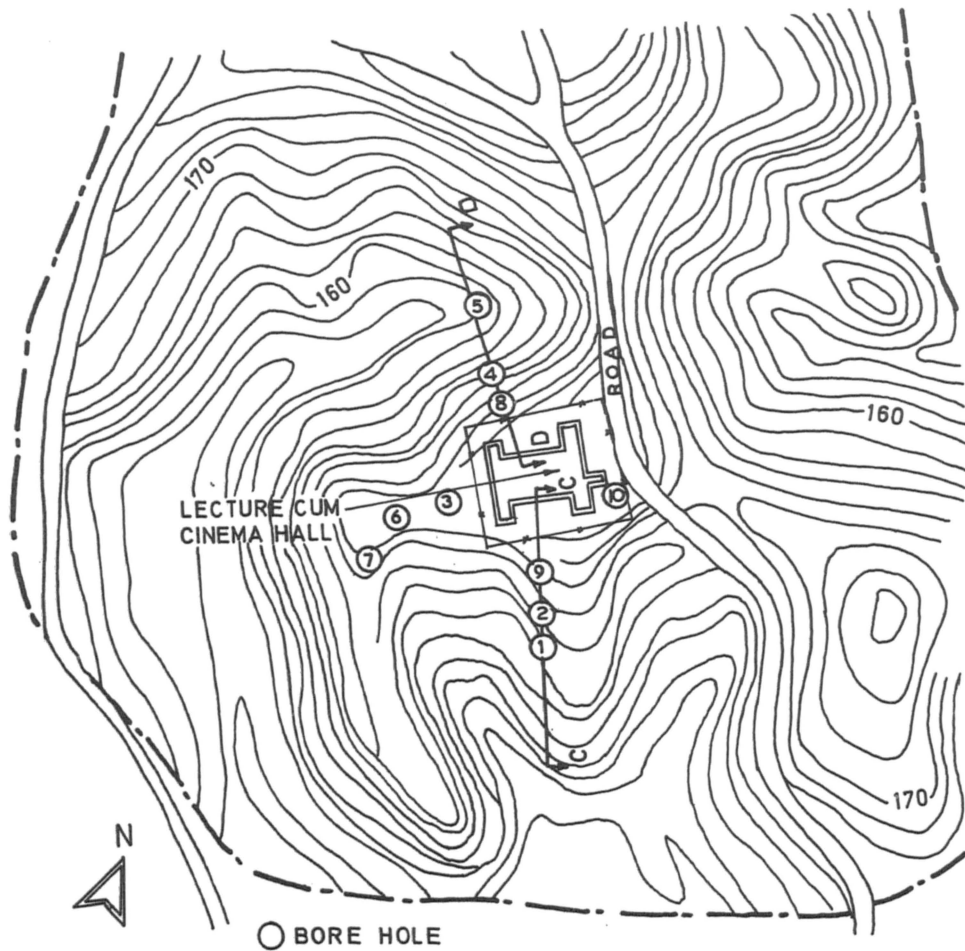
Fig.1 The Contour Map of the Site

The observed SPT values ranged from 35-60 in bore holes 3, 6, 7 and 10 (Fig.1) which are located on the western and eastern sides of the building where no distress was experienced. On
