(2013) - Seventh International Conference on
Case Histories in Geotechnical Engineering

EXPLORATION, DECONSTRUCTION, AND REPAIR OF A DISTRESSED MSE RETAINING WALL IN SAINT PAUL, MINNESOTA

Joseph G. Bentler, P.E.

American Engineering Testing, Inc.
St. Paul, Minnesota-USA 55114

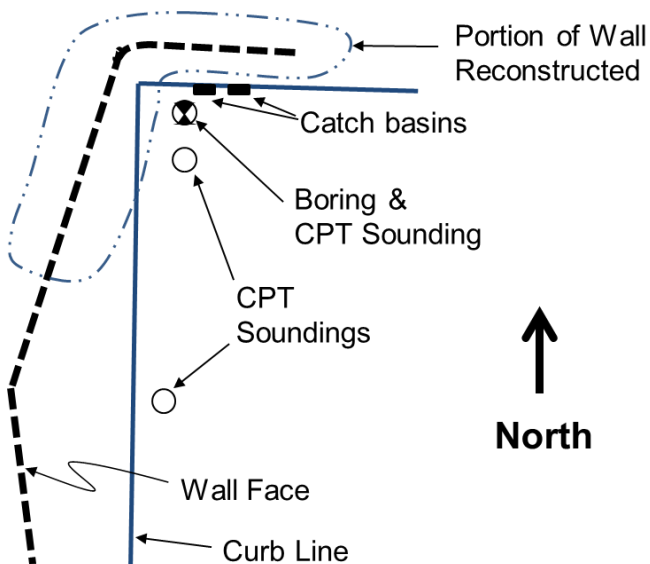
about 10 feet farther back, and the third CPT sounding was performed near the south end of the wall in an area of no visible wall distress. Figure 8 indicates boring and sounding locations relative to the wall and the catch basins.

Fig. 8. Approximate soil boring and CPT sounding locations relative to MSE wall plan layout (scale varies).
