Evaluation and Repair of a Subterranean Parking Garage to Resist Hurricane Flood Levels

EVALUATION AND REPAIR OF A SUBTERRANEAN PARKING GARAGE TO RESIST HURRICANE FLOOD LEVELS

Matthew E. Meyer, P.E.
Senior Associate
Langan Engineering & Environmental Svcs.
Miami Lakes, FL - U.S.A

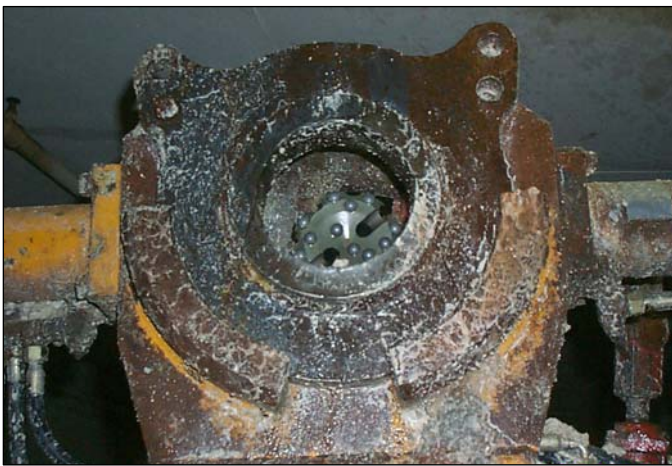
Photograph H – Downhole percussion hammer

Initially, several attempts were made to install the anchor assembly without the use of internal temporary stabilizing casing. After several attempts, installation techniques were modified to include the use of internal temporary 5½-inch (14 cm) O.D. casing. Drilling was accomplished using a downhole percussion hammer and cuttings were removed via compressed air. See photographs H and I below showing the downhole percussion hammer and internal casing system.

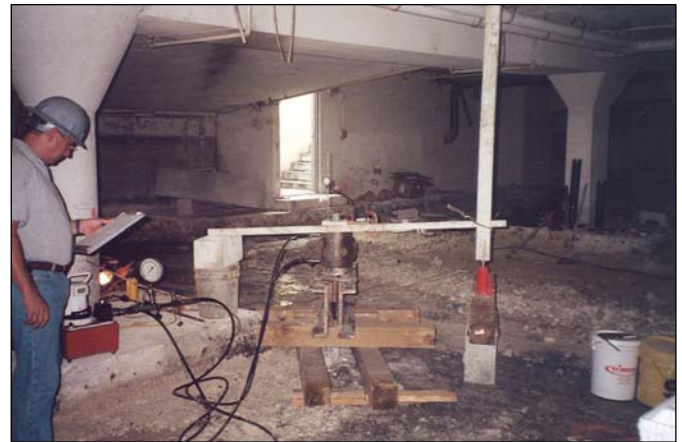
Photograph J – Anchor load test set-up

All production anchors were proof-tested prior to construction of the replacement slab. Typically, the rock anchors were proof-tested three days to seven days after installation. The results of the proof testing showed the anchor movement averaged 0.2 inch (0.5 cm) under the maximum test load. Ninety percent of the anchors tested moved less than 0.25 inch (0.64 cm) under the maximum test load. No excessive creep movement in excess of PTI guidelines was observed for the majority of the anchors during the ½ minute to 5 minute hold period. Where anchors moved excessively upon application of the test load (1.5 times the design load), replacement anchors were installed. See Fig. 5 for a graphical representation of the proof tests.
