Subsidence Movements and Structural Damage Related to an Abandoned Coal Mine

SYNOPSIS: An area in southwestern Illinois has been experiencing surface and subsurface movements with associated damage to surface structures. The area is underlain by an abandoned, partially extracted room-and-pillar underground coal mine. Instrumentation included TDR (Time Domain Reflectometry), Inclinerometers, Sondex, Tiltplates, and precision land surveys. This paper presents the results of a 16-month cooperative study between the Department of Mining Engineering at SIUC and a local coal company.

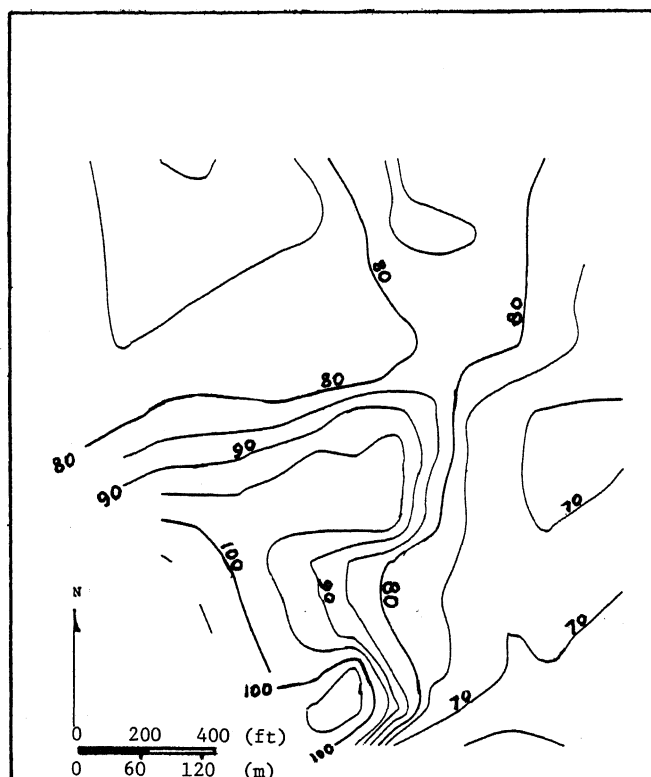
Figure 3. Unconsolidated Overburden Contours

Surficial overburden thickness in the area varies from 17-27 m (50 to 80 ft.) and primarily consists of glacial silts and clays (Figure 3). The rocks overlying the coal seam consist of interbedded limestones, sandstones and shales and vary in thickness from 11.7-13.3 m (35-40 ft.). Claystone forms the immediate floor of the coal seam and its thickness varies from 0.3-1.7 m (1-5 ft.). It is underlain by

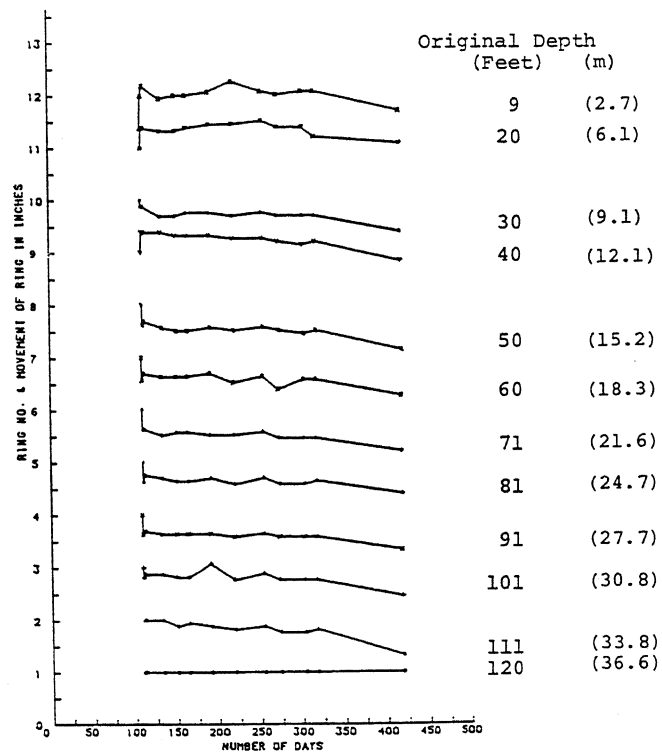
Figure 8. Subsurface Vertical Movements Sondex Hole IS2

1. Vertical surface subsidence movement data (Figure 5) show gradual downward movement with time over the entire area. Surface movements over mine openings and coal pillars are approximately the same except near the barrier pillars where movements are somewhat smaller. Subsurface vertical movement data from Sondex instrumentation in boreholes over the coal pillars (Figure 8) also show downward movement in lower portions of the pillar near the claystone floor. Over the 16-month study period, approximately 12 mm (0.5 in.) of compressional settlement is noted in the area.

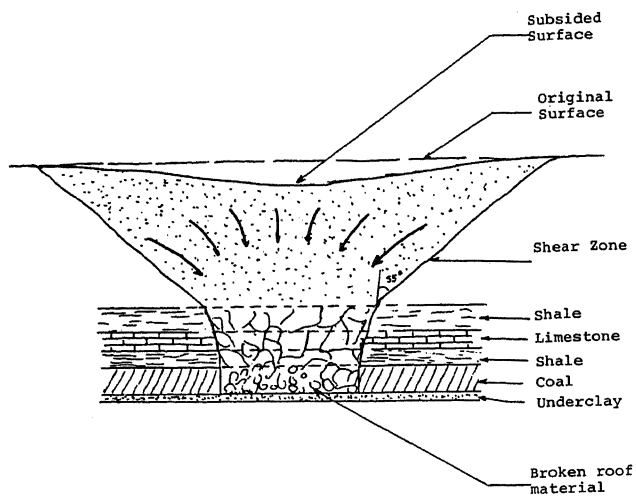
Figure 11. Schematic of Subsidence Mechanism 1

2. Fracturing of immediate roof strata due to wide intersections, discontinuities in the immediate roof, and/or prolonged excessive loading of thinly layered and weak overburden may cause the soil overburden to flow into mine voids causing surface subsidence (Figure 11). Differential settlements of pillars on weak claystone floor may also cause initiation or development of such subsidence movements. At least three or four such events (A, B, C, D) with vertical movements ranging from 25-90 mm (1.0-3.5 in.) were observed during the study period. At one such site where access was possible after the subsidence event occurred,

underground mine observations by the Coal Company staff showed flow of surficial overburden into mine voids. No cracks are expected on the surface or subsurface in the surficial overburden in this mechanism also since its moisture content is at or above its plastic limit.
