Pile Driving Adjacent to Municipal Drinking Water Storage Facility

PILE DRIVING ADJACENT TO MUNICIPAL DRINKING WATER STORAGE FACILITY

ABSTRACT

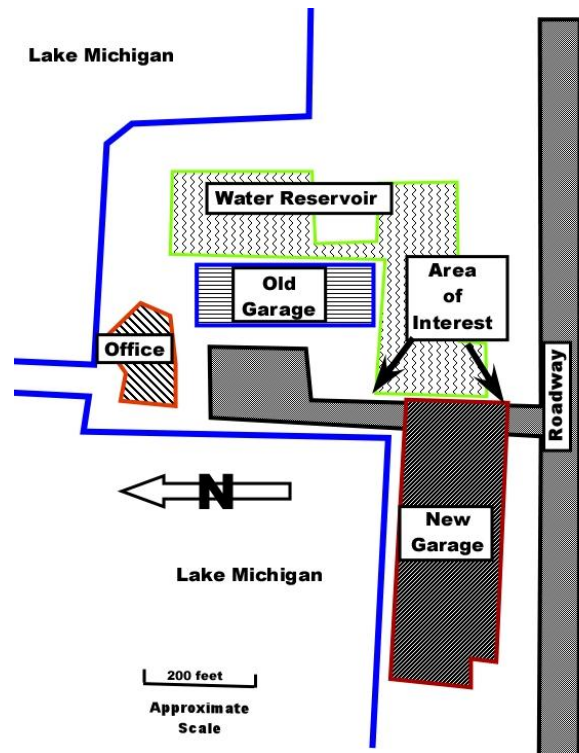
Fig. 1: Site Location.

This site is located in an older urban/ industrial area in Indiana. Figure 1 shows the site, including the outlines of the old and new parking garages, as well as the existing water storage reservoir. This paper focuses on the area where the water storage reservoir and the new parking garage meet (Fig. 1).

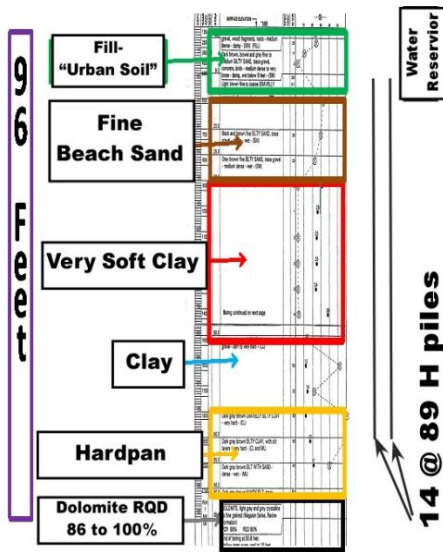
Fig. 2: Site Soil Cross-Section.

The site geotechnical conditions were well understood based on previous projects on and around the site, as well as regional work (Peck and Reed, 1954). Figure 2 shows a generalized cross-section of the site, including the relationship between the water reservoir and adjacent H-piles. The 96-foot deep soil profile includes 9 feet of fill, overlying 21 feet of fine silty sand ($N = 9$ to 26), 30 feet of very soft to stiff gray silty clay ($Q_p < 0.5$ to 2.0 tsf, $w_c = 20$ to 34% , $N = WoH$ to 9), 25 feet of stiff to very hard silty clay ($Q_p > 4.5$ tsf, $w_c = 8$ to 14% , $N = 39$ to 115), and 5 feet of silty sand and sandy silt ($w_c = 17$, $N = 100$), and terminating in the Niagara Dolomite ($RQD = 95$ to 100%).

As shown in Fig. 2 the bottom of the water storage reservoir is located on the naturally-occurring fine beach sand at or below the water table. The geotechnical data indicated that this sand varied from loose to dense. As most of the parking garage piles were driven, the surface settled and sand was imported to maintain grade. This confirmed the general understanding of soil behavior during pile driving as stated by Peck and Hagerty (1971) and others:

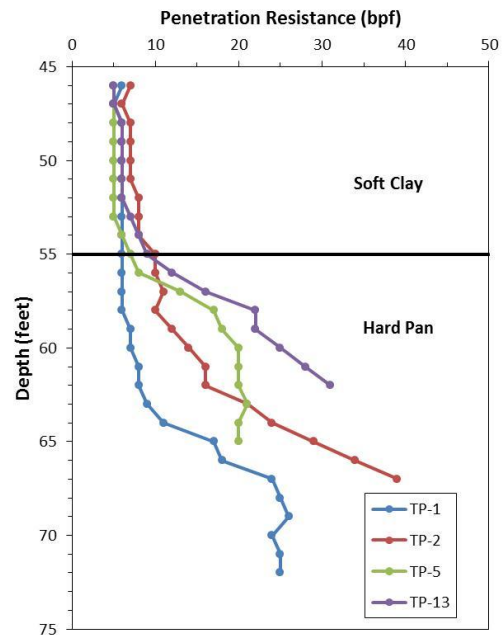
Fig.3-. Driving logs from four of the test piles.

Installation. The piles were driven with a Delmag D46-32 open ended diesel hammer which had a ram weight of 10.14 kips and a manufacturer’s maximum rated energy of 113 k-ft. The intent was not to drive the piles to bedrock but rather to bear the piles within the hard pan. Figure 3 presents a plot of penetration resistance with depth for four test piles.

As shown in Fig. 3, the piles experienced relatively easy driving within the soft clay, with penetration resistances on the order of 5 to 9 blows per foot, with a 6 to 6½-foot hammer stroke. The penetration resistances increased in the hard pan, but were not excessive. The test piles terminated at penetration resistances of 20 to 38 blows per foot, with hammer strokes on the order of 8 to 9 feet.

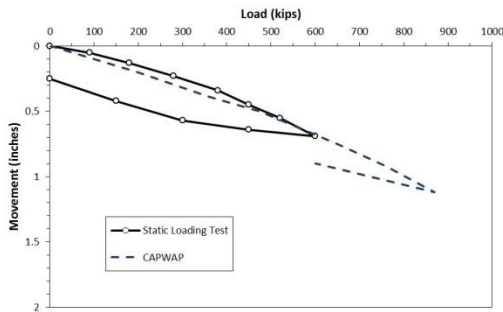
Fig. 4: Comparison between the static loading test results and the CAPWAP simulated load-movement curve from beginning of restrrike.

The pile driven to 65 feet, however, had a high restrrike penetration resistance, and the full capacity may not have been realized, even though the CAPWAP analysis predicted a total ultimate capacity of 870 kips. This pile was one of the piles also tested by a static load test. The static load test was performed first, after which the pile was restruck the same day and monitored with the PDA. Apart from predicting the pile resistance, the CAPWAP analysis also produces a simulated pile top force versus pile top movement loading test graph. Figure 4 presents the results of both the static load test load-displacement curve and the CAPWAP produced curve.

During the static load test, the pile was only loaded to twice the required allowable load, therefore the test was terminated at a load of 600 kips. Superimposing the CAPWAP simulated graph shows very good agreement, and it also shows that the pile could have been loaded much higher.

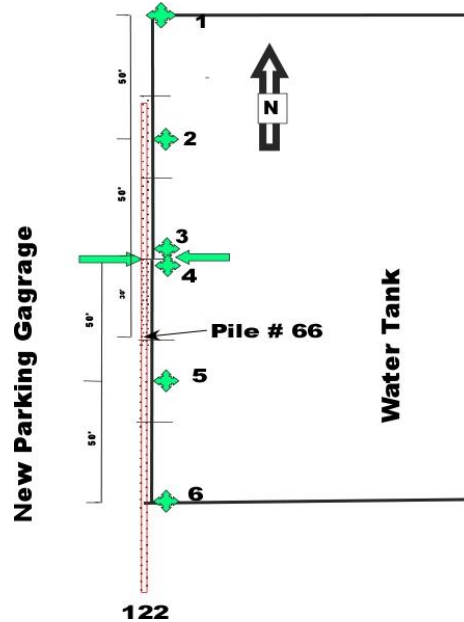
Fig. 6: Pile locations and vibration monitoring stations.

Figure 6 shows the locations of the 122 H-piles, and six monitoring stations. The piles were labeled beginning with 1 at the North end and ending with 122 at the South end. The center pile, number 66, is located approximately 30 feet south of the construction joint.

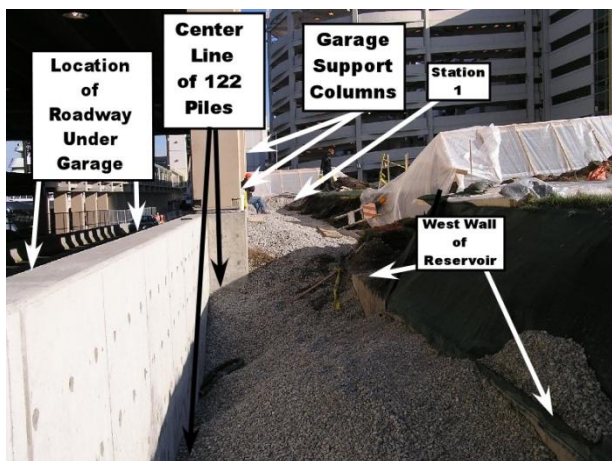
Fig. 8: Completed Garage Barrier Wall.

Figure 8 shows the vehicle barrier wall and garage support columns supported on a grade beam cast over the top of the H-piles shown in Fig. 7. Note the top of the reservoir wall and soil cover on the right hand side.
