International Conference on Case Histories in Geotechnical Engineering (2008) - Sixth International Conference on Case Histories in Geotechnical Engineering

Forensic on Construction Induced Failure of Pipe Pile Foundations

FORENSIC ON CONSTRUCTION INDUCED FAILURE OF PIPE PILE FOUNDATIONS

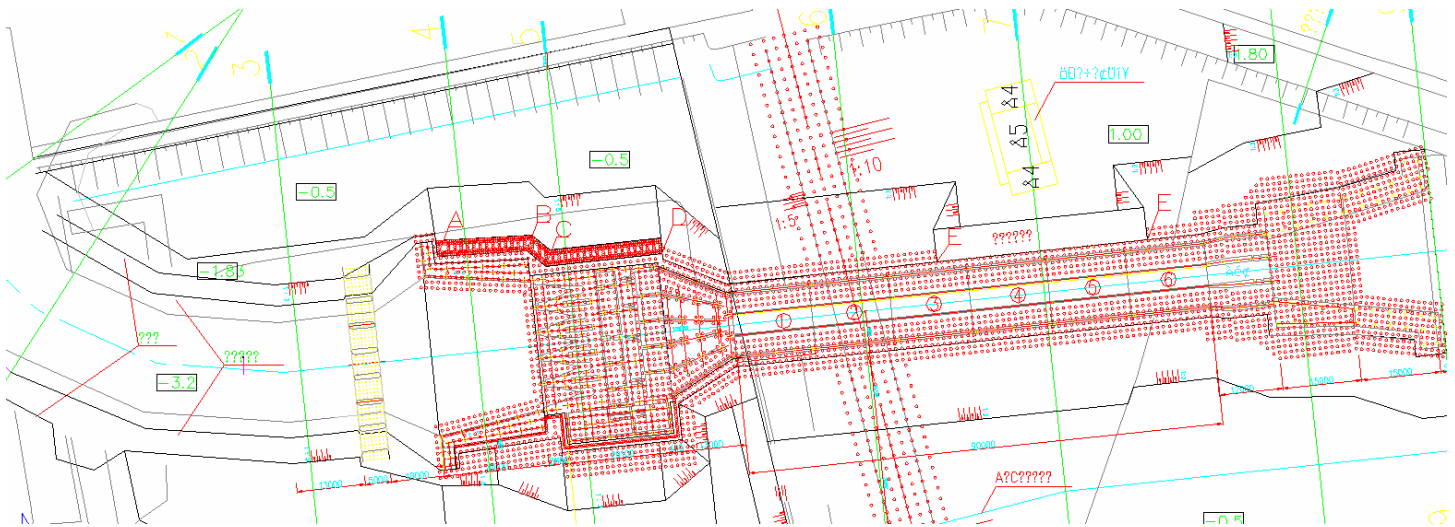
Fig. 1 Schematic design of Jiaoxi pump station

Jiaoxi pumping station is located in the Nansha District of Guangzhou city in the southern province of Guangdong, China. It belongs to part of a comprehensive hydraulic project for JiaoMen Canal. A schematic of the pumping station design is shown in Fig. 1. It includes wing-wall, house of pump station, and transition inducts, and sluice etc. Deep foundation was selected due to the thick soft soil layer, which involved the use of pre-stressed concrete pipe piles to reduce structure settlement. Prior to installing the pipe piles, the ground under pumping station was treated by cement deep mixing. The diameter of these cement deep mixing columns
