Accumulation of Rainfall in the Permeable Fill Behind a Soil Nail Wall

ACCUMULATION OF RAINFALL IN THE PERMEABLE FILL BEHIND A SOIL NAIL WALL

ABSTRACT

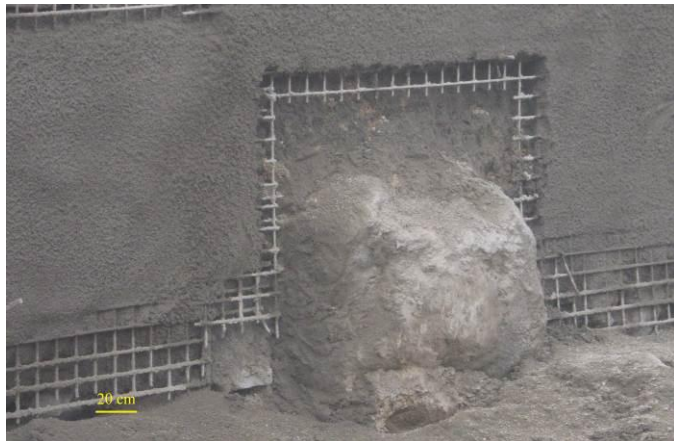
Fig. 4. The site consists of silty and clayey sand and gravel along with boulders up to few meters in diameter

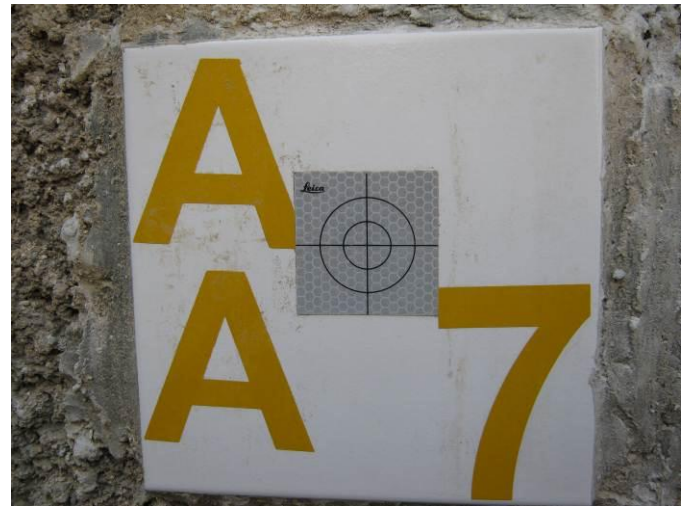
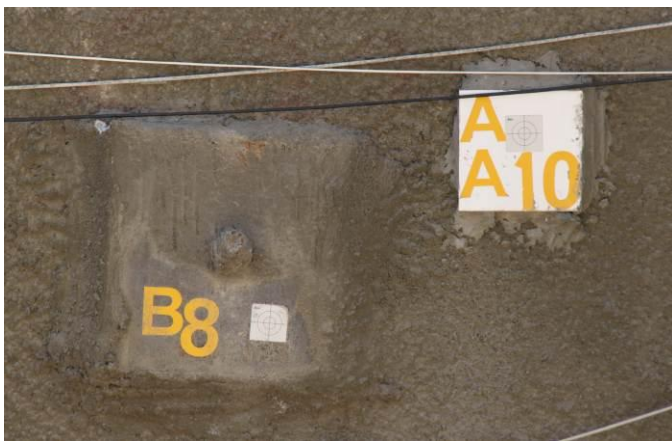
Fig. 24. Target installed on the shotcrete facing
Recording of the deformations of the soil nail walls was continued until 14th of June 2010 well after the excavation process was completed.

Fig. 23. Targets installed on the shotcrete facing and nail heads

Fig. 23 and Fig. 24 show examples of the targets installed on the shotcrete facing and nail heads. These targets were monitored regularly. Deformations of the southern soil nail wall (near the school building) and western soil nail wall (near the residential building) were within acceptable limits. No signs of cracking were observed in the school and residential buildings. Deformation pattern at these wall sections were compliant with the deformation of the soil nail walls published in the literature and numerical modeling of the wall with PLAXIS (maximum horizontal deformation at the end of excavation occurred at the middle third of the height of the soil nail wall). The main purpose of this paper is discussion of the practical aspects of this project; therefore, a complete discussion of the numerical modeling with PLAXIS is beyond the contents of this paper. Deformations after each excavation lift remained constant therefore no evidence of creep deformations was observed. On the other sections of soil nail walls, however, the measured vertical and horizontal deformations were negligible and were very close to the tolerance of the reading device. In other words, deformation recordings from these sections did not produce meaningful results.

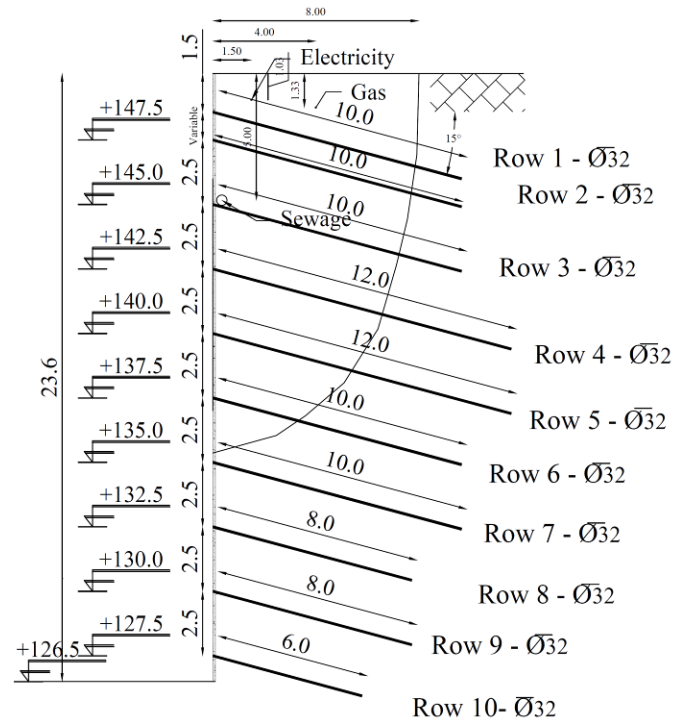
Fig. 32. Cross section of E3 soil nail wall (view XII-XII)

In August 29, 2011 following a three-day rainfall a tension crack suddenly opened on the surface of the road at the eastern side of the excavation site, just behind the E3 soil nail wall. The maximum width of the crack at the surface of the tarmac was 3 cm. The speculation was that the actual crack width beneath the tarmac could be wider. Later reports show that the width of the crack increased to 7 cm during the next day. Tension cracks could happen in passive earth retaining structures such as soil nail walls; but, an opening to the width

of 3 cm very close to the top of the wall over the period of one night after 3 days of continuous raining was interpreted as a signal that a shallow moving block has formed.

indicated that there is a high pressure gas pipe to the south east of the TOOBA tower which supplies the tower. Fig. 30 shows the position of the gas pipe the crack and their relative positions to the E3 soil nail wall and the TOOBA tower. The gas pipe has held in place using a strut system since the beginning of the excavation as shown in Fig. 30. In this picture, water marks are also evident on the shotcrete surface of the E3 soil nail wall.

All the cracks on the surface of the road were closed with proper combination of tarmac to avoid further intrusion of water into the tension crack.

The scratching of the shotcrete at the location of watermarks alone allowed that some of the accumulated water behind the wall to dissipate quickly. However, 6 meter long handmade drains which consisted of a grooved PVC pipe wrapped inside a geotextile cover were installed to help dissipate the rest of the water possibly trapped inside permeable deposits behind the wall. Fig. 34 shows the strut from a different angle while workers are installing the drains on the locations where water marks have appeared on the surface of the shotcrete.

A new monitoring scheme was developed to monitor the further movements of the wall and the strut with prism targets. The quality of the water escaping from the drains showed that the waste water from the water closets shown in Fig. 30 might have been leaking therefore escalating the situation of the E3 soil nail wall. Therefore, these water closets which were made for the construction force at the vicinity of the wall were relocated. The sewage pipe shown in Fig. 33 was used to carry the waste water from the tower to the main sewage system of the area. Construction crew assigned with the task of preparing the shotcrete for the temporary facing and the grout for injection sometimes used the manhole shown in Fig. 30 and Fig. 33 to discharge their excess water/cement mix to the sewage pipe. Although care was taken for the water/cement mix to be very lean when discharged, it seemed possible that the presence of waste water in the ground water behind the wall could have been due to the clogging of the pipe by the discharged grout. Therefore, the pipe was abandoned and the waste water from the tower was carried through a different route.

The temporary shotcrete facing of the soil nail wall was carefully investigated for any signs that could indicate that a moving block of soil has been formed. Based on the fact that the crack occurred 8 meters from the excavation boundary, it was expected that the toe of the block be located at 14 to 15 meters below the top of the wall. Since no manifestations of the crack was observed on the wall surface, the premise that soil block is moving was abandoned. Further monitoring of the E3 soil nail wall did not indicate progressive deformations.

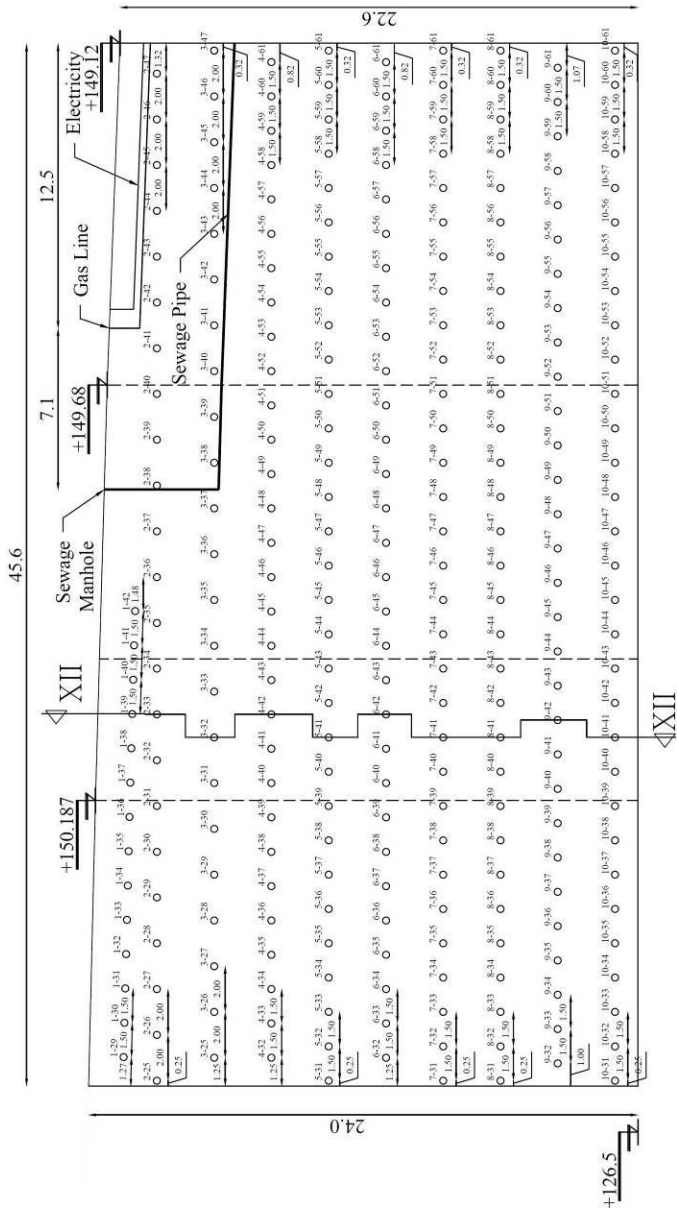
Fig. 33 . Front view of E3 soil nail wall

Fig. 32 and Fig. 33 show schematic cross section and front view of the E3 soil nail wall and depict the location of the underground infrastructures.
