## Vibration Response of Railway Bridge Piers to Nearby Pile Driving

**SYNOPSIS:** In the development of a new highway system approaching Tel Aviv, Israel, long piles had to be driven very close to an existing railway bridge. In view of the danger of structural damage to the bridge, as a result of ground vibrations excited by the pile-driving work, field measurements were ordered.

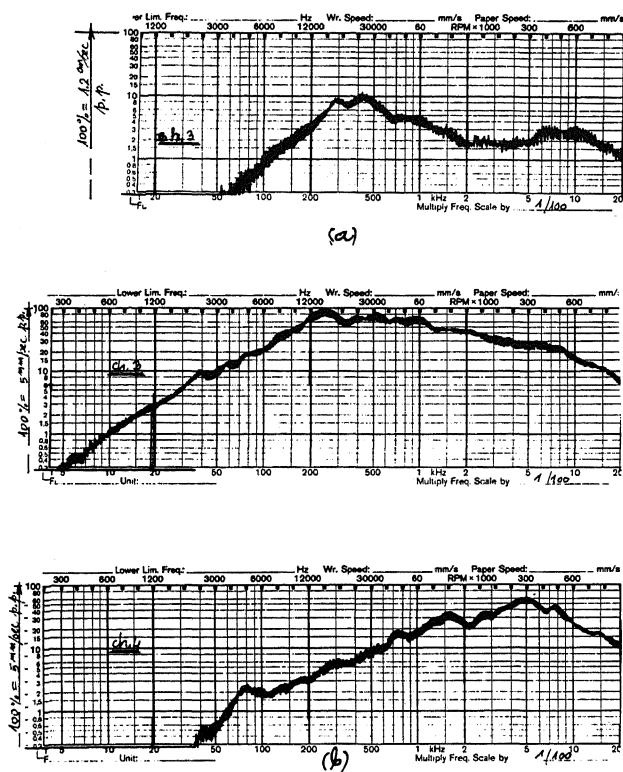
Fig. 8 - Velocity spectrum (third octave):  
 a) Test 1, channel 3: driving of pile SB-1,  
 b) Test 2, channels 3,4: passage of train.

Analysis has shown that the peak transverse amplitude at pier head obtained during the passage of a rapid train were at least 10 times higher than during pile driving operation. Considering an amplification factor of 2 of the vibration at the pier head (see Fig. 3,a), the ground vibration at the pier foot should be half of it, or +0.209mm. This result is in good agreement with amplitude limits of foundation block, which do not cause any damage to the structure, as mentioned in the British Code of Practice, i.e. +0.200mm, up to 20 Hz. Other codes (e.g. DIN 4150), specify a limit velocity

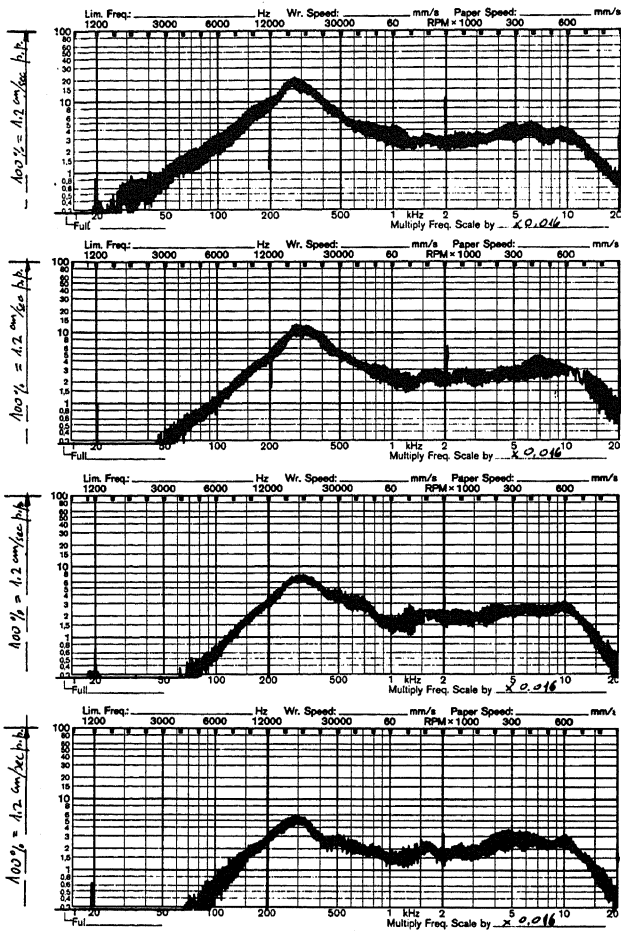
Fig. 10 - Velocity spectrum (third octave), Tests 6 to 9, channel 3: driving of special pile, at various depths.

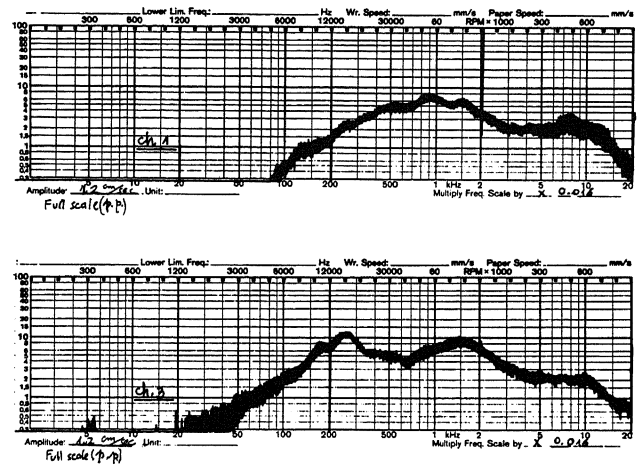
of 20mm/sec up to 10 Hz, as one which generally does not produce any damage to a structure. The maximum velocity, as measured at pier head 7, was +8.40m/sec or 16.80mm/sec peak to peak, which does not yet endanger the bridge.

Fig. 11 - Velocity spectrum (third octave), Test 14, channels 1 and 3: driving of closest pile at 30m deep.
