Nipigon River Landslide

SYNOPSIS A massive landslide occurred on the Nipigon River, north of the Town of Nipigon, Ontario, Canada in the early morning hours of April 23, 1990 and involved an estimated 300,000 cu m of soil. Although there was no loss of life, there were significant environmental and economic impacts.

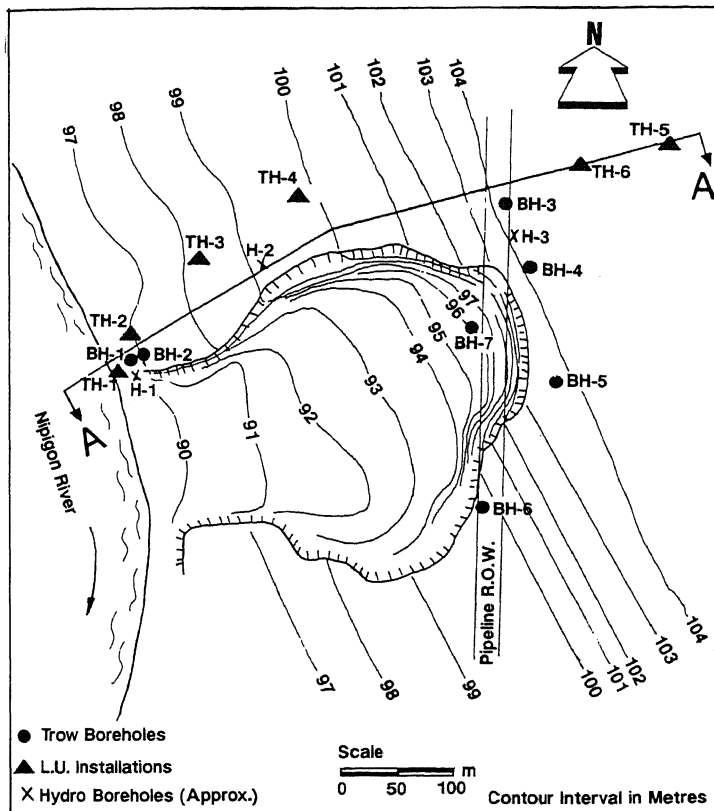
Figure 3 Site Plan

The locations of boreholes and ground instrumentation installed as part of the investigation of the landslide are shown on a site plan on Figure 3 and in a stratigraphic section on Figure 4. Field work has been carried out independently by three agencies.

The field work for the initial and immediate investigation by Trow consisted of advancing two boreholes at the river bank immediately north of the failure zone. Borehole No. 1 was drilled to a depth of 21.9 m and Borehole No. 2 to a depth of 12.8 m. A slope indicator casing to measure on-going soil movements was installed in Borehole No. 1. One piezometer and one stand-

pipe were installed in Borehole No. 2 to at depths of 10.8 m and 6.4 m respectively. In addition, five boreholes were advanced near the natural gas pipeline.
