Performance of an Earthdam and Cut-off Through Deep Alluvium

SYNOPSIS: The main dam at the Bighorn development consists of a zoned earthfill embankment with a concrete cut-off wall constructed through the river alluvium by the slurry trench technique. Upon first filling of the reservoir in 1972, erratic drops in piezometric heads in the alluvium upstream of the cut-off and significant downstream leakage prompted the construction of a weight berm at the downstream toe and implementation of a program of regular monitoring of all piezometers and seepage measuring facilities. Concern for the integrity of the structure was not allayed until completion of a dam safety evaluation in 1984. The paper summarizes the design and construction aspects of the main dam and concrete cut-off, documents the results of monitoring records of seepage and piezometric heads since reservoir filling and assesses the extent of reservoir siltation. Records and inspections demonstrate satisfactory performance of the structure.

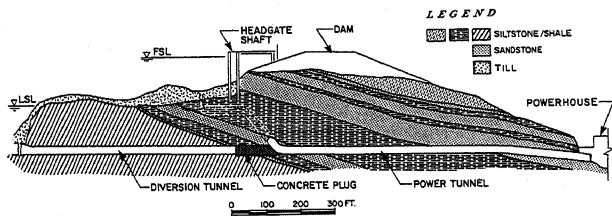
Fig. 3 Section through north abutment

The Blackstone Formation forms the upstream segment of the canyon and descends downstream below riverbed level beneath the Bighorn Formation which predominates within the abutment areas of the dam as shown on Figure 3. The contact between the two formations dips conformably with

the bedding at about 14 degrees downstream and is estimated to lie at a depth of between 40 and 70 ft below the riverbed surface at the location of the cut-off wall. The Blackstone beds of dark, fissile, often ferruginous shales and dark grey siltstones extend to heights of up to 165 ft above the valley floor at their upstream limit where they daylight within the reservoir. The overlying Bighorn Formation embraces three principal fine-grained grey sandstone strata separated by relatively massive beds of siltstone, while some thin partings of carbonaceous shale and conglomerate were encountered. The blocky sandstones of this formation constitute the hardest rocks in the project area. The Wapiabi Formation, which overlies the Bighorn on the downstream flanks of the canyon, consists of highly friable siltstones in a fractured and weathered condition.

The diversion tunnel had a length of 1700 ft and passed through the siltstone and sandstone strata of the Bighorn and Blackstone Formations in the north abutment (Figure 3). It was lined throughout with concrete 12 in thick. Later it was plugged with concrete at an intermediate point, and converted to a power tunnel with an inclined shaft sloping up to a surface intake from the downstream side of the plug. About 690 ft of the original tunnel downstream of the plug was utilized in the conversion. When completed the power tunnel had a total length of approximately 1350 ft and a finished diameter of 22.5 ft. The upstream 60% of its length has a concrete lining 24 in thick, and the downstream 40% (or 560 ft to be exact), where internal pressure exceeds the overlying weight of rock, has a steel liner.

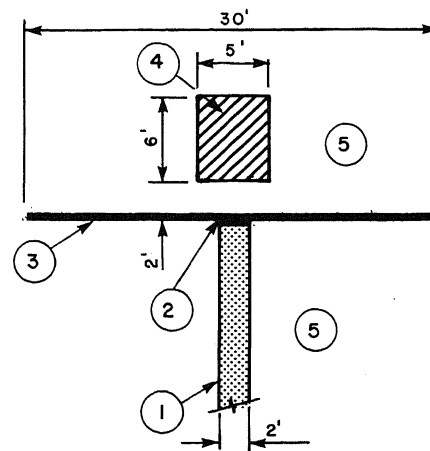
Fig. 5 Detail of cap at top of wall

The adoption of the diaphragm wall was based on the confidence expressed in its suitability by Dr. A. Casagrande who, together with Dr. R.M. Hardy, provided specialist geotechnical expertise to the project. To counter the effects of any disruption of the core arising from settlements relative to the wall, the wall was capped with a 30 ft wide galvanized steel plate surmounted by a 5 ft wide trench centred over the wall and filled with bentonite, as shown on Figure 5. As it was anticipated that differential heads across the wall exceeding 100 ft

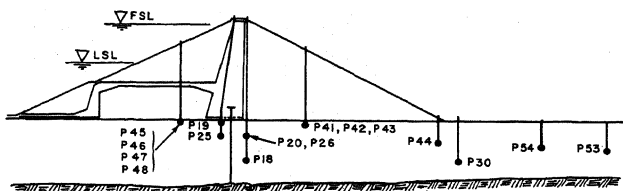
Fig. 7 Relative locations of foundation piezometers

Piezometric Records - Only five standpipe piezometers upstream of the cut-off have remained operational since 1972 to monitor piezometric heads in the river bed alluvium. Of these P25 is located 30 ft upstream of the wall and the tip is set approximately 60 ft below the original river bed (Figure 7). The other four, P45 through P48 inclusive, are collared on a berm on the upstream slope about 135 ft from the cut-off wall and are set just below the contact between the dam fill and the native gravels.

Downstream of the cut-off eleven piezometers set in the alluvium are still functioning. Readings from P26, set closest to the wall and at about the same depth as P25, have been used, in conjunction with P25 readings, as an indication of the head drop across the cut-off.

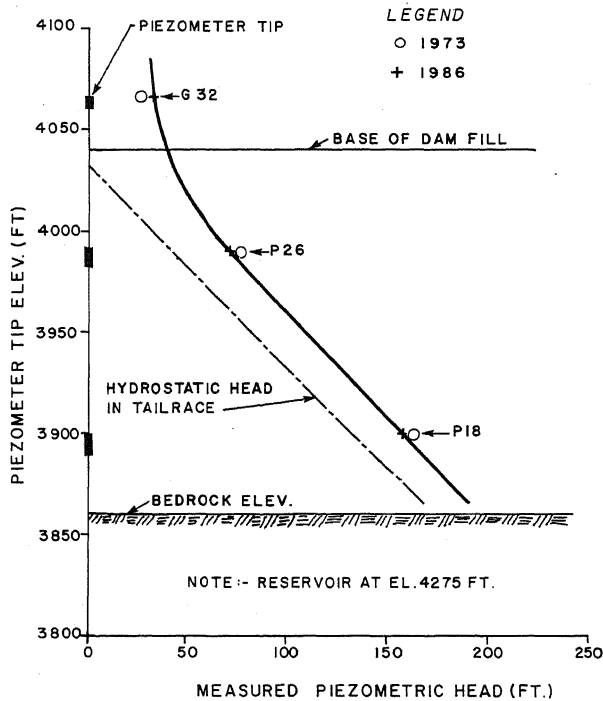
Fig. 11 Piezometric profile through alluvium downstream of cut-off

An indication of the performance of the cut-off wall is illustrated on Figure 10. Except for erratic variations during the first few months following reservoir filling, the head drop across the wall has declined at a decreasing rate over the years until the early 1980's when conditions more or less stabilized (Figure 10a), varying only with reservoir elevation (Figure 10b). Downstream of the cut-off wall, the piezometric profile through the bottom of the chimney drain and underlying alluvium (Figure 11) indicates that hydrostatic conditions with heads 25 to 30 ft. higher than the tailrace level have prevailed in the alluvium since 1973. However, pneumatic piezometer G32, located in the chimney drain, denotes pressures in excess of hydrostatic suggesting the native sands and gravels are more pervious and acting as an

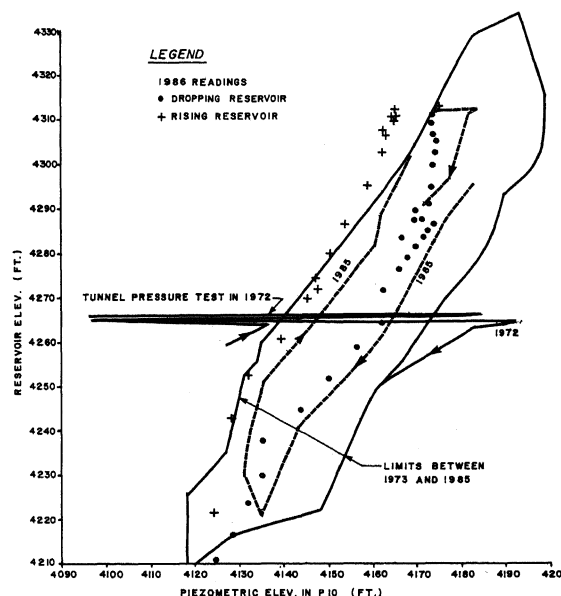
Fig. 14 Piezometric heads in north abutment

Discharge from the tunnel drainage system when the tunnel is pressurized and the reservoir is at FSL is approximately 1800 Imperial gallons per minute. The discharge reduces to zero when the tunnel is drained signifying minor storage in the surrounding rock. In addition there appears to be no hydraulic connection between the tunnel drainage system and the river bed alluvium through faults and joints in the abutment rock. When the tunnel was unwatered in late 1972, the pressure head in the rock surrounding the tunnel dropped about 90 ft to Elev. 4095 ft as recorded in nearby piezometer P10 (Figure 14) whereas the piezometric heads in the river gravels remained within the range of Elev. 4148 (P19) to Elev. 4168 (P46).
