A Geological Appraisal of Slope Instability and Proposed Remedial Measures at Kaliasaur Slide on National Highway, Garhwal Himalaya

G.S. Mehrotra
Central Building Research Institute, Roorkee, India

R.K. Bhandari
Central Building Research Institute, Roorkee, India

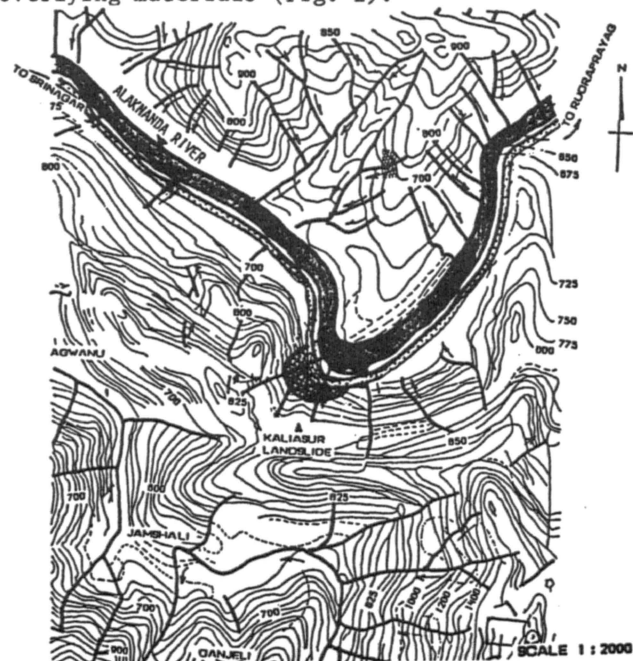
FIG. 2 - CONTOUR MAP SHOWING THE LOCATION OF KALIASAUR LANDSLIDE

The slope forming material consists of weathered, loose, crushed and pulverised rockmass mainly of quartzites and shales. The slide is constantly on the move particularly during the monsoon season (June-September) when the debris flow and rock fall are quite severe. These mass-movements are caused mainly by heavy precipitation and consequent development of hydrostatic pressure build up in the colluvium in highly fractured and jointed rock mass. In addition, extensive toe erosion by meandering Alaknanda river also cause progressive failure of the overlying materials (Fig. 2).

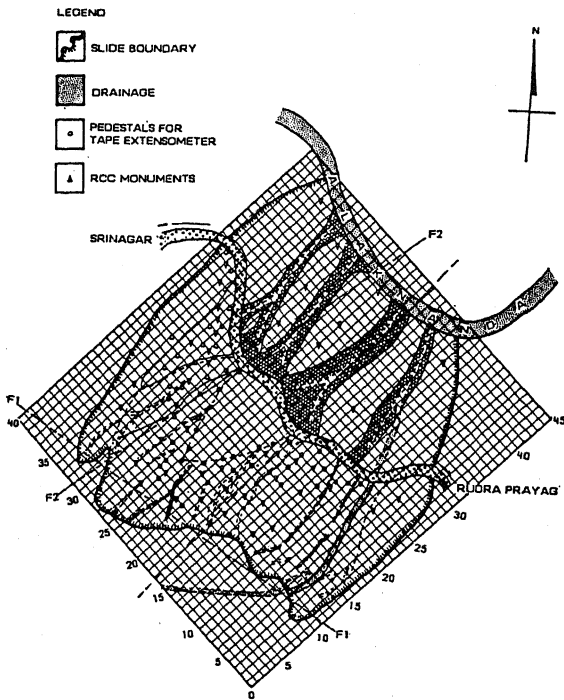
FIG. 4 - SCHEME FOR MONITORING OF SURFACE MOVEMENTS OF SLOPES AT KALIASAUR LANDSLIDE

For measurements of slope movement a scheme was drawn for locating markers for tape extensometer and geodetic triangulation observations. Grid map of the slide area was used for locating the positions of monuments and pedestals (Fig. 4). To facilitate measurements of relative surface displacements between points, 65 pedestals (markers) were installed. Measurements were made through tape extensometer and clinometer. Additionally 50 RCC pillar/monuments (markers) anchored up to 2 - 3 m depth were monitored through triangulation and high precision methods.

Monitoring of surface movements were started before the onset of the monsoon in 1986. During rainy season fortnightly observations were taken. About 1000 observations have been taken so far. Some of the typical time displacement observations are shown in Fig. 5. The analysis of the data clearly indicated two directional movements - north eastern and north western - in the eastern and western sides of the slide zone (Fig. 6). The extent of the lateral movement of pedestals towards the eastern side varied from 0 - 117.8 cm whereas the pedestals on western side showed movement 0 - 76.1 cms indicating thereby that the eastern part of the slide area is more unstable.
