04 May 2013, 10:30 am - 11:30 am

Ground Deformations Observed After 23.10.2011 M_w 7.2 VAN Earthquake (Turkey)

GROUND DEFORMATIONS OBSERVED AFTER 23.10.2011 M_w 7.2 VAN EARTHQUAKE (TURKEY)

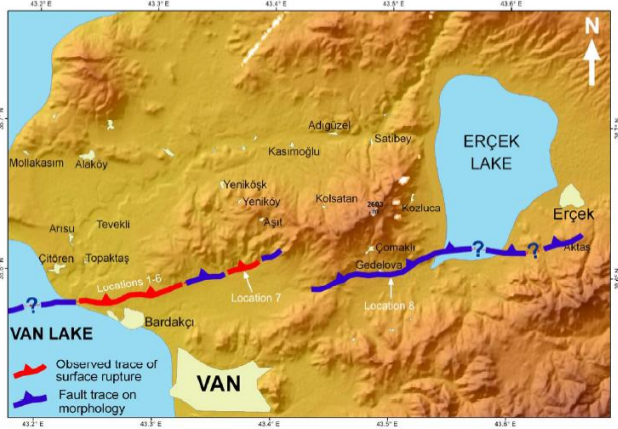
The causative fault that ruptured during the M_w 7.2 Van earthquake is located about 10 km to the north of the city center (Figure 2). No significant surface rupture was observed during the field studies carried out by the authors or other investigators just after the earthquake. However, small scale traces of compressional deformations up to 5-10 cm were measured at several locations along the fault line especially in brittle structures (Figure 3). The signs of compressional deformations point out a thrust fault with the upper plate thrusting southward. The city center of Van is placed on the footwall side of the thrust fault whilst heavily damaged Ercis district is on the hanging wall side. The fault ruptured during the Van earthquake is classified as a blind fault since no obvious sign of surface rupture presents (Alan et al., 2011, Ozkaymak et al., 2011). A fault is identified as a blind fault when the rupture does not reach all the way up to the ground surface and so no clear evidence of fault rupture can be observed (Groshong, 1999; Gates and Ritchie, 2007).

Fig. 2. Trace of the causative fault ruptured during M_w 7.2 Van earthquake (Akyuz et al., 2011)
