Failure of a Dredged Slope in a Sensitive Clay

SYNOPSIS During construction of a new wharf facility in Portland, Maine, an underwater slope failed during dredging and subsequent driving of piles through the slope. The construction and failure of the slope are described. The major factors which contributed to the failure were: 1) high sensitivity of the silty clay, 2) placement of riprap on the crest of the slope to 4 to 6 ft above the design elevation, 3) method of dredging which caused high shear stresses and probable disturbed zones near the toe of the slope, 4) dredging slope steeper than design slope, 5) pile driving causing localized disturbed zones with low strength around the piles, and 6) sequence of dredging and pile driving.

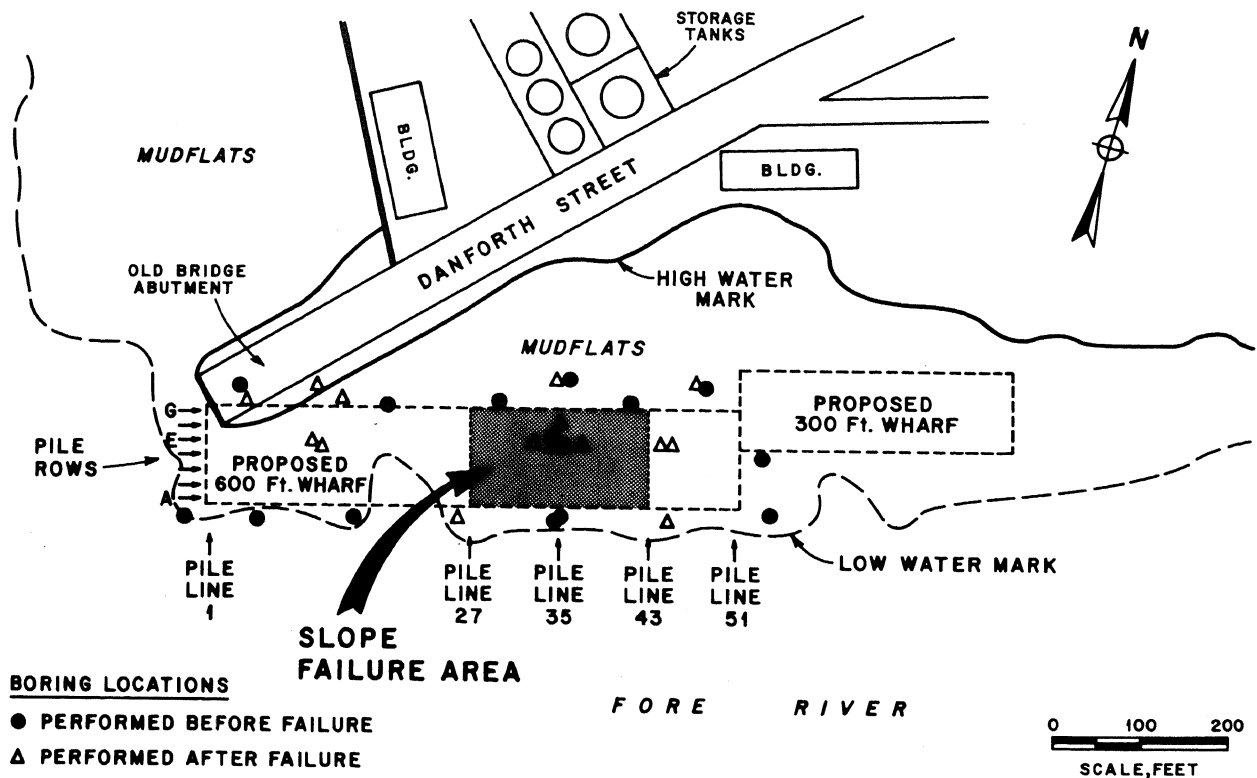
Fig. 1 Project Site

The Merrill Marine Terminal facility is located on the Fore River in Portland, Maine. The facility consists of a wharf for shipping and receiving bulk cargo and storage areas for bulk cargo. The wharf is located on the tidal mudflats along the river bank, as shown in Fig. 1. As originally designed, the wharf was to consist of a 600-ft section and a 300-ft section. The slope failure described in this paper occurred in the 600-ft section. The 300-ft wharf was not completed and was eliminated from the project.

The locations of the borings, performed before the failure in the vicinity of the outboard slope during the design phase and at the beginning of construction, are shown in Fig. 1. The results of the borings showed that the subsurface soil profile at the site consists of the following strata, proceeding downward from the ground surface: very soft organic clayey silt, soft to medium stiff silty clay, stratified silty fine sand and clay, glacial till and bedrock.
