## Large Horizontal Displacements of Houses in Rotterdam

G. Hannink Delft Geotechnics, The Netherlands

A. F. van Tol Rotterdam Public Works, The Netherlands

Proceedings: Second International Conference on Case Histories in Geotechnical Engineering, June 1-5, 1988, St. Louis, Mo., Paper No. 6.68

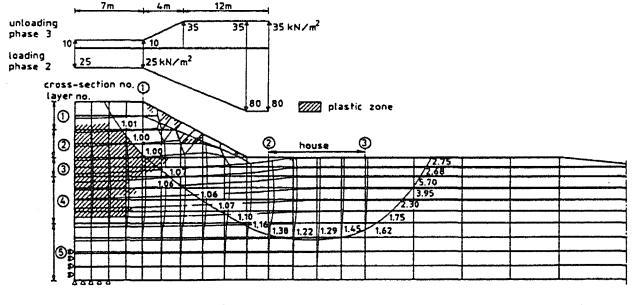
Fig. 5 Phase 3: Displacements and plastic zones after unloading
