International Conference on Case Histories in Geotechnical Engineering (2004) - Fifth International Conference on Case Histories in Geotechnical Engineering

## LANDSLIDE STABILIZATION AT MISSOURI ROUTE K BRIDGE OVER BLACKWATER RIVER

### ABSTRACT

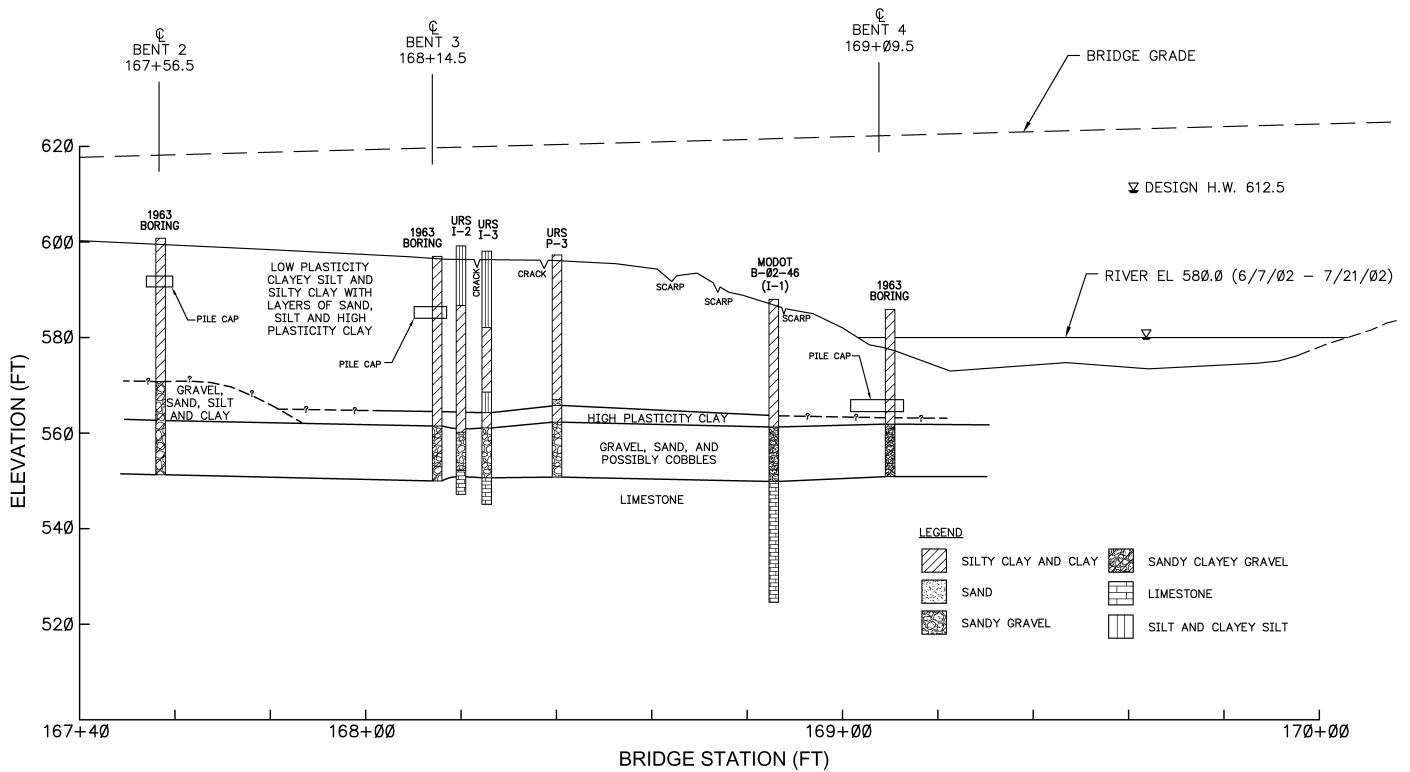
Fig. 6. Subsurface Profile.

Four primary subsurface strata are present at the site: (1) interbedded silts and clays; (2) high plasticity clay; (3) gravel and sand; and (4) limestone bedrock. Figure 6 presents the subsurface profile and Fig. 7 summarizes the index and engineering properties of the materials.

**High Plasticity Clay.** All recent (2002) borings encountered a 2 to 4-ft thick layer of high plasticity clay underlying the clay and silt layer. Water contents, liquid limits, and plasticity

indices in this layer ranged from 26 to 57% (3 tests), 65 to 89 (2 tests), and 41 to 64 (2 tests). Measured drained fully-softened friction angle ( $\phi'_{fs}$ ) ranged from 17 to 22°, while published correlations for  $\phi'_{fs}$  ranged from 14 to 18°.

**Gravel and Sand.** Underlying the clayey soils, all recent borings encountered a 10-ft thick layer of gravel and sand. Original bridge borings show that this layer pinches out south of Pier 6. Generally, this layer is loose to medium dense with SPT blowcounts ranging from 6 to 13. Grain size analyses conducted on two split spoon samples indicated average  $D_{50}$ ,  $D_{10}$ ,  $C_c$  (coefficient of curvature), and  $C_u$  (coefficient of uniformity) values of approximately 10 mm, 3.5 mm, 1.3, and 4.0, respectively. Additionally, the possible presence of cobbles in this layer was inferred from the original bridge boring logs, drilling characteristics, and the one high SPT blowcount value ( $N = 47$ ).

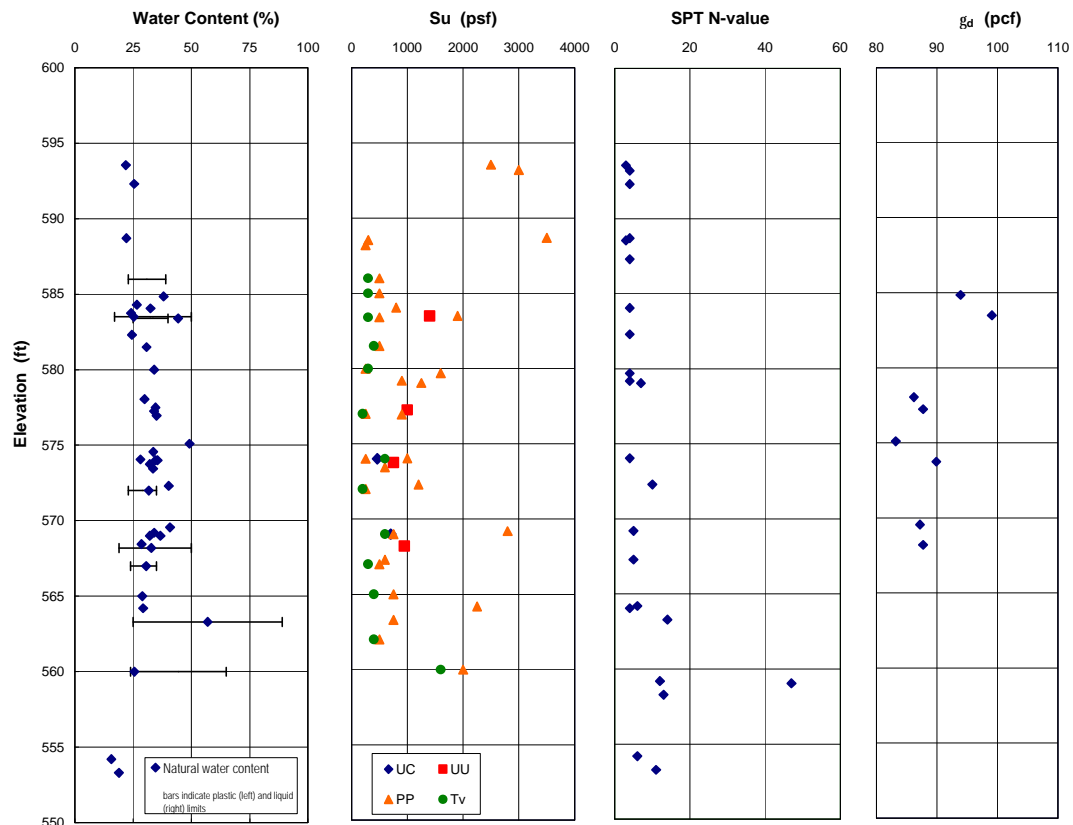
Fig. 7. Index and Engineering Properties of Subsurface Materials.

unconsolidated-undrained (UU) triaxial tests ranged from 460 to 1400 psf, averaging about 900 psf. Drained peak friction angles ( $\phi'$ ) ranged from 27 to 33°.
