## Causes and Circumstances of Red Mud Reservoir Dam Failure In 2010 at MAL Zrt Factory Site in Ajka, Hungary

David Turi  
*FUGRO Consult Ltd., Hungary*

## CAUSES AND CIRCUMSTANCES OF RED MUD RESERVOIR DAM FAILURE IN 2010 AT MAL ZRT FACTORY SITE IN AJKA, HUNGARY

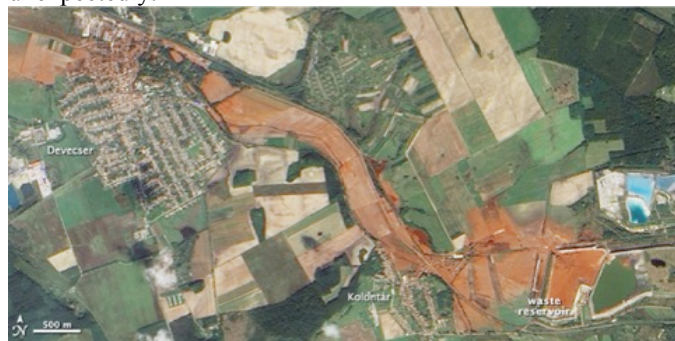
As a result of the dam rapture, hundreds of thousand cubic meters highly alkaline (around 13 pH) red mud and technological water flooded the surroundings: various parts of the municipalities of Kolontár, Devecser, and Somlóvásárhely along the Torna creek valley (see Figure 1.). The catastrophe resulted in 10 casualties, while 286 persons had to be treated by medical personnel, damaged 367 properties, and covered 1017 hectares land.

*Fig. 1. satellite image of the flooded are by NASA October 9, 2010*

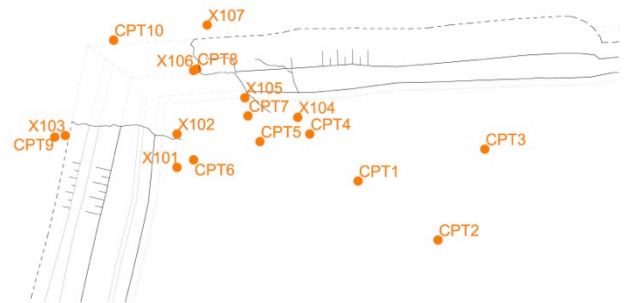
FUGRO Consult Ltd. carried out 7 borings with continuous core sampling near the failure with 10 CPTu soundings after the catastrophe (see Figure 5.). Our aim was to obtain trustworthy information on the strength parameters of the subsoil around the failure and particularly of the deposited red mud.

Fig. 5. Site investigations after the catastrophe

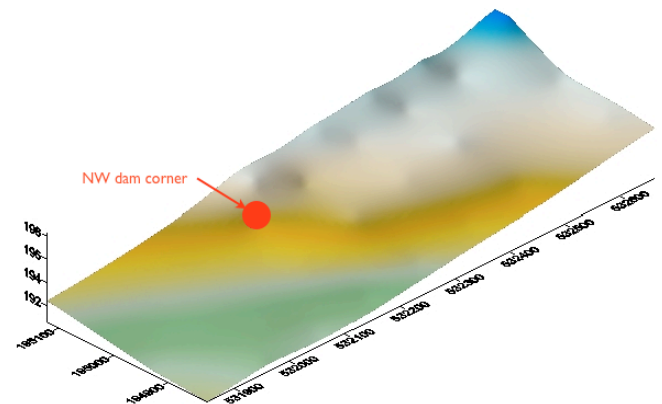
According to our site investigations and surveying datas under the critical NW dam corner the ground surface and also the pannonian clay surface gradient is much bigger than any other part of the area (see Figure 6.)

Fig. 6. Gradient of the surface level by the NW dam corner

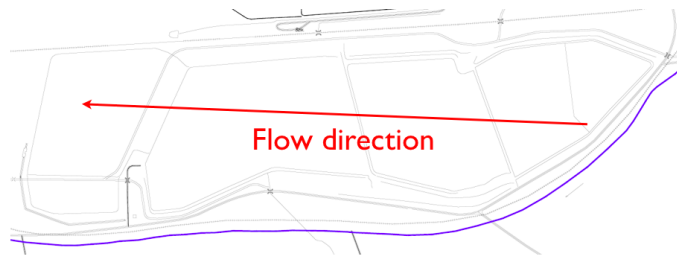
The creek was diverted from its original path in 1990 to south of the reservoirs, parallel with the relocated railway line. It reaches the area from northeast and flows towards Kolontár. Figure 15. shows the groundwater flow directions of the area based on 2010's first half-year data.

Fig. 15. Groundwater flow direction

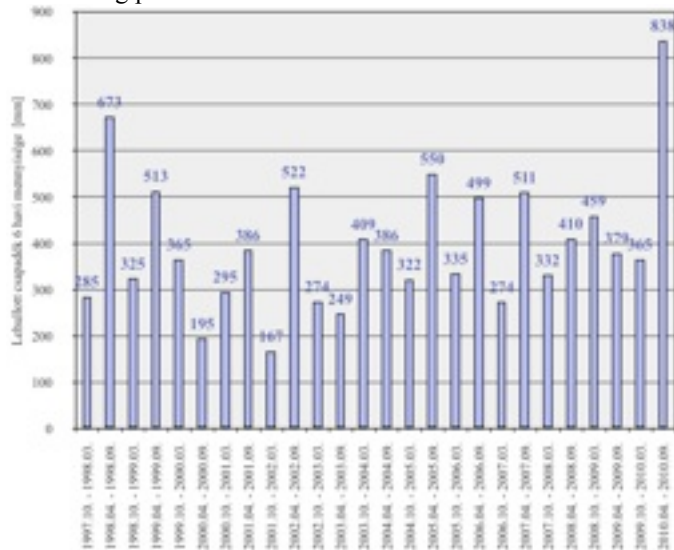
According to standards the precipitation of the area sealed by the diaphragm wall must have been collected and lifted up to the surface of reservoir X. Therefore it is crucial to know the exact amount of precipitation. A precipitation measurement station, called Ajka 135, monitored this. After January 1, 2006, the precipitation was registered by the factory's measurement station. Based on the data collected, the total amount's annual average between 1965 and 2009 was 714mm, the maximum was 958 mm (2007) and the minimum was 495 mm (2000). The data collected by the Hungarian Central Institute of Meteorology (OMSZ) between October 1997 and October 2010 are shown on Figure 16., broken down by 6 month long periods.

Fig. 16. Distribution of rainwater in 6 months periods

It is clear that before the catastrophe the precipitation was higher than the annual average for years retrospectively.

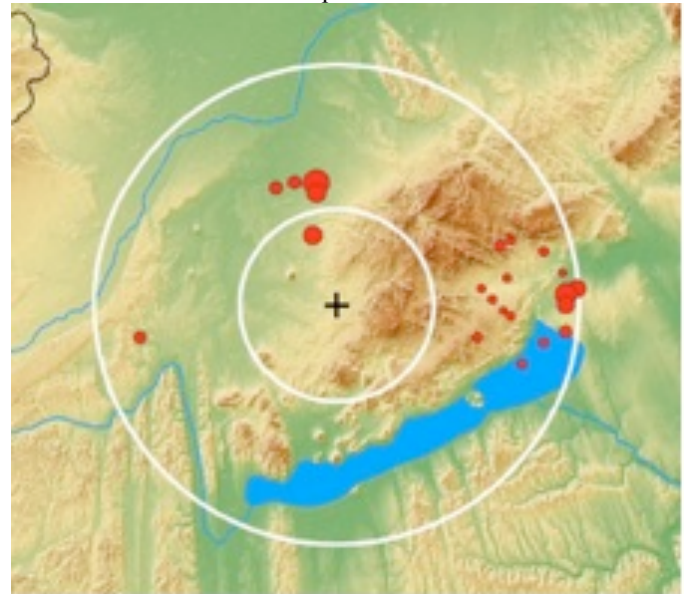
Ajka lies on an area of Hungary considered seismically calm. The nearest area, which has been active before, is in 45-50 km distance, called Berhida, or further areas of Bérbaltavár and Várpalota. Notably, low activity has been registered in this area during the observed period of January 1, 2000 and October 4, 2010 at Pápa, Csót, and Pápasalamon. Locations of the activities within 50 km diameter of the area (47° 05' 20.19" N; 17° 29' 43.76" E) can be seen on Figure 17. in the above mentioned time period.

Fig. 17. Earthquakes in the region

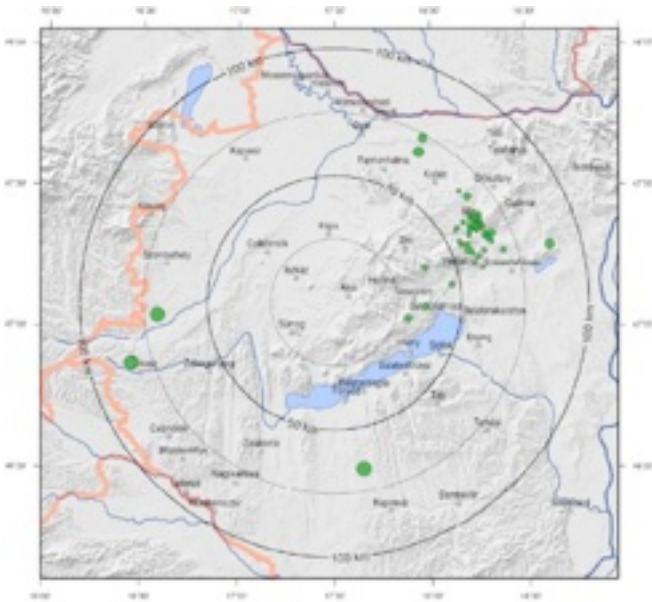
The Hungarian earthquake observation system has registered 115 earthquakes in the first 8 months of 2010, 72 of them within 100 km of the dam's area. A map of these locations is shown on Figure 18. The lowest magnitude was ML=0.5, while the highest was ML=2.7 (ML: local Richter magnitude). Most of them were micro quakes centred in the area of Móri Trench.

Fig. 18. Earthquakes in the bigger region

Based on approximations the maximum horizontal seismic soil velocity caused by these activities was  $0.0327 \text{ m/s}^2$  assuming loose surface deposits.
