The Agua Prieta Powerhouse Slope Instability

F. Gonzalez-Valencia and S. Herrera-Castañeda
Federal Commission of Electricity, Mexico, D.F.

The slope instability that endangered seriously the powerhouse of the Agua Prieta Hydroelectric Project and involved about one million cubic meters of soils and breccias is described. The evolution of the geotechnical instrumentation measurements done from October 1987 to date, the geomechanic analysis performed and the stabilization works are discussed.

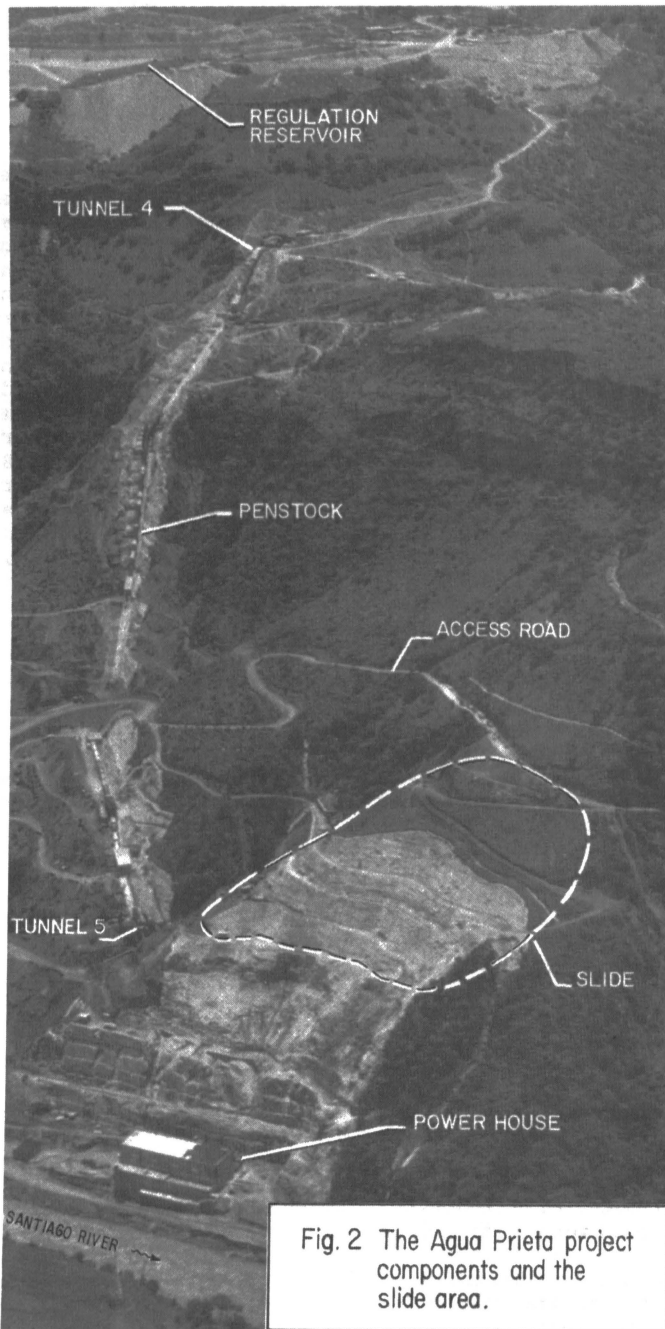
Fig. 2 The Agua Prieta project components and the slide area.

The project construction began in 1987 and some excavations were made to trim and increase the stability of the natural slope behind the powerhouse by removing the loose materials forming six berms. At that time, seven inclinometers were installed to monitor the potential local movements between the upper four berms. The frequent surveying and inclinometric measurements showed that during the rainy season of each year (June-September) the slope moved horizontally outwards at a rate of about 2 mm per month and then almost stopped. In September 1990 the rate of displacements increased to 9.8 mm per month and the slide did not stop after the end of the rains. Moreover, in July 1991 the velocity of the displacement increased dramatically to 118 mm per month on the average, putting in serious jeopardy the powerhouse at the toe of the slope.

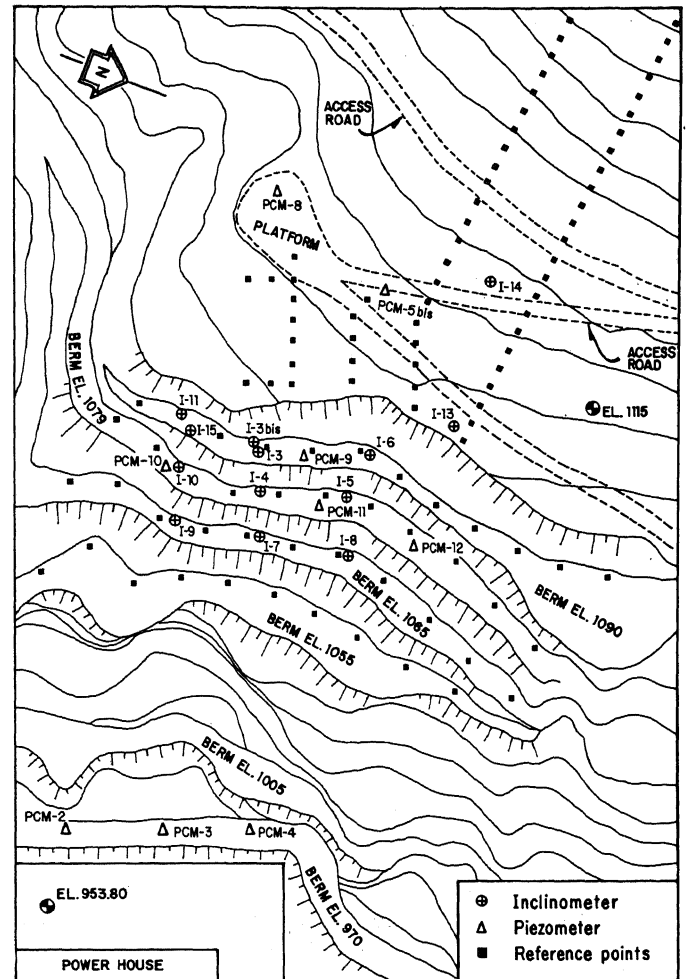
Fig. 5 Geotechnical Instrumentation and trimming berms

When the movements accelerated in 1990, there was necessary to increase the geological exploration to determine the back extension of the mass in movement and the boreholes were used to install more inclinometers and piezometers. The array of the instrumentation in the slope is shown in Fig 5.

As soon as the slide was detected (1988) several actions were undertaken to regain the slope stability including the prevention of water infiltration from the ground surface by applying shotcrete in the trimmed berms, by constructing several gutters, and then by the excavation of two draining galleries with a large number of boreholes from the inside.
