Punch-Through Foundation Failure of Oil Drilling Platform in the Deltaic Plain of the Niger River

PUNCH-THROUGH FOUNDATION FAILURE OF OIL DRILLING PLATFORM IN THE DELTAIC PLAIN OF THE NIGER RIVER

This paper presents the records and events that led to the collapse of the drilling platform, the findings of the post-failure investigation and the proffered solution for the reconstruction of the platform.

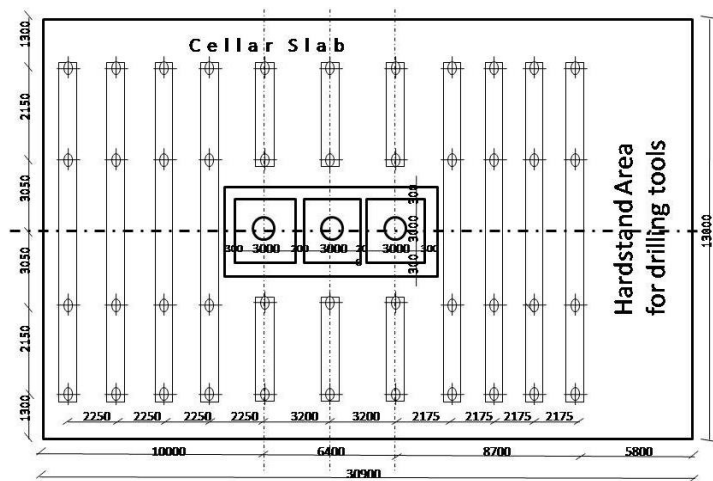
Fig. 2: Drilling Platform showing the cellar slab, hardstand area and piling layout

The platform was constructed with concrete vibrated to achieve a dense state and reinforced with 12mm high tensile steel. The reinforcement was spaced at 150 mm intervals in both directions. The cellar slab was supported on ground beams arranged in a grid over the foundation piles and interlocked with the pile caps.

Forty four tubular steel piles of 250mm diameter and 21.0 long were installed beneath the cellar slab with 22 piles under each skid. Fig. 2 shows the configuration of the cellar slab and the pile layout, and Fig. 3 shows the pile section.

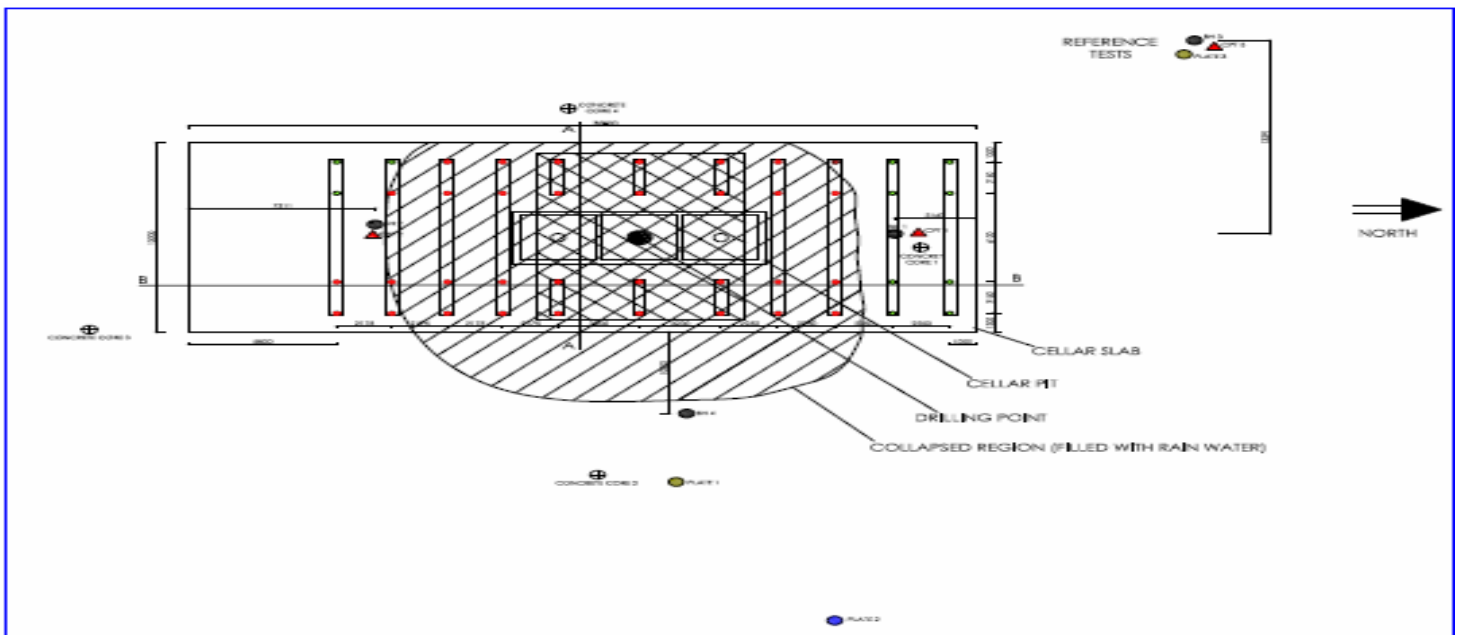
Fig. 5. Site plan showing test points

Three borings with soil sampling and three cone penetration tests were carried out at the site. Two borings and two cone penetration tests were located around the collapse cellar slab. Reference boring and cone penetration test were located at a distance of about 13m from the platform. These reference tests were needed to determine the original soil conditions that prevailed at the site prior to the project. Fig. 5 shows the plan of the cellar slab and the locations of the boreholes and the cone penetration tests carried out during the post-failure investigation.
