Wadi Qattarah Dams Case History

SUMMARY

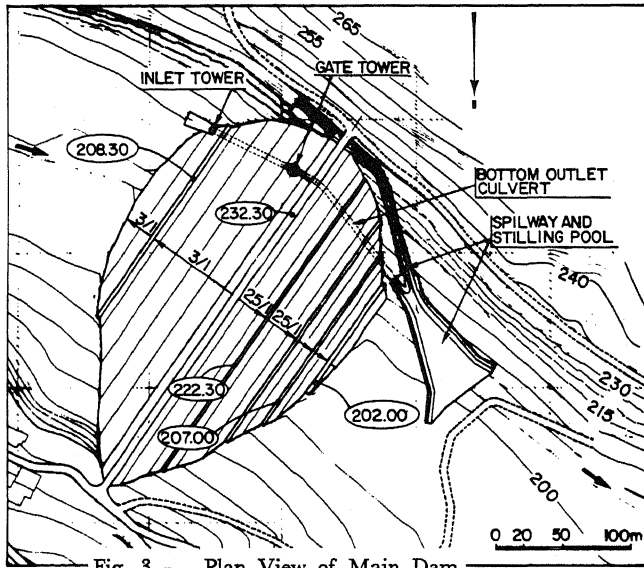
Fig. 3 - Plan View of Main Dam

Both dams are homogeneous embankments with similar design characteristics and similar appurtenant works. Fig. 3 and 4 show the plan view of both dams.
