(2013) - Seventh International Conference on
Case Histories in Geotechnical Engineering

Reconstruction of Road Embankment Failure Using Reinforced Geogrid: Revisiting the Site After 15 Years

RECONSTRUCTION OF ROAD EMBANKMENT FAILURE USING REINFORCED GEOGRID: REVISITING THE SITE AFTER 15 YEARS

A case history of repair works of road embankment failure at KM39, Route 68, Kuala Lumpur – Bentong Road in the state of Selangor, Malaysia and an observation on the condition of the site after 15 years and some tensile strength testing carried out on buried and exposed geogrid was presented in this paper. Due to heavy rainfall in 1995, about half of the road embankment which was located at the alluvial fan of an upslope stream valley was washout. For the reconstruction of the alignment, the existing half of the alignment was converted into a buffer zone with a row of gabion as a barrier to trap any fallen debris from the upslope stream valley. A geogrid reinforced embankment was constructed to provide an additional area for the new alignment of the road.

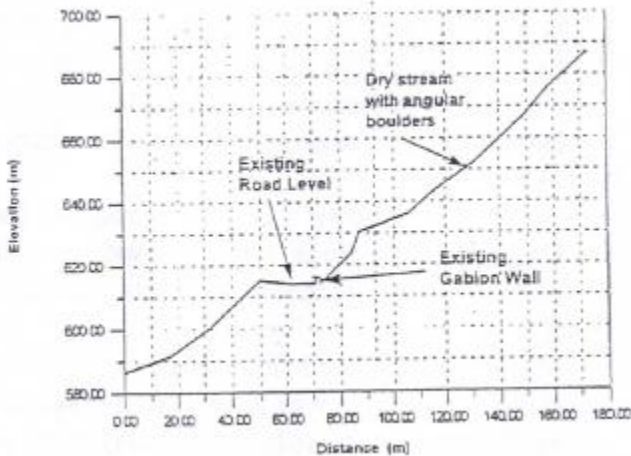
Fig. 2. Cross section profile at km 39

37°. Materials at the down slope consisted of spoils brought down from the upslope and previous fill materials, which were loosely tipped during the construction of the road. This resulted in erosion failure on the embankment face. Seepage water was also noticed on the surface of the embankment. The lateral extend of the scoured face was estimated to be about 40m and the affected height was approximately 15m below the road level.

Scouring of down slope embankment was due to seepage and surface flow from upslope. Seepage flow underneath the road embankment resulted blow out of piping of road embankment materials. This initiated the scouring of the embankment surface. Flow of surface runoff over the road downwards, causing further scouring of the down slope embankment surface (RAS, 1996).

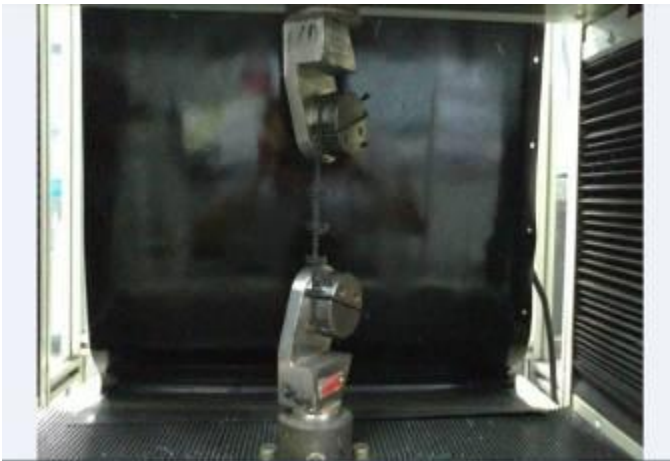
Fig. 24. Wide Width Tensile Test using split roller grips based on ISO 10319-2008

Due to the Fortract 80/30-20 and 110/30-20 geogrid was high strength geogrid, the Wide Width Tensile Test was carried out using split roller grips on the single strand of geogrid as shown in Fig. 24. This test procedure is based on ISO 10319-2008. A strain rate of 20% per minute was applied. The results were then multiply by 40 to get kN/M unit.

was observed. For exposed Fortrac 110/30-20, the percentages reduction of strength is between 2.3% and 17.7% with an average of 10.2% and standard deviation of 7.68%. Glaring in difference of strength reductions is difficult to explain. Is it the contractor tries to cut cost by using lower grade of geogrid? Noted that the only available grades of Fortrac geogrid attached in the Design Report (RAS, 1996) are 110/30, 80/30, 55/30, 35/20 and 20/13.

If we ignore the last two samples (BR6 and BR7), an average percentage reduction of strength for both condition is not much difference. This means that Malaysian tropical environment effect of ultraviolet, temperature and humidity) didn't much effect on the strength of geogrid.
