# Repair of a Reinforced Earth Wall

**SYNOPSIS** The facing of a Reinforced Earth retaining wall, built at an altitude of 1200 m, was damaged during the winter 1981. The repair was achieved quickly and under traffic. The instrumentation carried out on the repairs and the tests run on the backfill material have revealed the action of the frost and its increase in the fortuitous presence of water.

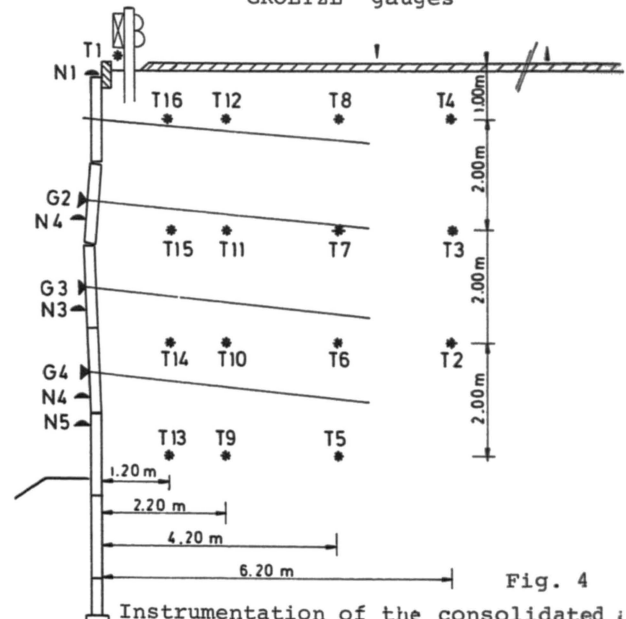
- Temperatures : 15 gauges were placed at the back of the facing and 1 at the top of the structure in order to measure the external temperature (fig. 4)

- Rotations : an insert was sealed to each part of the profile in order to carry out rotation measurements with a precision levelling instrument (L.C.P.C. type).

Fig. 4  
Instrumentation of the consolidated  
IV - MEASUREMENT RESULTS

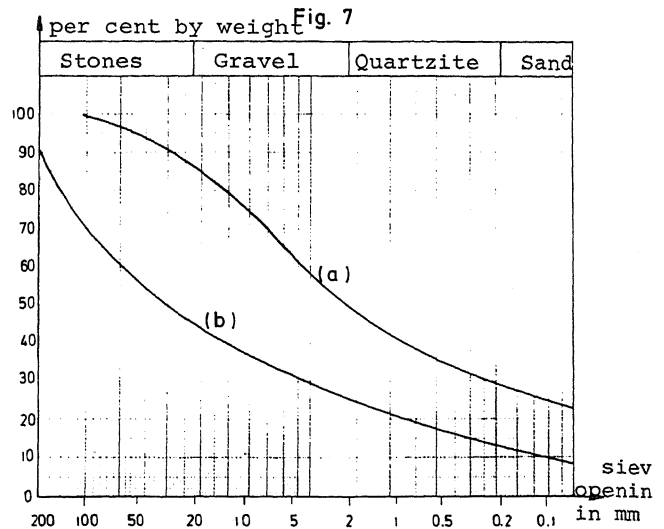
- Fill coming from the excavation of the access gate or from the wall pit itself (fig.7a). The percentage of fine backfill is over 15 %.
- The quartzite materials of an existing quarry (fig. 7b).

We chose to test portions 0/20 and 0/5 mm of soil a) which seemed the most expanding one.
