International Conference on Case Histories in
Geotechnical Engineering

Lessons Learned from the Disaster at Lippe Canal Bridge

LESSONS LEARNED FROM THE DISASTER AT LIPPE CANAL BRIDGE

Markus Herten

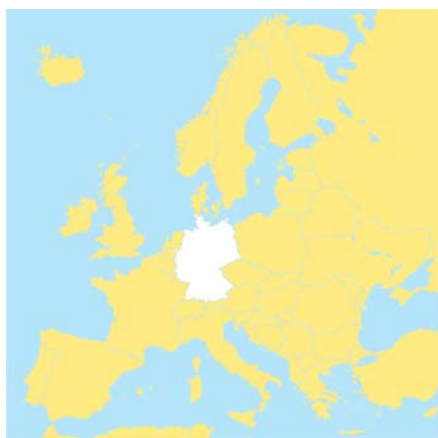
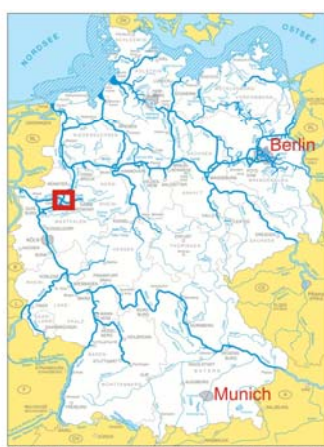
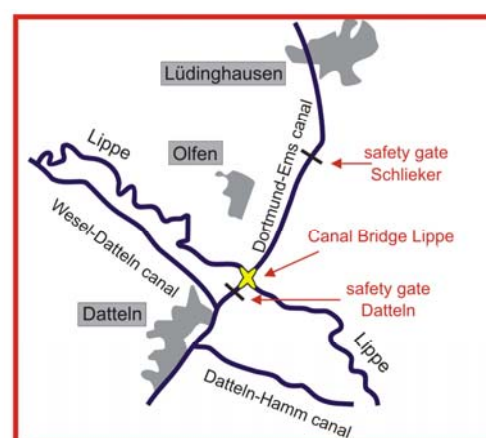
Fig. 1: Site plan

Disaster alarm was triggered and the safety gates Datteln and Schlieker were closed after all the ships had left the canal stretch (cf. Fig. 1). A downspout was moreover opened to empty the canal stretch. Several attempts to close the leak with soil material on the canal side failed (Fig. 7). Due to the high flow velocities, the embankment next to the wing wall eroded totally (Fig. 8). An 8 km long canal stretch was emptied completely. The water from the canal flew around the old and the new wing walls into the Lippe River.

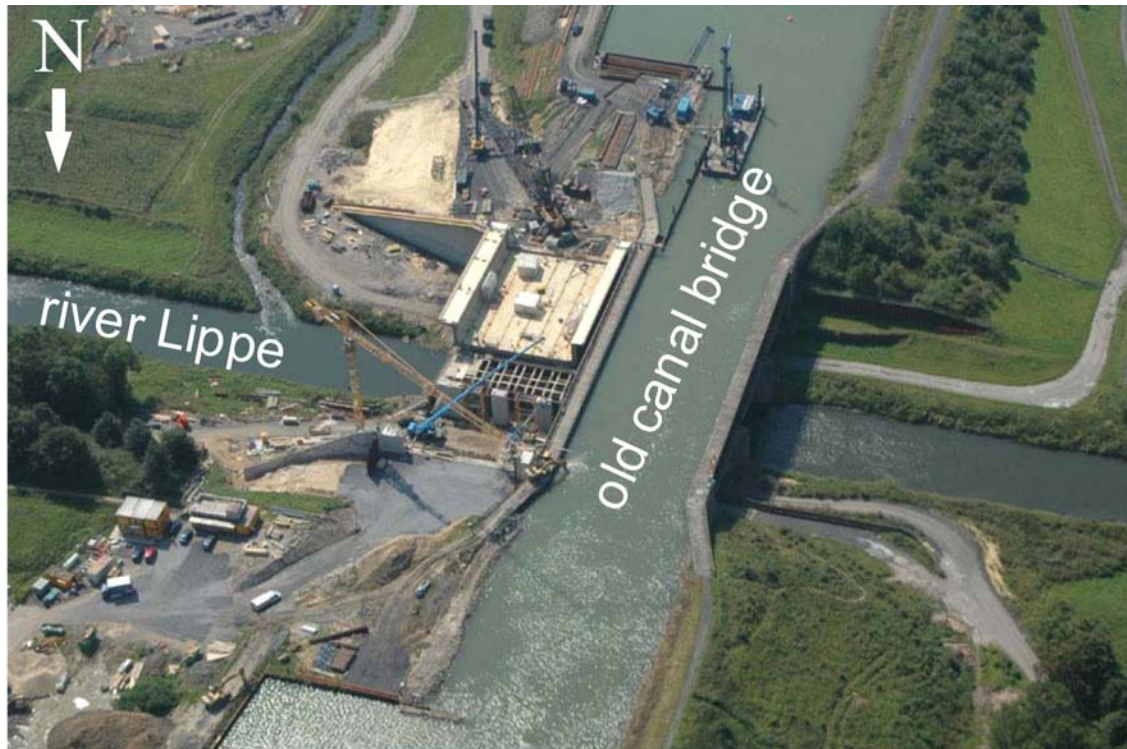
Fig. 2: Aerial photograph of the construction works (August 18th, 2005)

The DEK is being expanded to meet the requirements of larger motor cargo vessels. This measure requires the renewal of the canal bridges spanning the Ems and Lippe Rivers. Construction works at the Lippe canal bridge started in spring 2004. The construction of the Ems canal bridge is planned to start soon. The aerial photograph of the Lippe canal bridge (Fig. 2) shows that the construction area is situated in an above-ground canal stretch of the DEK. The embankment crest is at approx. 15 m above the natural terrain. The regular water level of the Lippe River is about 16 m below the regular water level in the canal. The DEK embankments are made of silty sands. The building ground consists of sandy marl. During construction works continuous ship traffic is maintained. This is why a new steel trough was installed directly adjacent to the existing trough made of concrete. It was not until the new trough was put into operation that the old canal bridge was supposed to be sealed off and demolished. The old aqueduct is supposed to be replaced by another new trough at the same location. At the time of the accident, the construction works on the new trough at the north side had almost as much progressed as the works on the south side in August 2005, as shown in Fig. 2.

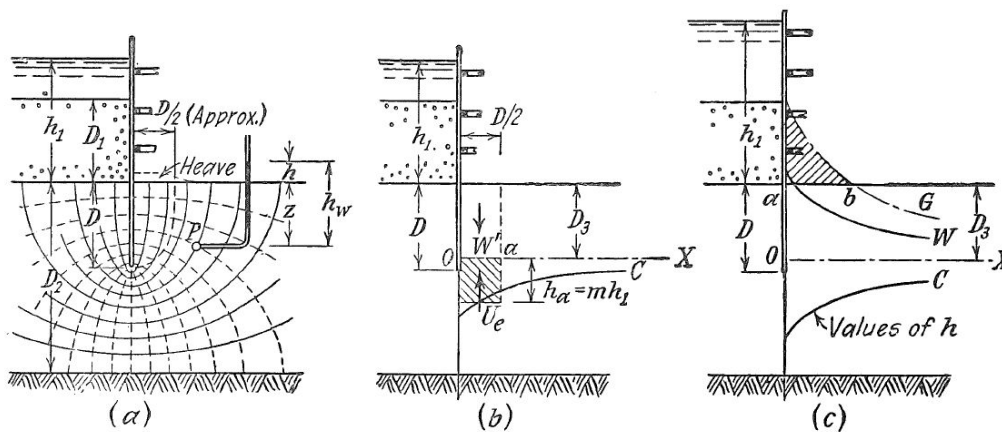
Fig. 9: Graphical determination of safety (from: Terzaghi K.(1947), Fig. 79)

Terzaghi further mentions in regard to failure by heave: “With sufficient accuracy we can assume that the body of sand which is lifted by the water has the shape of a prism with a width $D/2$ and a horizontal base at some depth D_3 below the surface. [...] For the simple row of sheet piles represented in Figure 79b an investigation has shown that the critical section passes almost exactly through the lower edge of the sheet piles, or $D_3 = D$.” In Germany, this is defined as the failure body after Terzaghi. Instead of using a potential net, another way of simplification is used in Germany for such a case; the potential at this wall base is calculated based on the formula by Brinch Hansen (1953), which is also mentioned in EAU (2004). According to this approach, instead of a prism with a width $D/2$, only a flow channel needs to be examined. The result for the simple row of sheet piles represented in Figure 9b would be on the safe side.

A more realistic result is obtained if, as described in Terzaghi (1947), the balance is considered not only at the wall base but also at other depths $D_3 \neq D$ (Fig. 9c). Terzaghi writes: "The investigation can be repeated for different horizontal sections through the sand, which are located at different depths D_3 below the bottom of the pit. The critical head is determined by the condition $h_p = \text{minimum}$, and the horizontal section to which this minimum refers is the critical section. It represents the lower boundary of the mass of sand subject to lifting in the initial state of the piping phenomenon." However, this was not considered when planning the excavation pit at the canal bridge Lippe and hence a false safety was calculated.

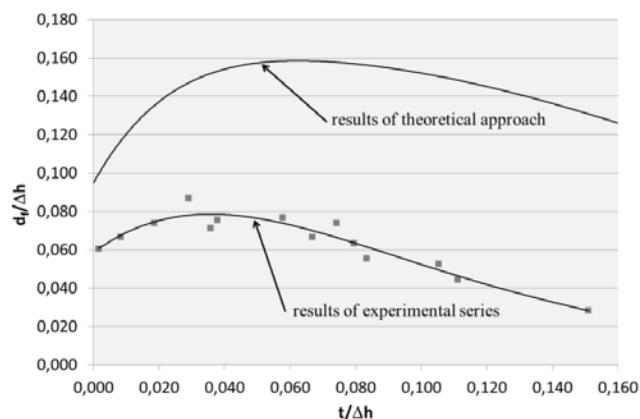
Numerical analyses conducted by BAW show that even if Terzaghi's statements are considered, the necessary thickness of the surcharge drain d_f becomes less if the leftover soil at the sheet pile bottom is removed. In the diagram (cf. Fig.12), Δh equates h_1 and t equates D according to Terzaghi. If $t/\Delta h$ equates zero, the upper line in the diagram drops after reaching a peak. As this is surprising, BAW ordered experimental tests to be executed at the Bundeswehr University Munich to verify the theoretical results (Schober et. al. 2011). As shown by the lower line in the diagram, the same

effect occurred in the test. The two lines are not identical since the calculation was performed only for the maximum thickness of the surcharge drain d_f without uniform distribution. Thus Terzaghi's statements were confirmed.

Fig. 12: Results of experimental series as a function of $d_f/\Delta h$ and $t/\Delta h$ in: Schober et. al. (2011), Fig. 12
