Investigation of Collapse of an Apartment Building Due to Differential Filling

SYNOPSIS Investigation of collapse of a five storey residential building in Calcutta is described. The failure occurred soon after construction but, fortunately, before occupation. Detailed soil investigation revealed that a bowl-shaped depression, 5.5 m deep, existed in the collapsed building area which was subsequently filled up. The foundation raft was placed 5.325 m below ground level and the subsequent filling put an overburden pressure of varying magnitude resulting in non-uniform pressure on the subsoil. This was apparently not considered in design. Factor of safety was found to be low against bearing capacity failure and the building tilted towards the heavier load concentration. This caused over-stressing, in structural elements which gradually failed and ultimately led to the collapse of the building.

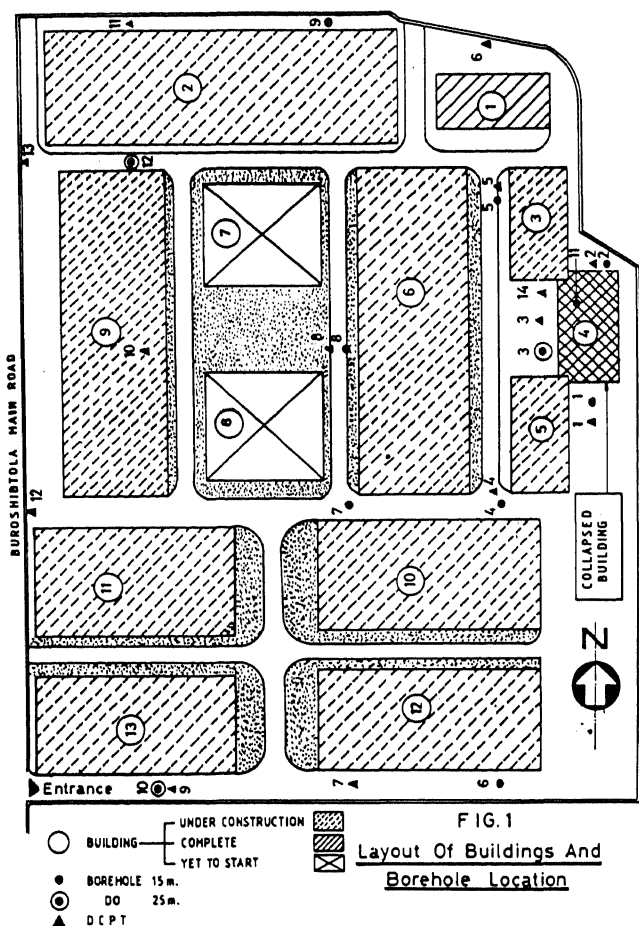
The boreholes were done at locations indicated in Fig. 1 to determine the subsoil stratification at the building site and to collect disturbed/undisturbed samples for testing. The borehole locations were so chosen as to get sufficient

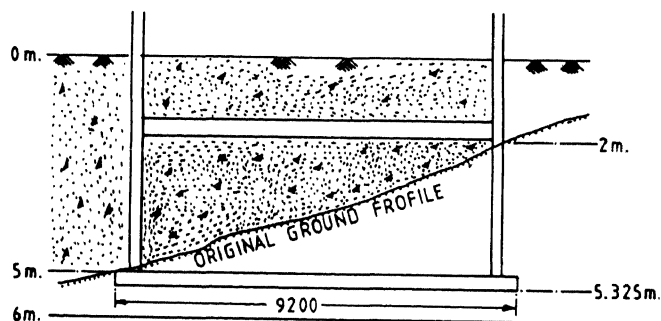
building area, Fig. 8. It would appear that the depth of the fill varied from 5 m on the western face to 2 m on the eastern face. The foundation raft was placed at 0.325 m below original G.L. at the western face of the building and excavation of varying depth - upto a maximum of 2 m at the eastern side - was made to build the foundation. The area was subsequently filled up with the factory waste to arrive at the finished ground level. With regard to the net foundation loading, therefore, a fill of varying depth - 5 m on the western side to 2 m on the eastern side - is to be considered on the foundation raft. This would give additional foundation pressure of 7.5 t/m² to 3 t/m² due to the overburden. The backfill upto the original ground profile was actually a replacement of the excavated soil and need not be considered as an additional load on the subsoil. The net foundation pressure below the raft may thus be obtained by considering the superstructure load and the backfill load separately. The data are shown diagrammatically in Fig. 8.

b. The soil in the collapsed building area had a bowl-shaped depression with a maximum depth of 5.5 m just west of the building. Differential
