Case Histories of Foundations on Top of a Rupturing Normal Fault During the Kocaeli 1999 Earthquake

G. Gazetas

I. Anastasopoulos

CASE HISTORIES OF FOUNDATIONS ON TOP OF A RUPTURING NORMAL FAULT DURING THE KOCAELI 1999 EARTHQUAKE

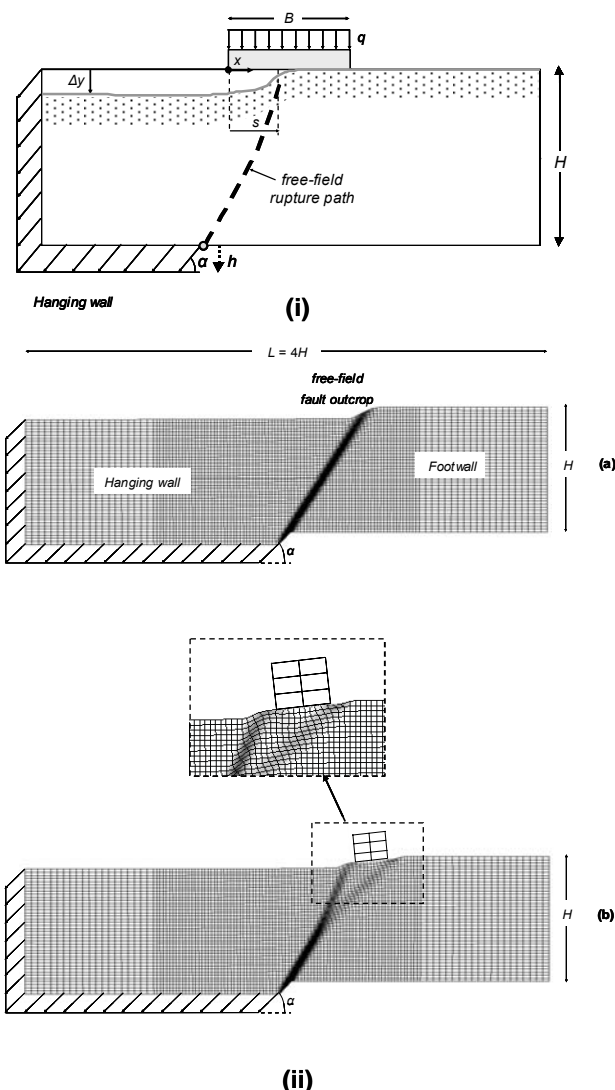
Figure 7. (i) Configuration of the soil–foundation system subjected ; (ii) Finite element discretisation and the two steps of the analysis: (a) fault rupture propagation in the free-field, and (b) interplay between the outcropping fault rupture and the structure.

A typical result elucidating the interplay between loose ($D_r = 45\%$) soil, rupture path, and a perfectly rigid foundation carrying a 4-storey structure is given in **Figure 7(d)**. A base rock dislocation of 2 m (5% of the soil thickness) is imposed. The structure is placed symmetrically–straddling the free-field fault breakout (i.e. the foundation is placed with its middle coinciding with the location where the fault would outcrop in the free field). Yet, a distinct rupture path (with high concentration of plastic shearing deformation and a resulting conspicuous surface scarp) is observed only in the free–field. The presence of the

structure with its rigid foundation causes the rupture path to bifurcate at about the middle of the soil layer. The resulting two branches outcrop outside the left and the right corner of the foundation, respectively. The soil deformations around these branches are far smaller and diffuse than in the free-field, and the respective surface scarps are much milder. Thanks to the substantial weight of the structure and the flexibility of the ground, the structure settles and rotates as a rigid body. The foundation does not experience any loss of contact with the ground ; apparently, the foundation pressure is large enough to eliminate any likely asperities of the ground surface.
