## Ground Heave Due to Jet Grouting Near an Existing Structure

## GROUND HEAVE DUE TO JET GROUTING NEAR AN EXISTING STRUCTURE

Renovations of the MBTA Copley Station in Boston included construction of a new elevator shaft to improve disabled access to the existing Green Line station. The site is immediately adjacent to the Eastern façade of the historic Old South Church. The construction work required excavation support including a perimeter secant pile wall and a jet-grouted base plug. Significant ground and structural movements were observed during jet grouting, mainly associated with soil displacements during grout injection. A three dimensional numerical model was developed, using the Plaxis 3D Foundation™ program, in order to test the hypothesis that the observed movements of the structure could be associated with the installation of the jet grout piles. The amount of volume expansion associated with installation of jet grout piles is estimated based by calibrating the model to measured ground movements. The finite element model results give a consistent explanation for the observed pattern of movements, including the heave of the church wall and lateral displacements at incl

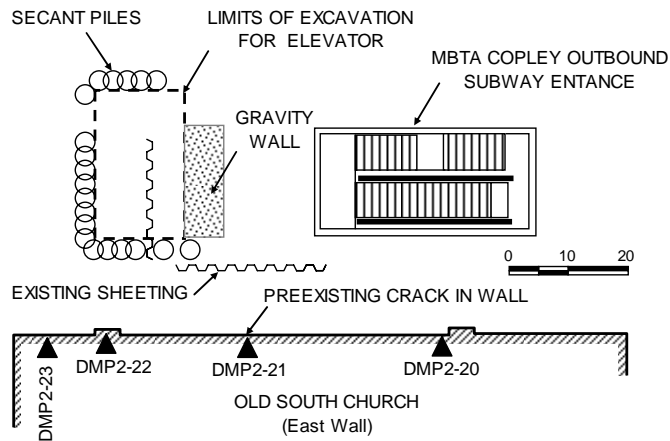
Fig. 1. Site plan

measured at several displacement measuring points (DMP, Fig. 1). The ground and structural movements were attributed to jet grouting activities for the new elevator shaft that were on-going at the time. Subsequent investigations focused on possible mechanisms causing the movements including detailed inspections of the OSC foundations (involving load testing of several timber piles), an extensive geotechnical site investigation, and implementation of a sophisticated instrumentation program to monitor for any further ground or structural movements. After establishing that movements had stabilized, the below grade works resumed in November 2009 using a revised construction sequence. With careful planning and execution, the elevator shaft was completed in April 2010, with no further movement or damage to the Old South Church. This paper summarizes the development and validation of a 3-D model of the soil-structure interactions that was carried out to test the hypothesis that the observed movements of the OSC could be associated with the installation of the jet grout piles.

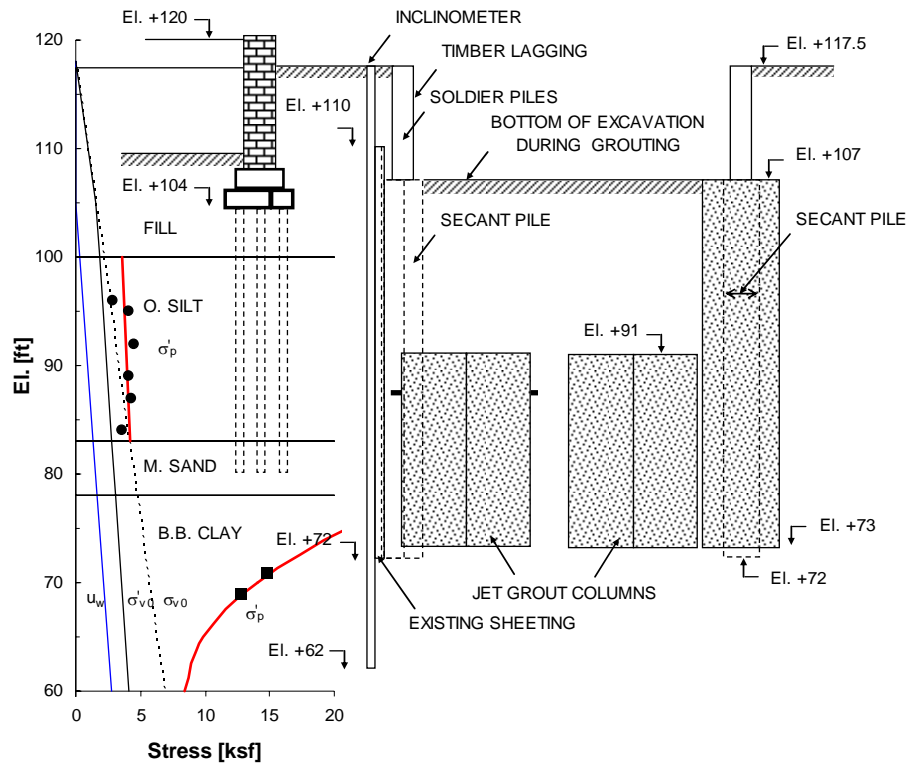
Fig. 3. Typical soil profile, OSC foundations and excavation support for elevator shaft

Figure 3 shows the typical soil profile, together with a vertical section showing the excavation support system for the elevator shaft and pile foundations of the Old South Church.

The ground surface is level at El. +117.5 ft. The average soil profile at the site is comprised of an 18-ft thick layer of dense sand and gravel fills (average  $N = 44$  bpf), an organic silt unit of similar thickness ( $N = 6$  bpf), and a 5-ft thick layer of very dense marine sand ( $N = 72$  bpf), underlain by Boston Blue Clay (BBC). Groundwater conditions are assumed to be hydrostatic with a seasonally-averaged groundwater level located in the fill at El. +105ft. Laboratory tests conducted on samples from the forensic site investigation (September 2009) shows that the organic silts are lightly overconsolidated with an average  $OCR = 1.70$ , while the upper BBC is desiccated and more highly overconsolidated ( $OCR \geq 5$ ).

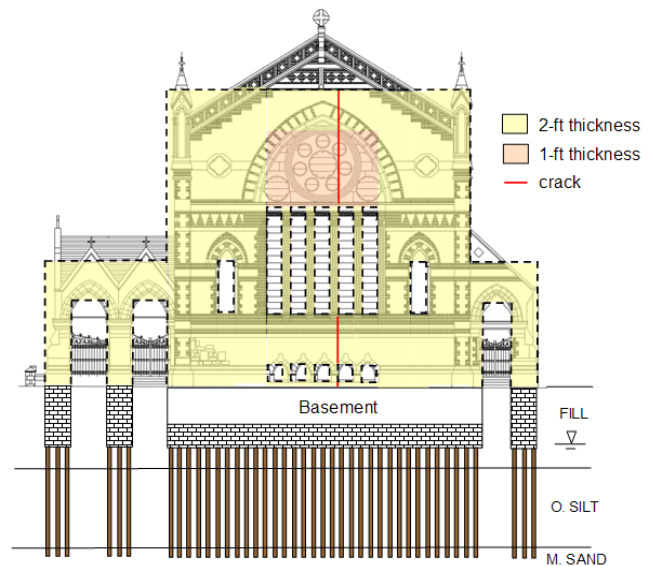
Fig. 5. FE representation of East Wall

Due to limitations in the capabilities of the FE program used in the current analyses (Plaxis 3D Foundation™, v2; Brinkgreve & Swolfs, 2007), only horizontal planes and lines are allowed in the model. Figure 5 shows a representative model of the East Wall, where a vertical crack is introduced at the observed location. The model approximates the crack pattern with a continuous vertical through-crack. This approximation captures the lack of continuity between the two wall “blocks”, as well as the intersection of the discontinuity line at the ground corresponding to a point of rotation when deformations take place.

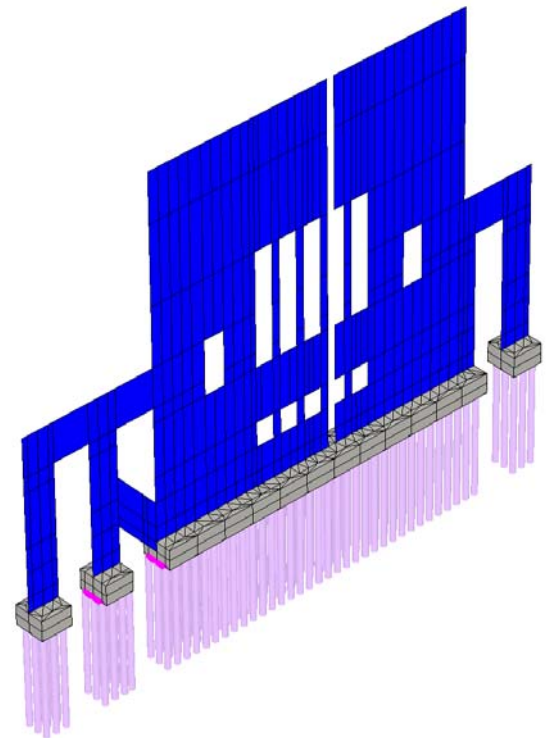
Fig. 6. East wall and foundations – FE Model

Figure 6 shows a 3D view of the FE model of the East wall and foundations, where the vertical crack is shown as a vertical discontinuity. Piles are modeled by means of embedded beam elements, connected to a granite pile cap that supports the church wall. Additional connection elements are included in order to provide a smooth transition of forces between these elements, without significantly altering the overall behavior of the foundation-wall system.

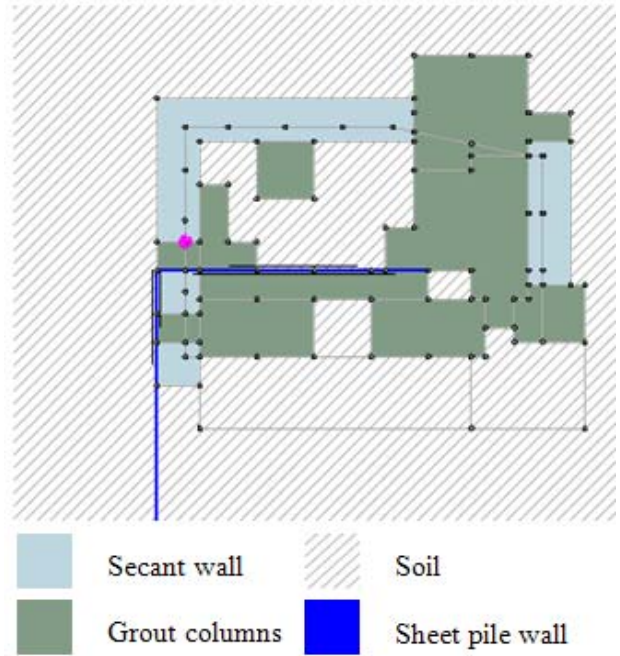
Fig. 9. Plan view of FE representation of jet grout piles installed through Dec. 2008

Figure 9 shows a plan view of the FE model of support elements for the elevator access shaft.

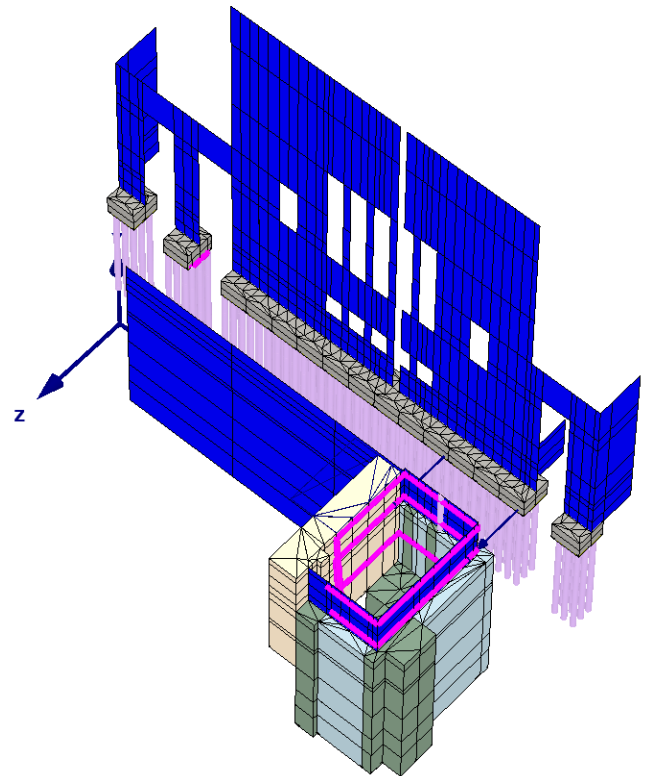
Fig. 10. FE model showing all structural elements for support of the elevator access shaft and Old South Church façade

Figure 10 shows an isometric view of the complete structural model, highlighting the relative positions of the elevator access shaft, the pile foundations and eastern façade of the Old South Church.
