The Observed Seismic Behavior of the Matahina Dam

M. D. Gillon

Ministry of Works and Development, Wellington, New Zealand

SYNOPSIS: On 2 March 1987 the 86 m high Matahina earth dam in the Eastern Bay of Plenty region of New Zealand was shaken by a nearby magnitude 6.3 earthquake. The dam response was recorded by five strong motion accelerometers and a maximum crest level acceleration of 0.42 g was measured. The crest level rockfill settled about 100 mm and moved downstream 250 mm during the earthquake. No major leakage has resulted from the earthquake.

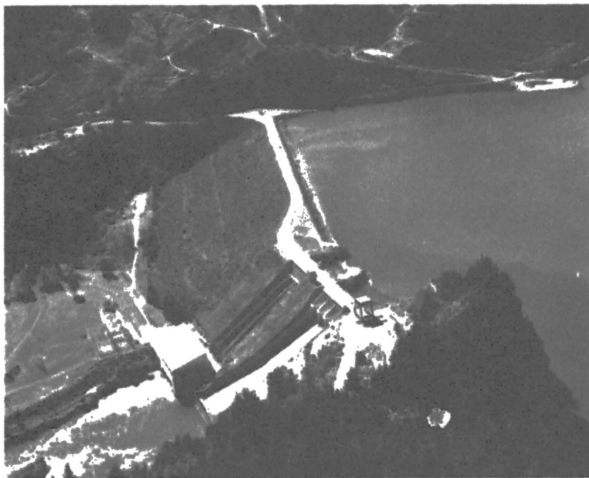
Figure 4. Matahina Dam (D.L. Homer DSIR)

The diversion and dewatering tunnels, the spillway, the penstocks and powerhouse are founded on a prominent rock spur which forms the left abutment (Figure 4). There is a grout curtain forming a partial cutoff within the spur supplemented by two drainage drives. Seepage flows and groundwater levels are monitored.

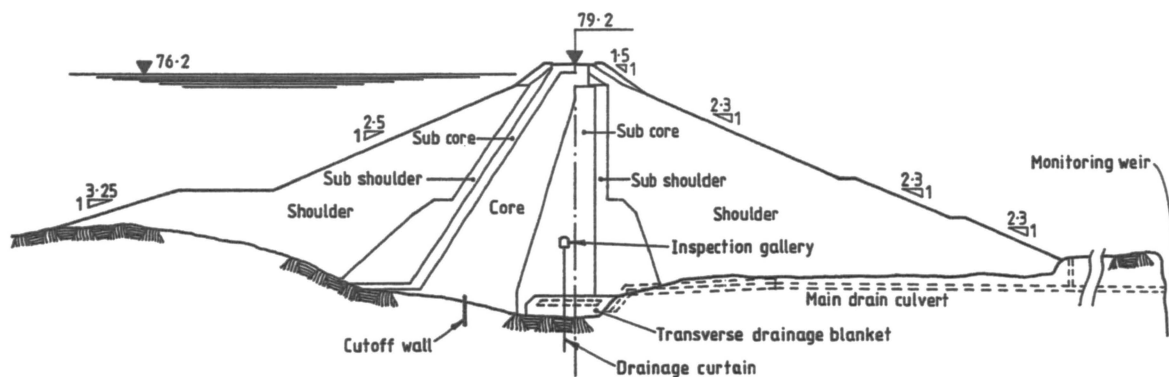
Figure 5. Cross section of the Matahina Dam.

The dam (Figure 5) stands 86 m high above foundation level and has a crest length of 400 m. It has an upstream sloping core of moderate width. The core material is weathered greywacke with a low plasticity gravelly clay grading. The dam shoulders are of hard ignimbrite rockfill compacted by heavy tractor track rolling. The transition zones between the core and shoulders comprise the fines and softer strippings from the ignimbrite rockfill quarry.
