Damage and Remedial Measures for Buildings on Hill Slopes

SYNOPSIS The paper deals with details of geotechnical investigations carried out for evaluating the reasons of damage to the buildings resting on hill slopes in northern region of India and also to evaluate the soil parameters for designing retaining walls and other remedial measures for preventing further damage to structures. Three causes of failure were identified namely (i) instability of slopes, (ii) improper design of retaining walls and (iii) differential settlement of structures. Shear strength parameters of the soil mass required for the analysis of slope stability and stability of retaining wall sections have been chosen based on three methods of investigations viz. large scale direct in-situ shear tests, plate load tests and the back analysis method. The stability analysis of various sections of slopes have been carried out and measures for strengthening of slopes have been suggested.

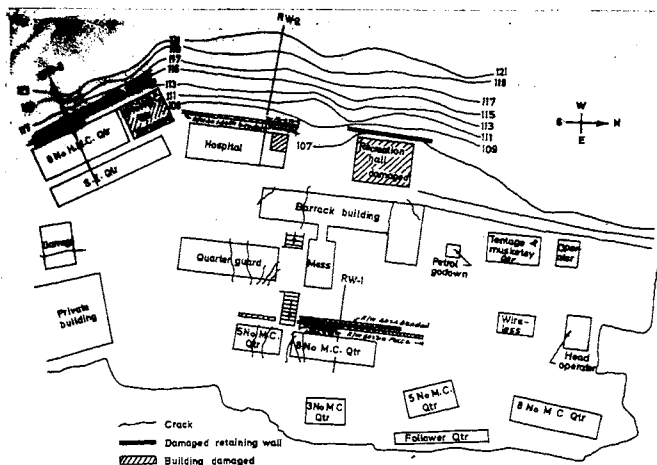
Fig.1 Site Plan

The site is located in the northern part of India in the foothills of Himalaya and it falls in seismic zone IV. The main construction consists of single and double storeyed residential buildings. The building walls were made of random rubble masonry with sloping roofs of G.I. sheeting. Retaining walls (banded or with dry stone packing) were also to retain slopes. An year after construction some of the buildings developed cracks and a few of the retaining walls failed (Fig.1) damage suffered by the structures built at the site.

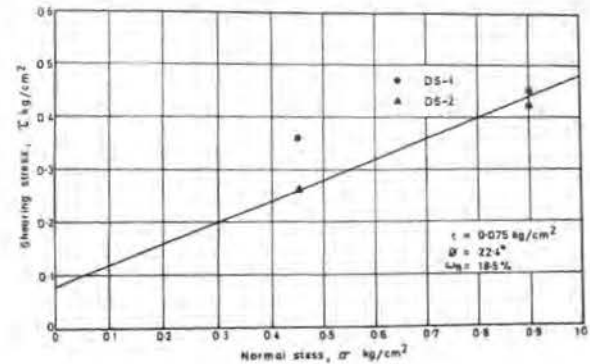
Fig.3 Normal Stress vs Shear Stress Plots

In-situ direct shear tests at two different locations (Fig.1) on square samples of area 5000 sq.cm and 900 sq.cm in plan (Ranjan, Prakash and Srivastava, 1977) were carried out at normal stresses ranging from 0.45 kg/cm^2 to 0.90 kg/cm^2 . The Mohr's envelope from the in-situ shear tests is plotted in Fig.3. The results indicate an average value of angle of internal friction $\phi = 22.4^\circ$ with a cohesion

$c = 0.075 \text{ kg/cm}^2$.

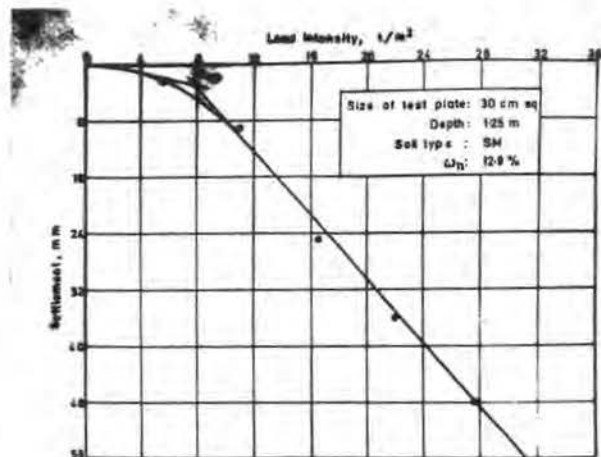
Fig.4 Load Intensity vs Settlement Plot (VPL-5)

The allowable bearing pressure is determined through vertical plate load tests carried out as per Indian Standard IS:1888-1971. Four vertical plate load tests were carried out using $30 \text{ cm} \times 30 \text{ cm}$ size plate in pits $1.5 \text{ m} \times 1.5 \text{ m}$ in plan. These tests were carried out at a depth of 1.25 m at four different locations (Fig.1). Figure 4 shows a typical load intensity vs settlement curve from vertical plate load test at location P-5. Similar curves for locations P-6, P-7 and P-8 were obtained.

From load-settlement curves the failure load of the plate is obtained by intersection tangent method (Leonard, 1962). The values of ultimate bearing capacity of plate, q_{up} , so obtained are listed in column 4 of Table 1.

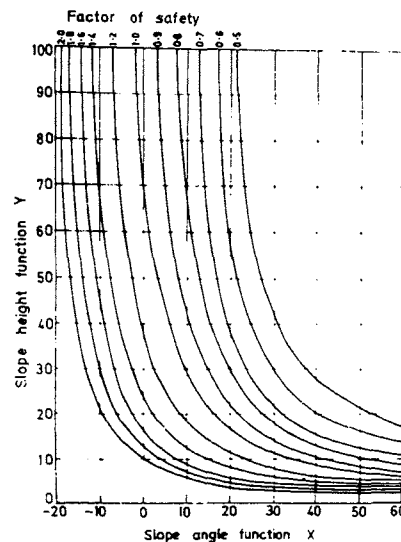
Fig.6 Slope Design Charts

Hoek defined two functions X and Y (Eqs.1 and 2) for estimating the factor of safety from these charts (Fig.6).

Equation 2 takes into account filling of crack with water and Eq.1 is applicable where there is no water table. In the present case taking $i = 46^\circ$, $z_o = 50$ cm, $\gamma = 1.80$ g/cc and $H = 450$ cm, computations were made (Table 2). Column 1 shows the probable values of cohesion for which the corresponding angle of internal friction is to be evaluated. Substituting the value of c and other parameters in Eq.2, the value of function Y is computed. The same is listed in Col.2 (Table 2). For a factor of safety of unity and the computed value of Y, the corresponding value of the function X is read from the chart (Fig.6). The angle of internal friction is then determined from Eq.1 using the value of function X (Tab.2)
