Factor Analysis of Damage to Small Earth Dams Due to the 1995 Hyogoken-Nambu Earthquake

FACTOR ANALYSIS OF DAMAGE TO SMALL EARTH DAMS DUE TO THE 1995 HYGOKEN-NAMBU EARTHQUAKE

Paper No. 3.07

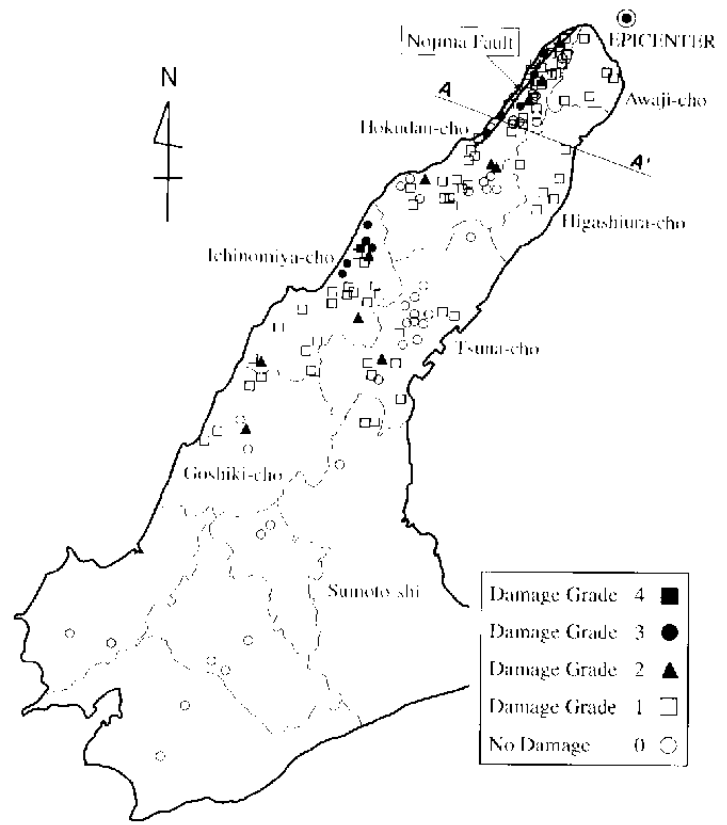
Fig. 1(a) Locations and damage grade of investigated earth dams in Awaji Island

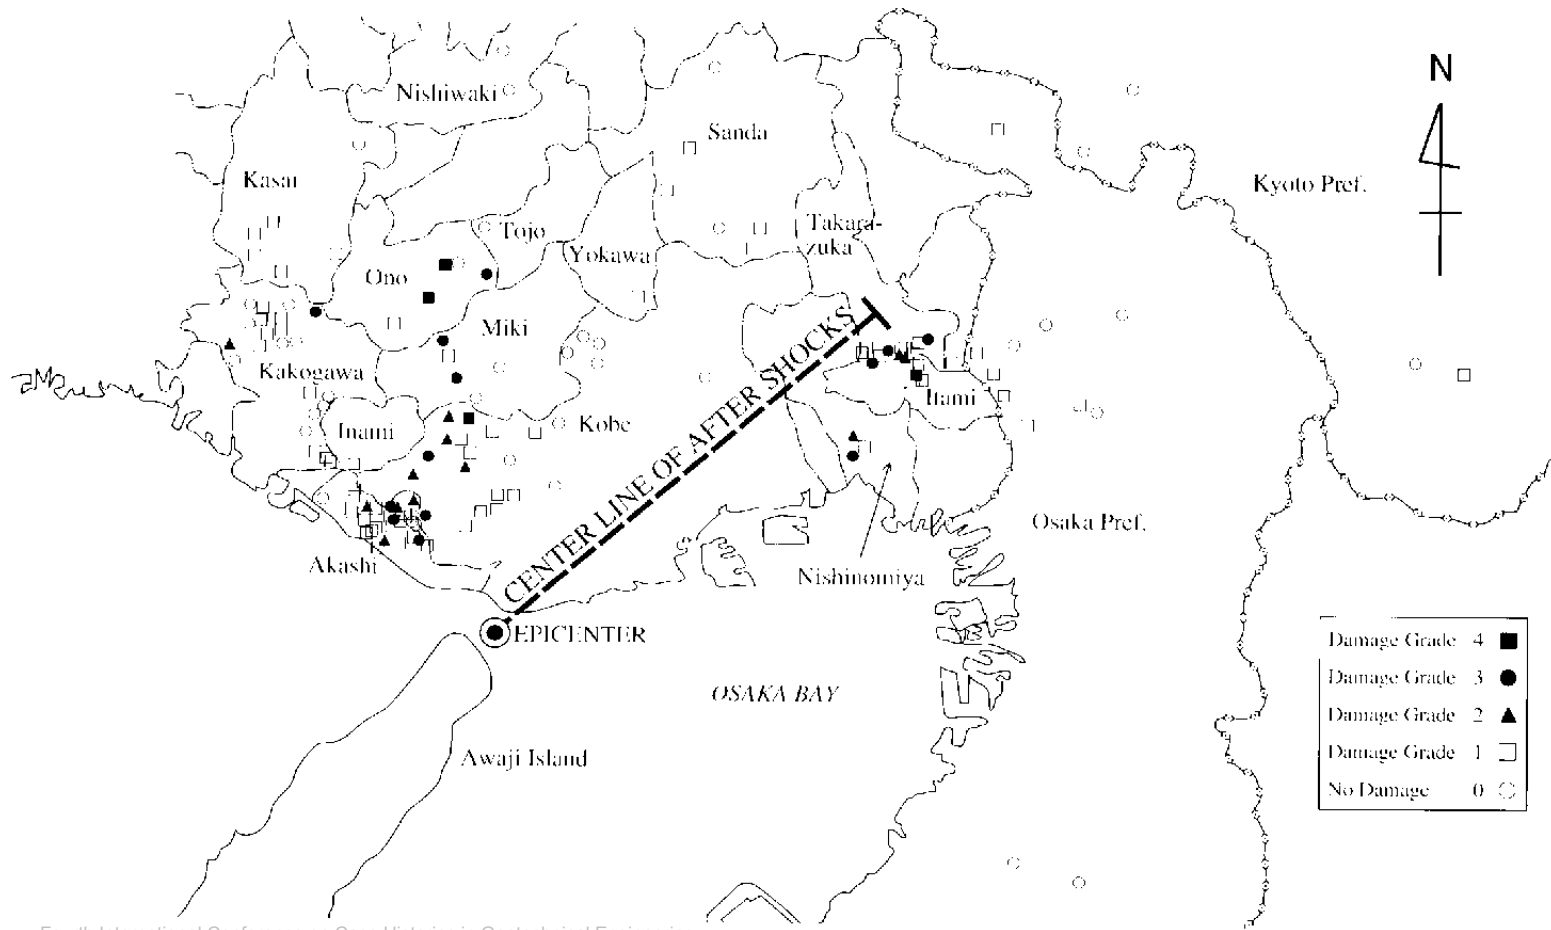
Fig. 1(b) Locations and damage grade of investigated earth dams in Honshu Island

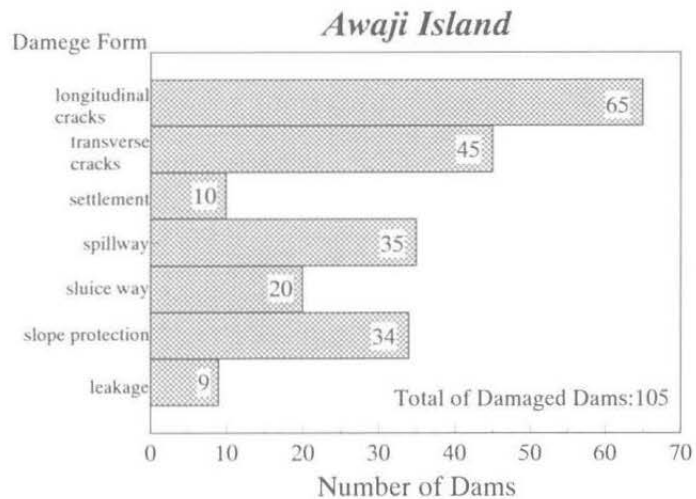
Fig. 2(a) The number of earth dams for each damage form in Awaji Island

We classified the forms of major damage to small earth dams into seven types: longitudinal cracks, transverse cracks, settlement, damage of spillways, damage of sluice ways, damage of slope protections, and leakage. Figure 2 shows the

number of dams for each damage form; (a) indicates in Awaji Island and (b) in Honshu Island. The most popular form of damage was longitudinal cracks. Over sixty percent of damaged earth dams occurred longitudinal cracks. Most of the dams damaged severely (over Grade 3) were those of the longitudinal cracks. The damage of the dams in the area over 30 km away from the aftershocks area on Honshu Island was

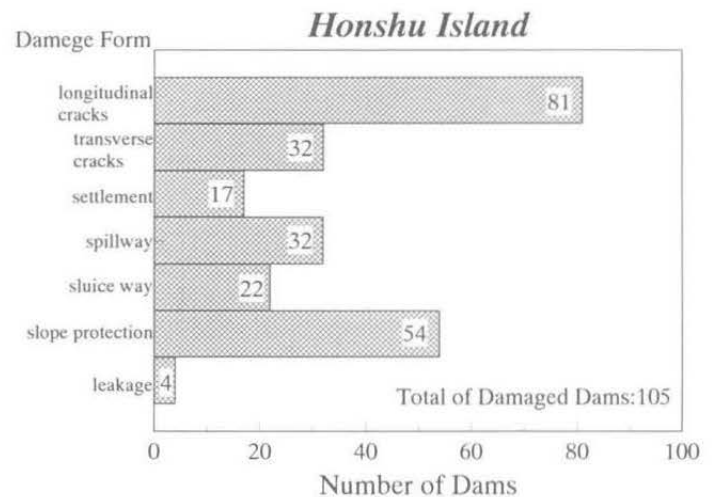
Fig. 2(b) The number of earth dams for each damage form in Honshu Island

mainly to slope protections, but the damage was slight (Grade 1).

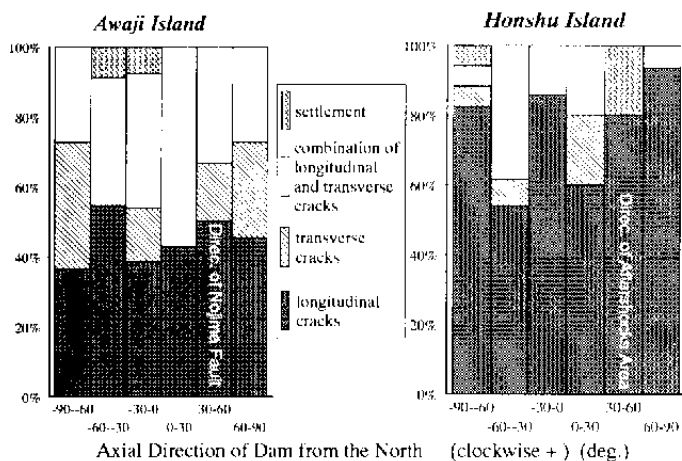
Fig. 3 Relations of damage forms with axial direction of damaged earth dams

Figure 3 shows the percentage of each major damage form for each range of axial direction of dam. It seems that there is no special relationship between the form of damage and axial direction of dams.

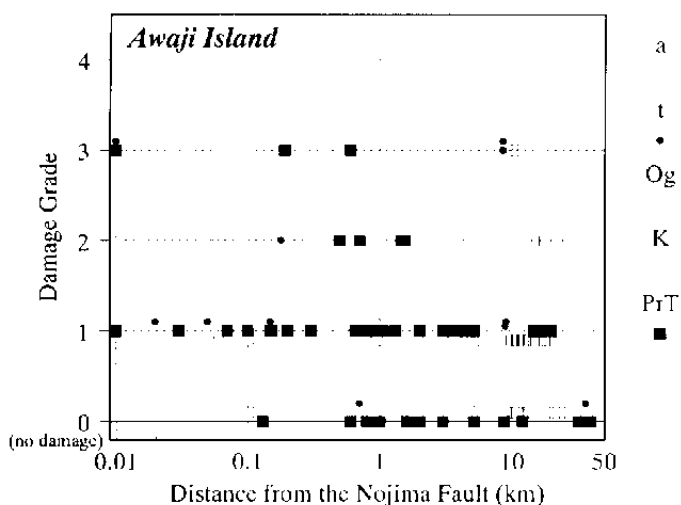
Fig. 4(a) Relations of damage grade of earth dams with distance from the fault and geological stratum of dam foundation in Awaji Island

Figure 4 shows the relations between damage grade of earth dams and the closest horizontal distance from the fault; (a) indicates in Awaji Island and (b) in Honshu Island. The lateral axis in Fig. 4 indicates the distance from the Nojima Fault in Awaji Island, and the distance from the center line of the aftershocks area in Honshu Island. Symbols in Fig. 4 differ by the geological stratum of the foundation of each dam shown in Table 2.

Awaji Island The damage grade of dams decreases with increase in distance from the fault, for the dams on the stratum

prior to the Osaka group over 10 km away from the fault. Even within a few kilometers of distance from the fault, there was no dam damaged in Grade 4 severely, and some of these dams suffered no damage. The earthquake ruptures of the Nojima Fault passed just near about ten earth dams. In spite of the location, these ten dams suffered damage, the grades of which were only Grade 1 to 3. None of the dams collapsed. Some of the dams were undamaged. A small dam was directly above the Nojima Fault. It suffered a failure of the spillway and only a medium damage to the downstream body.

Awaji Island There are few earth dams on alluvium or terrace deposits, which is of young geological age, because the distribution of the alluvium and terrace deposits in Awaji Island is limited to narrow areas. The younger the geological stratum of a dam foundation and the longer the distance from the Nojima Fault to the dam, the severer the damage to the dam, for the dams on the stratum of the Pre-Quaternary Age.

Next, the dams with a foundation prior to the Tertiary Age suffered only slight damage of under Grade 1 if over two kilometers from the Nojima Fault.

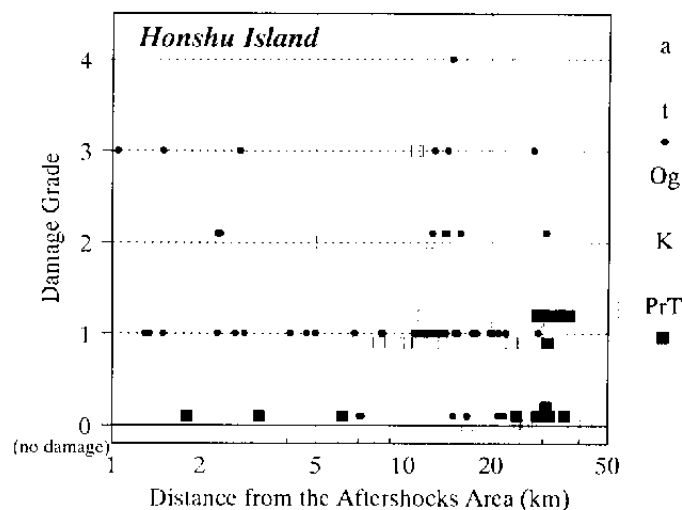
Fig. 4(b) Relations of damage grade of earth dams with distance from the fault and geological stratum of dam foundation in Honshu Island

Honshu Island The attenuation of damage to dams was not observed clearly because we focused our investigation on severely damaged earth dams far away the fault. In spite of the long distance from the fault, several dams on alluvium, terrace deposit and diluvium of the Osaka group suffered severe damage. Three earth dams on the Osaka group of 20 to 30 km away from the fault suffered large-scale slides (Damage Grade 4). The view of one of them is shown in Photo. 2. These dams were constructed over 70 years ago and had shapes with steep slopes.

Honshu Island The earth dams with higher damage than Grade 2 were limited to those constructed on alluvium, terrace deposits and the Osaka group. The earth dams with geological foundations prior to the Tertiary Age were not damaged or limited to slight damage.

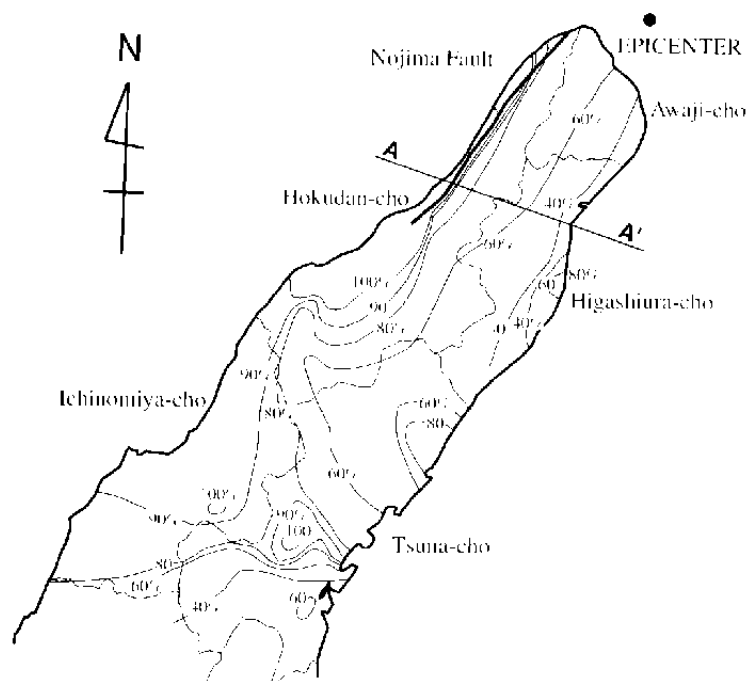
Fig. 5 Distribution of the ratio of the overturned tombstones against a total of the tombstones surveyed at each graveyard in the northern part of Awaji Island

Figure 5 shows the distribution map of the ratio of overturned tombstones obtained from our investigation at the northern part of Awaji Island. The geological cross section (Mizuno et al., 1990) of the line A-A' drawn in Fig. 1 (a) is shown in Fig. 6. The damage grades of earth dams and the percentages of overturned tombstones at graveyards near the line A-A' are also shown in Fig. 6. We compared Fig. 5 with the distribution map of damaged dams in Fig. 1(a) and evaluated Fig. 6. The percentages of overturned tombstones exceeded eighty percent in the areas where the damage to dams was over Grade 3. This suggests that very strong earthquake motions were experienced in the areas.

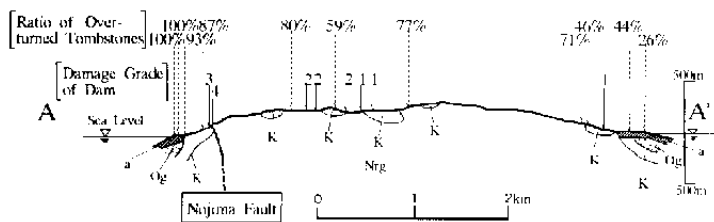
Fig. 6 Distribution of damage grade of earth dams and the ratio of the overturned tombstones in the geological cross section (Mizuno et al., 1990) of line A-A' shown in Fig. 1 (a) and Fig. 5 of north Awaji Island

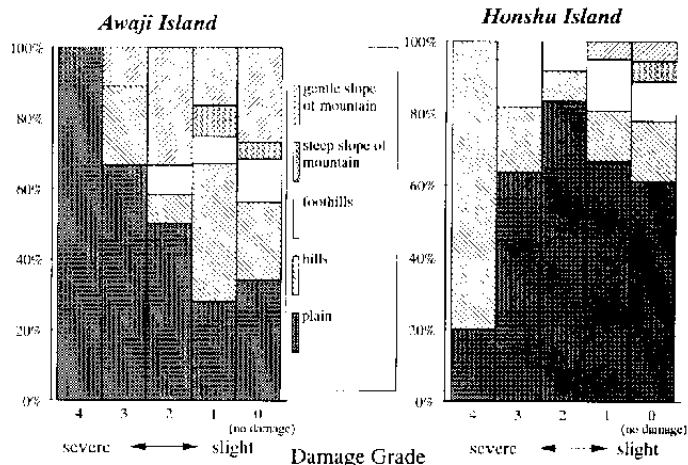
Fig. 7 Relations of damage grade of earth dams with topology at dam sites

We classified the topography of dam sites into plains, hills, foothills, steep slopes of mountain, and gentle slopes of mountain. Figure 7 shows the percentage of each topography for each damage grade.

Awaji Island The damage to earth dams was severer in the order of plains > hills > gentle slopes of mountain > foothills > steep slopes of mountain from Fig. 7, although the number of investigated dams is different for each topography. Damaged dams of over Grade 3 are concentrated in plains and hills, which is also related with their geology.

Honshu Island Most of the damaged dams were ones constructed in plains or hills. Earth dams at gentle slopes and steep slopes of mountains suffered practically no damage, although few dams investigated at the topographical areas. Topography of plains reflects that the foundation geology is the alluvium deposit.

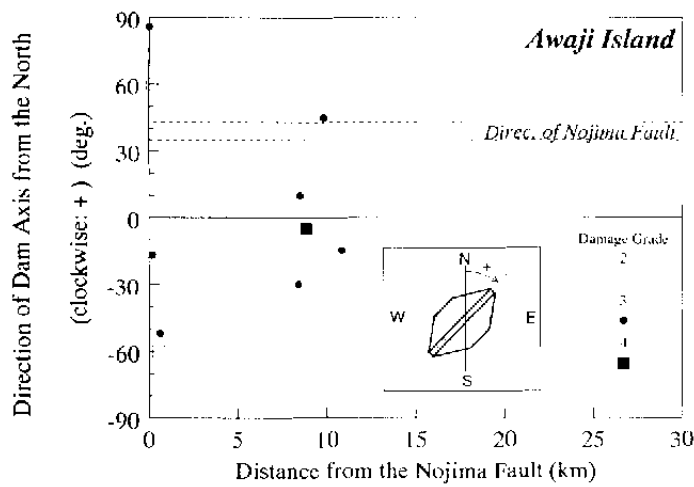
Fig. 8(a) Distribution of axial direction of damaged earth dams in Awaji Island

Figure 8 shows the relations between axial direction of dam and distance from the fault with damage grade of 2 or higher. The axial direction of dams indicates the differential direction from the north. The differential direction ranges within $\pm 90^\circ$; a plus sign indicates clockwise from the north and a minus sign counterclockwise.

Awaji Island The axial directions of damaged dams were concentrated in the direction of around 30° to 40° from the north even for the dams over ten kilometers away from the fault, with the exception of the damaged dams within a few kilometers from the fault. These directions agree well with the direction of the Nojima Fault. The predominant directions of

the earthquake motions due to the rupture of the fault make right angles with the fault. Hence, Fig. 8 (a) indicates that the predominant direction of earthquake motions agreed with the stream direction of the dams.

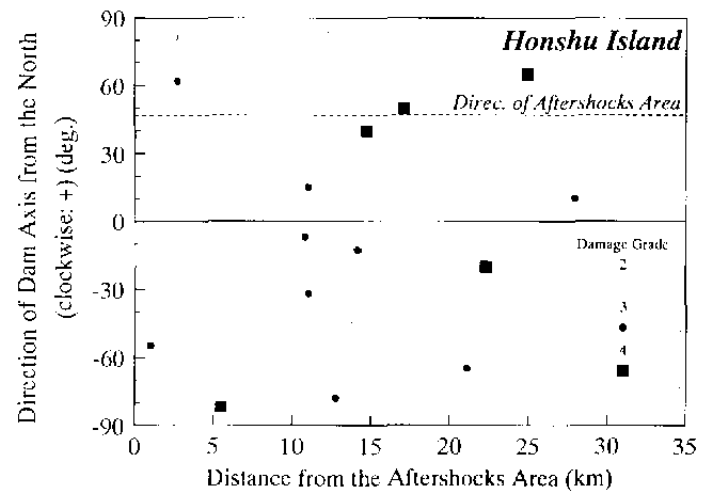
Fig. 8(b) Distribution of axial direction of damaged earth dams in Honshu Island

Honshu Island The axial direction of dams was not clearly related with the damage to dams in Fig. 8 (b) about Honshu Island.

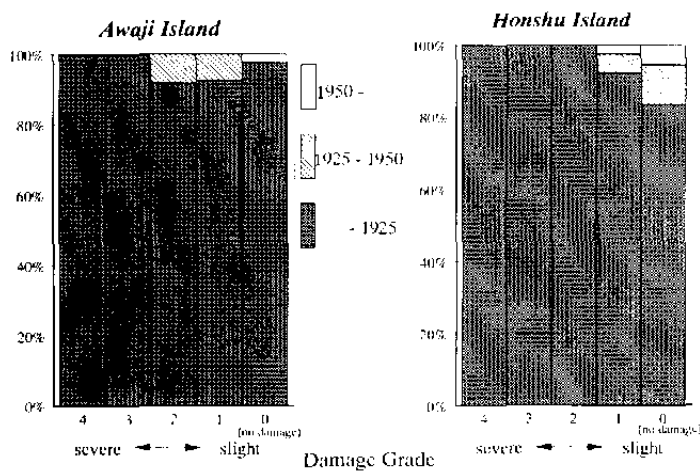
Fig. 9 Relations of damage grade of earth dams with year of completions

The construction method of an earth dam and the structure of a dam body depend on banking techniques, tools and machines available at the time of the construction of dams. The year of completions of an earth dam can thus be used as an index for evaluating the dam structure, construction method and especially the degree of compaction. We divided it roughly into three periods of before 1925, 1925 to 1950 and after 1950. Figure 9 shows the percentages of the period of the completion year for each damage grade.

Awaji Island The small earth dams damaged in Grade 3 or higher were old dams constructed before 1925.

Honshu Island The small earth dams damaged in Grade 2 or higher were old dams constructed before 1925. Two dams on the alluvium deposit in Kakogawa City suffered the damage of longitudinal cracks at the crest and suffered damage of Grade 1, although they were constructed after 1950. Both of them had heights of lower than three meters and steep slopes of sixty to a hundred in a hundred.

The old small earth dams constructed before the early twentieth century were banked by human-power under inadequate construction management and have steep slopes in their cross sectional shapes, that is poorly engineered. The relatively recent earth dams constructed after the 1950's were compacted probably by machines and well engineered. Hence, they were not damaged or very slightly damaged (Grade 1) in spite of the few number of investigated dams.

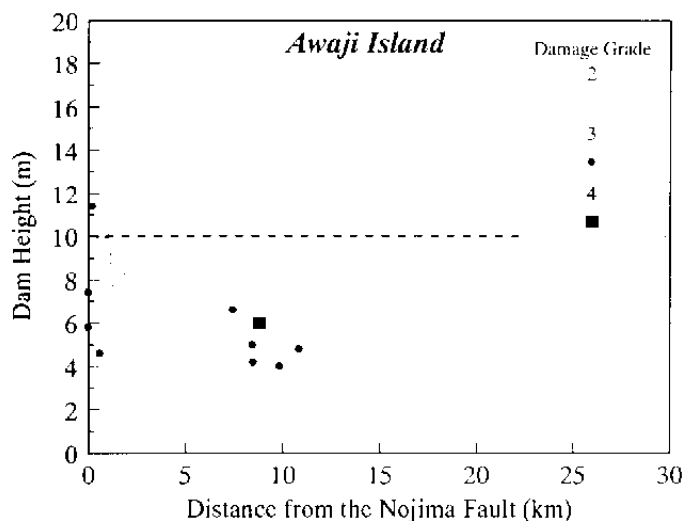
Fig. 10(a) Relations of damage grade of earth dams with dam height in Awaji Island

Figure 10 shows the relations between height of dams, damage grade and distance from the fault for the damaged dams of over Grade 2.

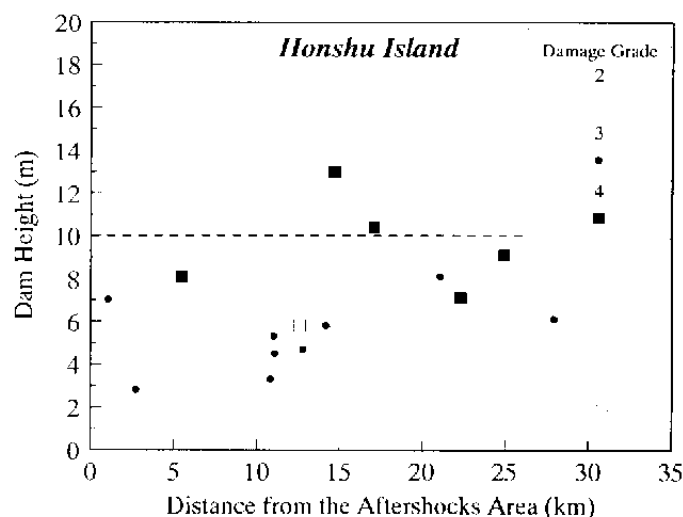
Fig. 10(b) Relations of damage grade of earth dams with dam height in Honshu Island
