Behavior of Reinforced Wall System During the 1999 Kocaeli (Izmit), Turkey, Earthquake

BEHAVIOR OF REINFORCED WALL SYSTEM DURING THE 1999 KOCAELI (IZMIT), TURKEY, EARTHQUAKE

ABSTRACT

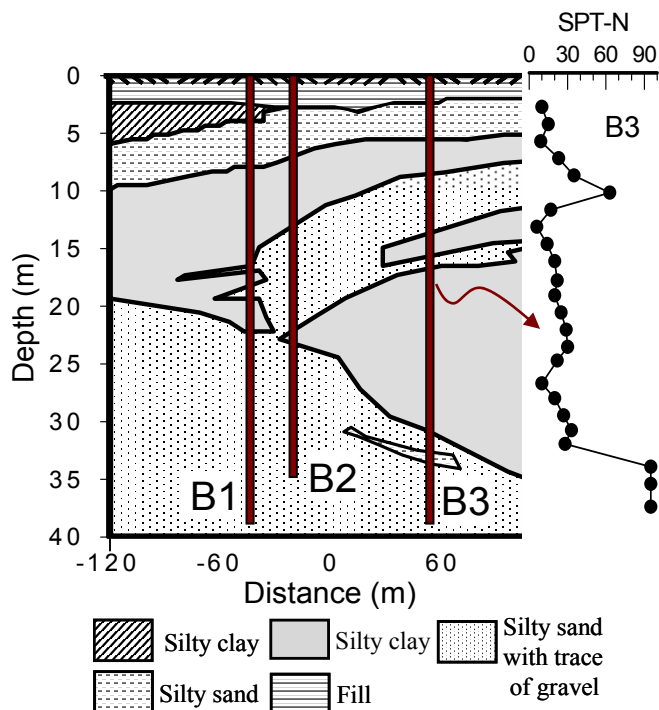
Fig 4. An approximate visualization of subsoil geology along the axis of Arifiye Overpass (modified based on ITU, 1999).

Standard penetration tests (SPT) were conducted by the Turkish General Directorate of Highways (GDH) to gain sufficient subsurface information between both ends of the bridge overpass soon after the earthquake. Three subsurface borings to a depth of 38 m were drilled. Their locations are shown as B1, B2 and B3 in Fig. 2a. A 2-D visualization for the local subsoil conditions along the axis of the bridge overpass is shown in Fig. 4. The ground water table was approximately 5 m below the ground surface.

B1 shows that very soft layers of soil deposits lie under the southern abutment and extend to a depth of 22 m where a dense ($N_{30}=100$) layer of sedimentary deposit (i.e., Pliocene base rock) of silty sand with some gravel was encountered. The loose layers became thicker to the depth of 34 m below the northern abutment as shown in B3, which was the nearest boring to the MSE walls. The soil profile at B3 consisted of a 2.5m-thick fill followed by varying thicknesses of silty sand and silty clay deposits. Loose silty sand and silty clay layers (with $N_{30}< 20$, Fig. 4) below the reinforced walls might have been prone to liquefaction or seismic-induced densification during the seismic
