International Conference on Case Histories in Geotechnical Engineering (2008) - Sixth International Conference on Case Histories in Geotechnical Engineering

Evaluation of the Taum Sauk Upper Reservoir Failure

EVALUATION OF THE TAUM SAUK UPPER RESERVOIR FAILURE

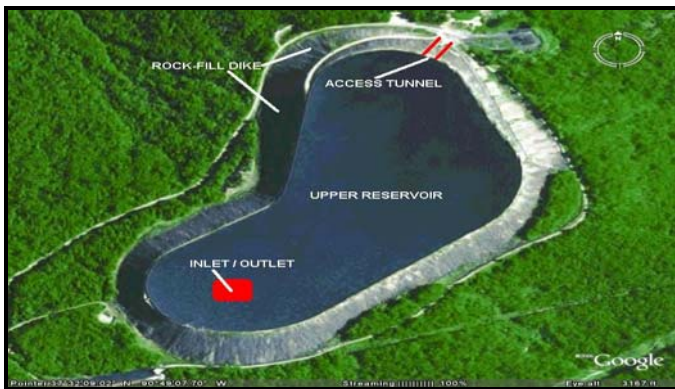
Figure 4. Aerial view of Upper Reservoir.

The following is a summary of the components that comprise the Taum Sauk Upper Reservoir. The information was obtained from a report provided by AmerenUE and made available soon after the failure (Rizzo, 2006). This evaluation focuses on the upper reservoir at the top of Proffit Mountain. Figure 4 illustrates an aerial view of the Upper Reservoir with locations of various components discussed below. The upper reservoir dike is about 6,500 feet long and closes to form a kidney-shaped reservoir. The concrete-faced dumped rockfill dam (CFRD) had a maximum height in the range of 85 feet above the base of the
